Outward leaning walls

John E M Macgregor

Society for the
Protection of
Ancient Buildings

Technical pamphlet 1

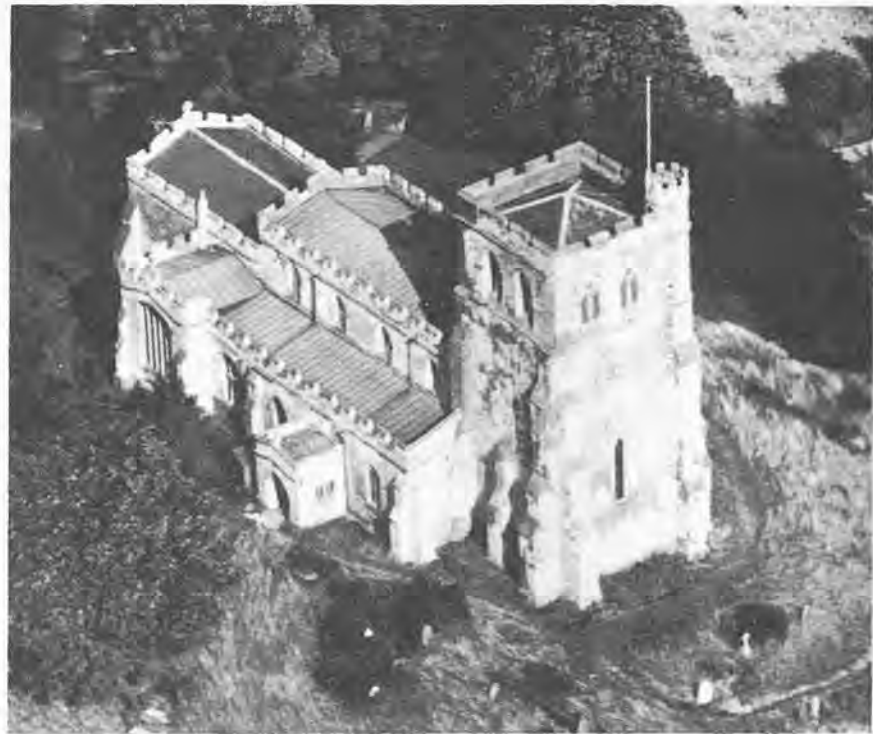
fig 1 (above): Edlesborough church, Buckinghamshire

The invisible stabilization of outward-leaning walls has been a continuous study of mine both in theory and in practice during my 50 years as an architect. During this time I have dealt with a large number of historic buildings of all types, from castles to almshouses, and many churches dating from Saxon times onwards. The defect occurs in practically every type of building, but most commonly in the medieval church where walls are massive and not deeply founded, such as the parish churches of Castle Hedingham, Ivinghoe, Edlesborough, Kilsby and Orby.

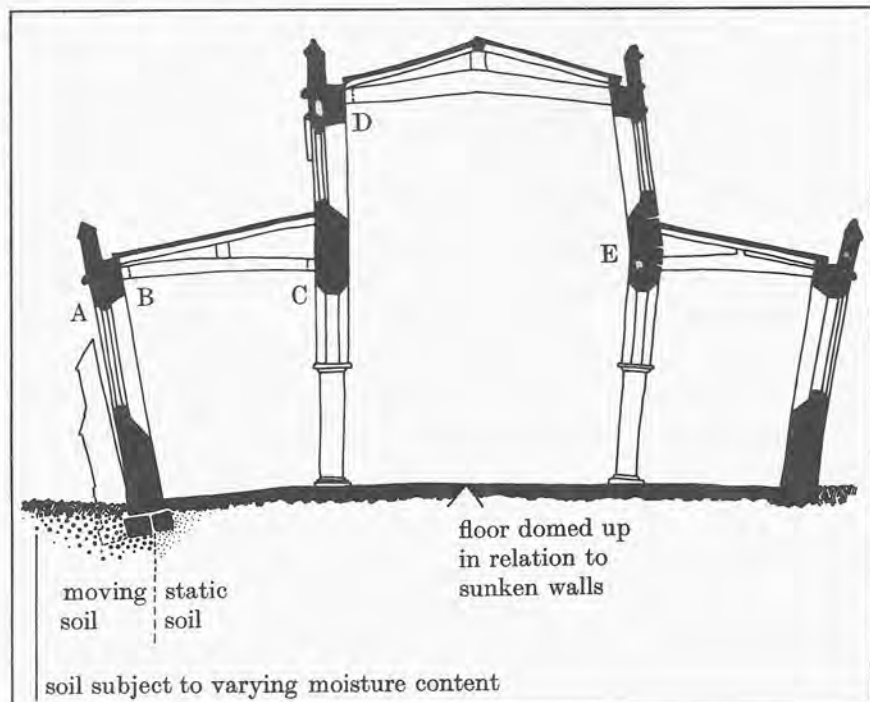
fig 2 (right): The effects of intermittent saturation of the soil

The effect of this destructive action is, however, not confined to external walls, as can be seen in Fig. 2. Over a period of centuries the force of the continuing defect is so great that the north and south walls of a church draw outwards (A), thus either reducing the bearing of the aisle roofs or, where these were anchored securely at the ends (B), transferring the stress to the nave arcade walls which in turn have been drawn apart (C). Where this has occurred either the nave roof bearings have been perilously reduced (D), or the nave roof structure has held the clerestory walls together so that they have buckled within their height (E).

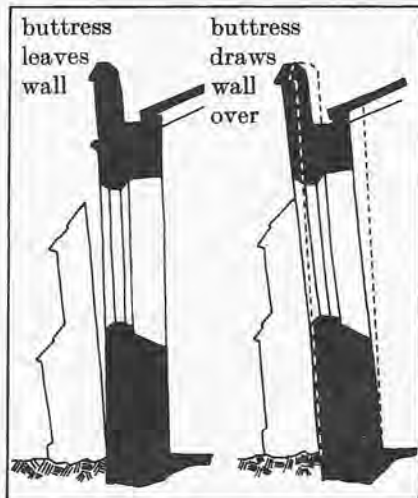
There are, however, many instances where there is no such obvious physical stress to account for the failure. It is not uncommon to find aisle walls leaning outwards, leaving roof timbers and tie beams behind. The result of this is often that there is little bearing left for the roof construction. Buttresses built against leaning walls to stabilise them are often found to have pulled away from the wall, or, when bonded into the original masonry, to have pulled the wall further over.

fig 3: The failure of an external buttress

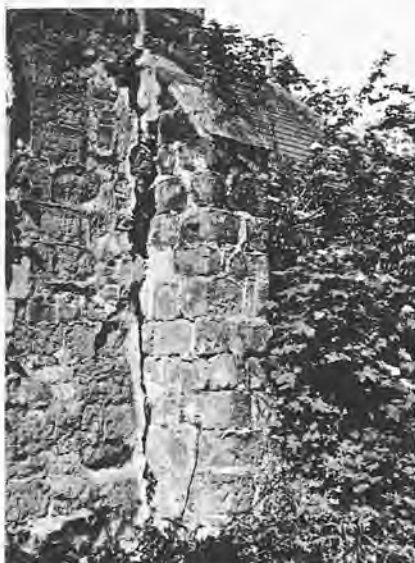
In 1913 I was carrying out repairs to *Orston church*, Nottinghamshire, under Mr William Weir, who in my opinion was the finest exponent and practitioner of the Society's methods. He pointed out to me the aesthetic and functional failings of external buttresses. The job was being conducted by direct labour methods. He made it clear that, not only do these buttresses mar the appearance of the building, they also fail in their purpose by falling away from the wall (Fig. 3), or even make the defect worse by pulling the wall further out of plumb. For these reasons, the addition of external buttresses should be scrupulously avoided wherever possible (Fig. 4). What, then, are the alternatives?

fig 4: Buttress failure at All Saint's church, Malby le Marsh, Lincolnshire

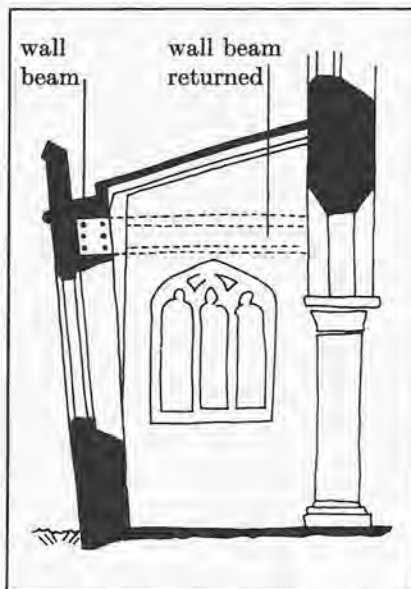
fig 5: Wall-top beam inserted and returned along the end walls. The wall-top beam must be anchored securely to the surrounding masonry.

At *Orston church*, the fine three-foot-thick, 13th-century north wall of the north aisle was leaning about 18 inches out of plumb. Mr Weir instructed me to remove the masonry about two feet down from the wall plate from the inside, cutting back almost to the outer facing stones, thoroughly brushing out the loose mortar and moistening the stonework, and then to fill up with concrete behind, shuttering on the inside face and embedding reinforcing rods. This concrete wall-head was inserted in sections of three or four feet, with the rods hooked together for the full length of the wall and returned along the east and west walls, thus using them as restraining buttresses (Fig. 5). When the shuttering was removed, the wall was plastered with lime mortar, so that the work was entirely invisible. I visited the church half a century later and found the structure perfectly sound, despite the external surface scars of the war damage that had occurred in the interval. It is worth noting that the advantage of far greater leverage is obtained by restraining a leaning wall at the top, horizontally, than vertically at the base.

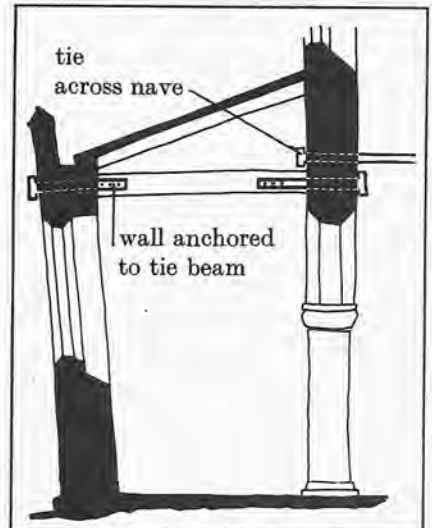
fig 6: Tie rod across the church aisles and nave

At *Kilsby*, Northamptonshire, Mr Weir anchored the aisle tie beams into the north and south walls and linked them with tie rods across the nave (Fig. 6). This form of wall-top restraint is now common practice, but the basic principles of horizontal strengthening can be applied using other materials and in different types of buildings. For instance, when the Society itself moved to 55 and 57 Great Ormond Street, London, in 1938, the front wall was already bulged and a two-

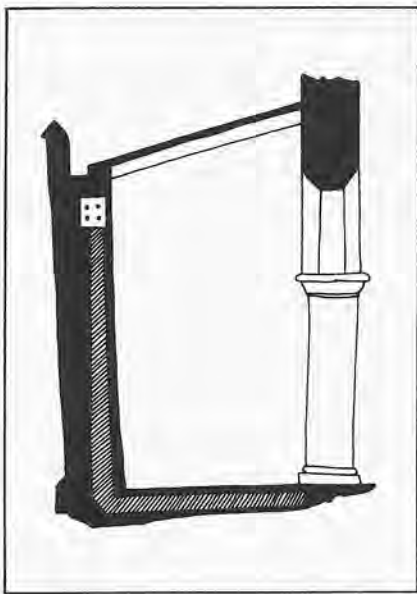
fig 7: Wall-top beam restrained by an internal buttress at Ivinghoe church, Buckinghamshire

The same method was used at *Ivinghoe*, Buckinghamshire, just after the last war. First, an internal buttress was inserted in the north wall (Fig. 7), and two other similar buttresses in the south wall were carried right through the wall and up behind the flint facing.

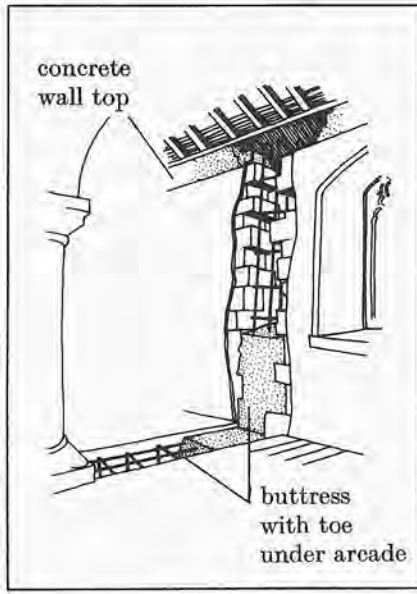
fig 8: Sketch showing method of inserting internal buttress and wall beam

When chases are formed for internal buttresses, they should be cut to provide irregular projections into the masonry on either side and taken back nearly to the external

facing of the wall to obtain maximum bond behind the shuttering. The concrete should be in mass form of weak mix, say 8 to 1, and can be made up largely of the material removed from the wall.

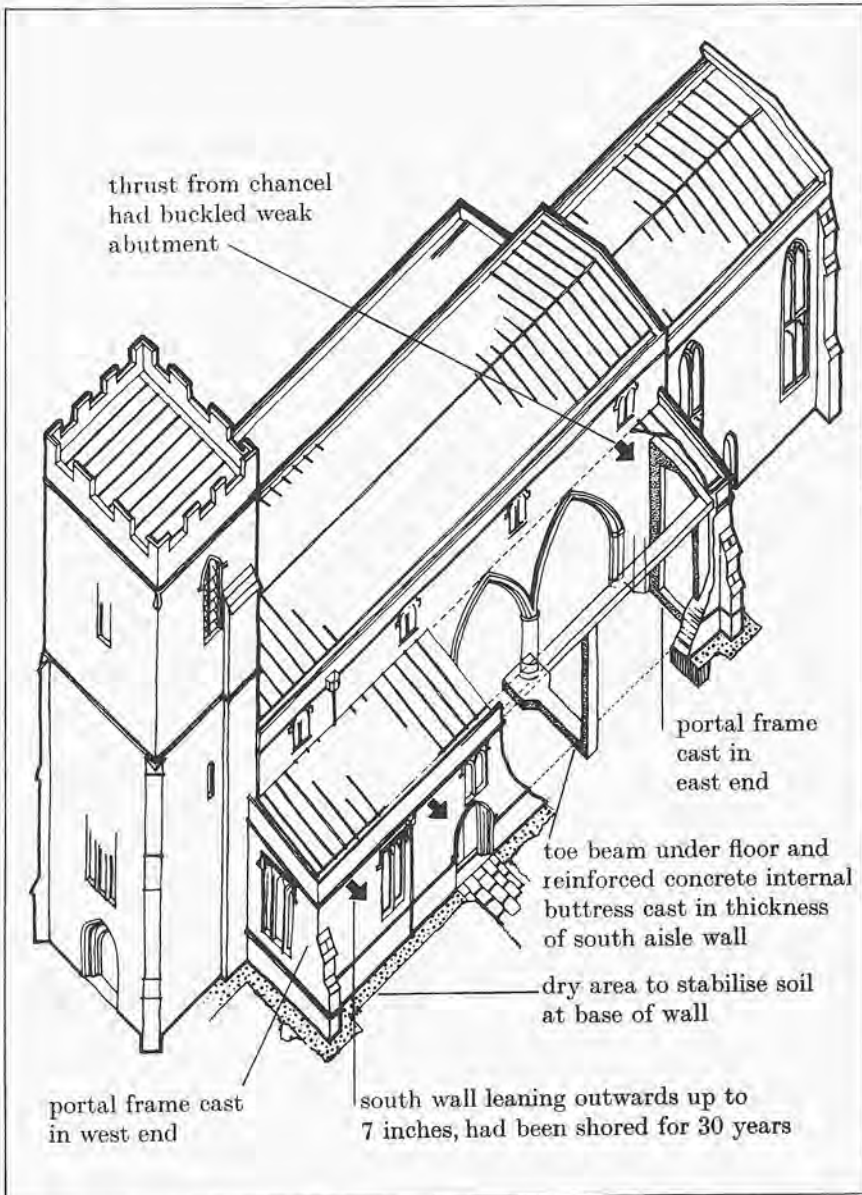
fig 9 (below): Axonometric projection of Marston St Lawrence church, Northamptonshire, showing the strengthening of the aisle wall.

At *Marston St. Lawrence*, Northamptonshire, I recommended the insertion of internal buttresses in the south wall. Some nine years later I inspected the building again, on behalf of the Historic Churches Preservation Trust, and repeated my recommendation. After a further period of years, during which other methods of repair were considered and discarded, my suggestions have been included in a programme of work that has now been carried out most economically by Donald Insall and Associates (Fig. 9).

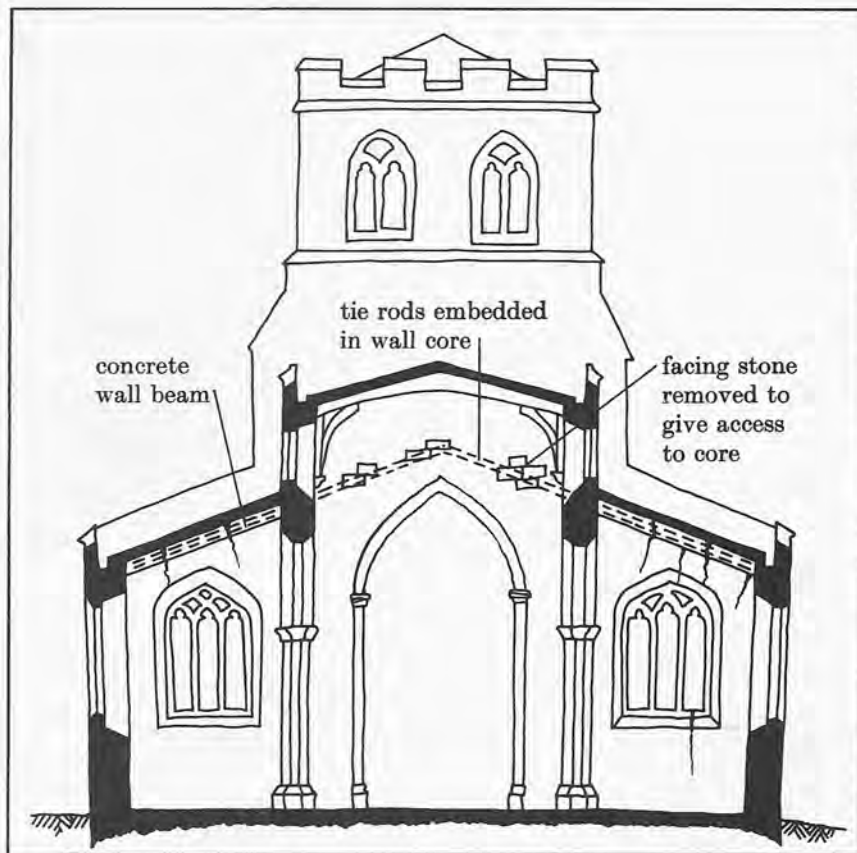
At *Edlesborough*, Buckinghamshire, the north and south aisle walls bulged outwards causing serious vertical fractures in the west wall on either side of the tower. A reinforced concrete tie was inserted in the thickness of the wall in short linked lengths, which, as it was faced inside and out in good ashlar, had to be burrowed from point to point. This tie started at the south-west corner of the church, was carried up in the west wall, over the tower arch and down to the north-west corner (Fig. 10, over)

fig 10: Outward leaning north-west and south-west corners restrained by reinforcement in core of west wall linking wall tops, at Edlesborough church, Buckinghamshire

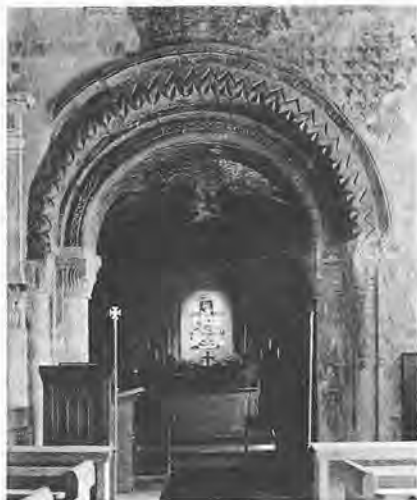
At *Kempley* church, Gloucestershire, the barrel-vaulted chancel, which is covered internally with 13th-century frescoes (Fig. 11), had sunk at the crown and was in a perilous condition. I recommended that a reinforced concrete floor beam should be laid and carried through the walls and up in the form of buttresses outside. The repair was carried out satisfactorily (Fig. 12).

fig 11: The barrel-vaulted chancel of Kempley church showing the 13th-century frescoes (Country Life)

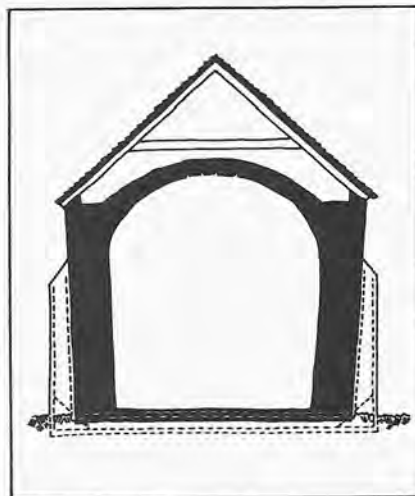
fig 12: Outward-thrusting vault restrained by buttresses linked by a floor beam

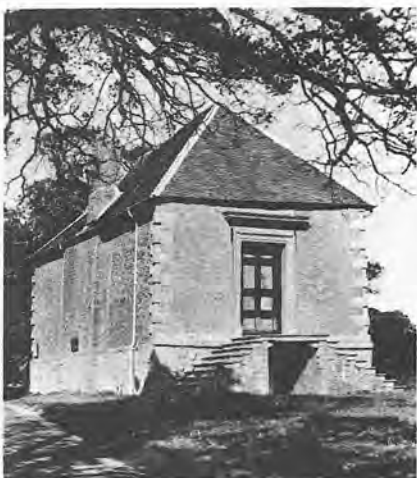
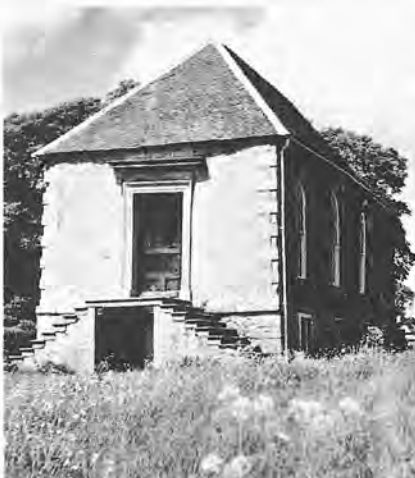
fig 13 (left): Newtown Town Hall, Isle of Wight (National Trust)

Ashlar-faced structures can also sometimes be treated in this way, but there is an alternative which is well worth considering. That is to draw the whole, or the greater part of the wall back to the vertical and retain it there. Two cases may be instanced. At *Newtown*, in the Isle of Wight, the 17th-century Town Hall stands on clay soil, and the ground falls away steeply westwards. The whole west gable was hanging over more than one foot in 12 above ground-floor level (Fig. 13). Below this the basement masonry was in fair condition and was easily repaired. It was decided to cut a chase along the inside face of the gable wall at ground-floor level to form a hinge, and then to pull the whole wall above this back to the vertical. The wall had been temporarily supported by raking shores.

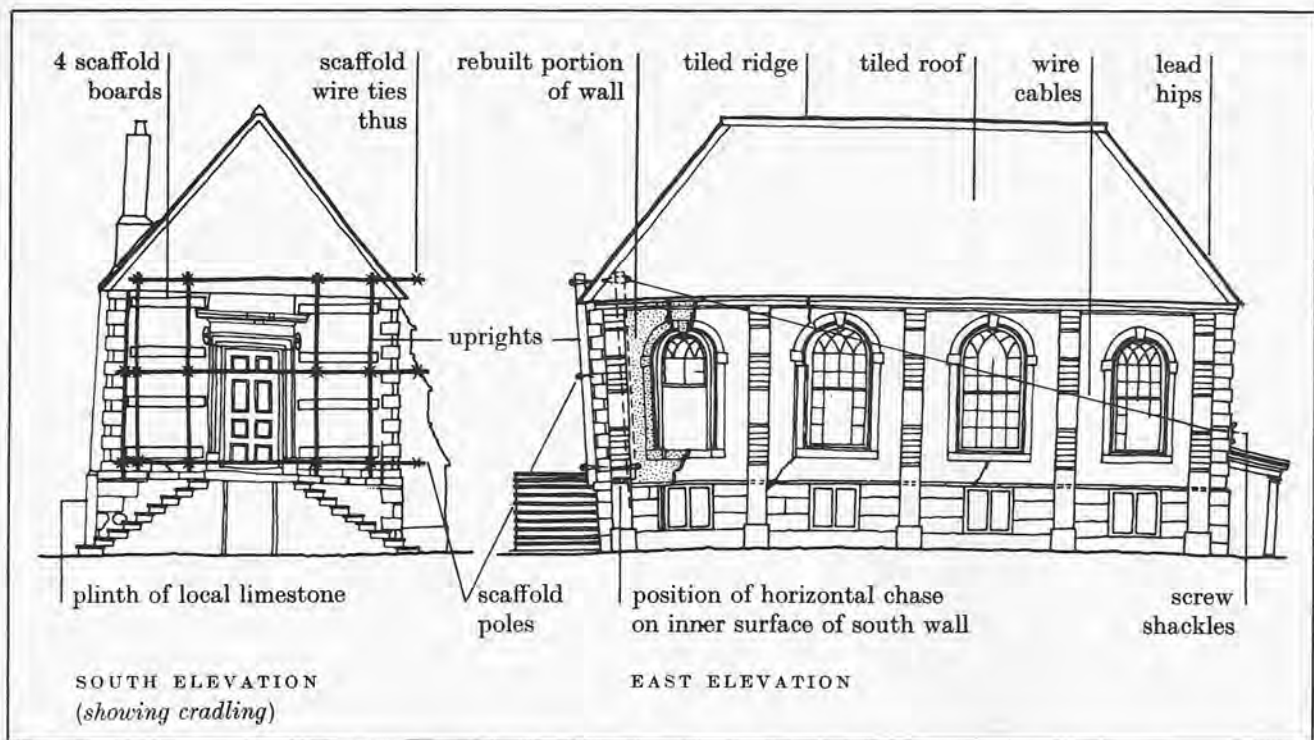
fig 14: Drawing back the west wall of Newtown Town Hall, Isle of Wight

A timber framework was erected against the facade, from the top of which steel cables were carried through the whole length of the building through the east window and attached with tightening gear to timbers against the outside face. The disintegrated brickwork and stone quoins of the two south-west corners were taken down, and the whole west wall gently drawn back to the vertical (Fig. 14, over).

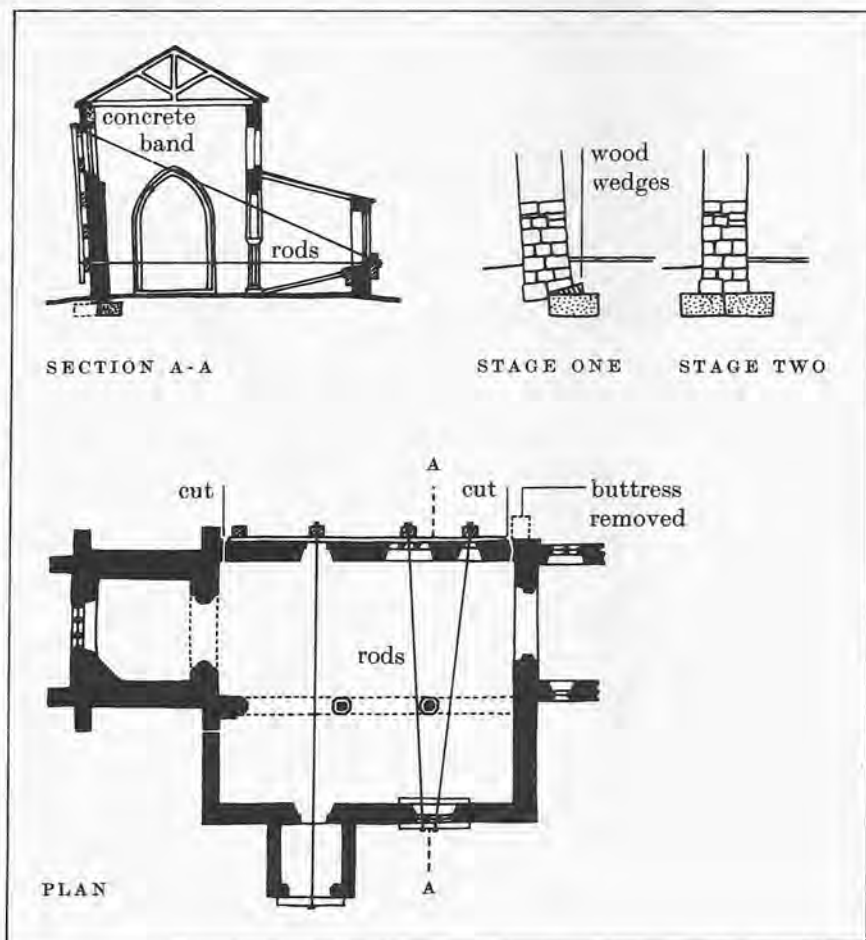
The wall overhung by almost two feet in the centre, and tall buttresses had been built against it, the one at the west having fallen away. Owing to the irregularity of the fenestration and the thinness of the upper part of the wall, the insertion of an internal buttress was impracticable. It was decided, therefore, to strut up the roof, cut and disconnect the full height and thickness of the wall at either end of the leaning portion, and pull it back in one piece. The procedure was comparable to that followed at Newtown, a rough cradle being erected against the outside, and the iron rods, subsequently used as reinforcement in the concrete wall top, slung across the aisles and nave to timbers set against the outside of the south aisle (Fig. 15).

fig 15 (right): Straightening the north wall of the nave of Orby church, Lincolnshire

The masonry at the base of the wall was removed on the inside up to its centre, and a new concrete foundation inserted in short lengths in its place. Folding wedges were placed temporarily beneath the masonry above. When this had been completed for the full length, the wedges were carefully removed, and the weight of the sagging rods was sufficient to draw the wall back to the vertical. It was then a straightforward job to insert the outer part

of the new foundation, form a concrete wall top, re-bond the drawn-back portion to the masonry on either side, and pick up the roof. Now that the buttress has been removed, there is little sign of the operation.

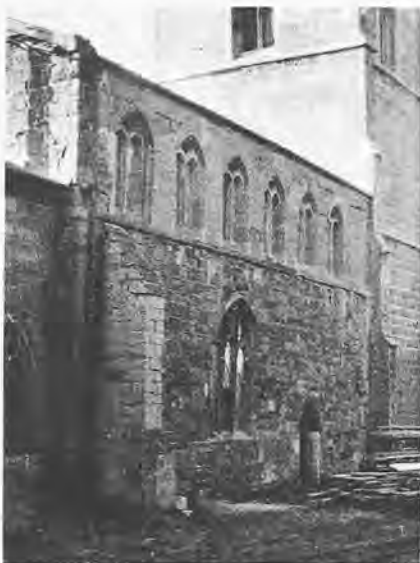
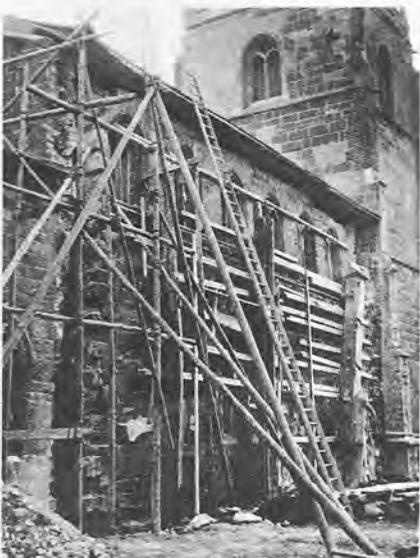
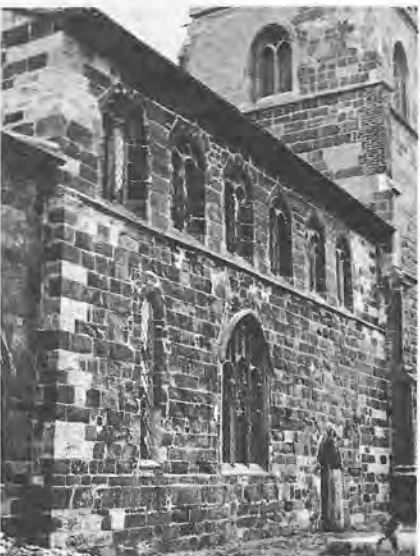
The three photographs (Figs. 16, 17 and 18) show the north wall before, during and after the operation, the overhanging eaves indicating the amount the wall was pulled back beneath the roof.

figs 16, 17 and 18: The progress of the work of pulling back the north wall of *Orby* church

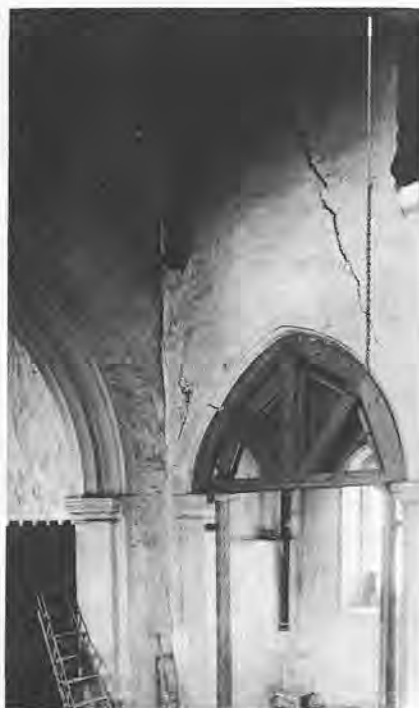
It is common to find that a western tower leant over early in its life, and that after a certain amount of foundation shrinkage stability was reached. In such a case, it is folly to interfere with it. At *Puttenham*, Hertfordshire, the tower went over early in its life in one mass, drawing the impost of the nave arcades over with it (Fig. 19). Some 40 years ago alarm was felt, and temporary shoring was carried out that consisted of raking shores against the west walls of the aisles, and centring placed in the western arches of the arcades. The trouble had apparently been diagnosed quite wrongly, the assumption being that the nave arches had thrust the tower over, whereas in fact the tower had pulled the arch.

fig 19: The effect of the drawing away of the tower on one of the nave arches at *Puttenham* church, Hertfordshire

The stability was simply and economically attained by dissociating the tower structure entirely from that of the arcades by the insertion of expansion joints. The thrust of the arches was restrained by a reinforced concrete beam inserted in the wall immediately above them which was carried down to the arch springing. Iron plates, with graphite as a lubricant between them, were inserted so that the impost beneath the abutments was free to move with the tower. An expansion joint was formed between the arcade wall and the tower with a concrete beam at eaves level projecting into the tower to give lateral stability.

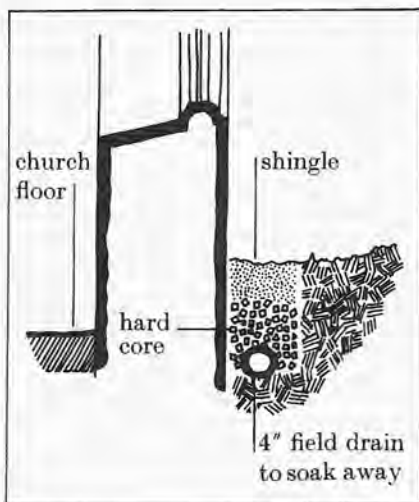
fig 20: Channelling ground moisture away from the building through a field drain: There is a tendency for the field drains to become blocked. The drain should therefore be provided with inspection chambers or be dug out and re-laid every ten to 15 years. Rainwater pipes should not be allowed to discharge into the drainage trench; they should be connected to separate drains that lead the water away from the building.

If, instead of this excavation and paving, the soil is left at its natural level, but a narrow trench is dug to about one foot below the floor level with a porous agricultural land drain in it, and then covered with hard core and finished in shingle, ground moisture approaching the building is immediately trapped and led away by the field drain (Fig. 20). As the period of actual rainfall is so much shorter than the intervening dry periods, the hard core is never saturated, but acts almost continuously as a sponge drawing the moisture out of the wall. It is essential that the field drain is led to special soak-aways, and the rainwater from the down pipe is dealt with by a quite independent drainage system. The wall-top beam must be anchored securely to the surrounding masonry.
