Strengthening timber floors

by John E M Macgregor OBE, FSA, FRIBA

Strengthening Timber Floors: A notice from the SPAB Technical Panel

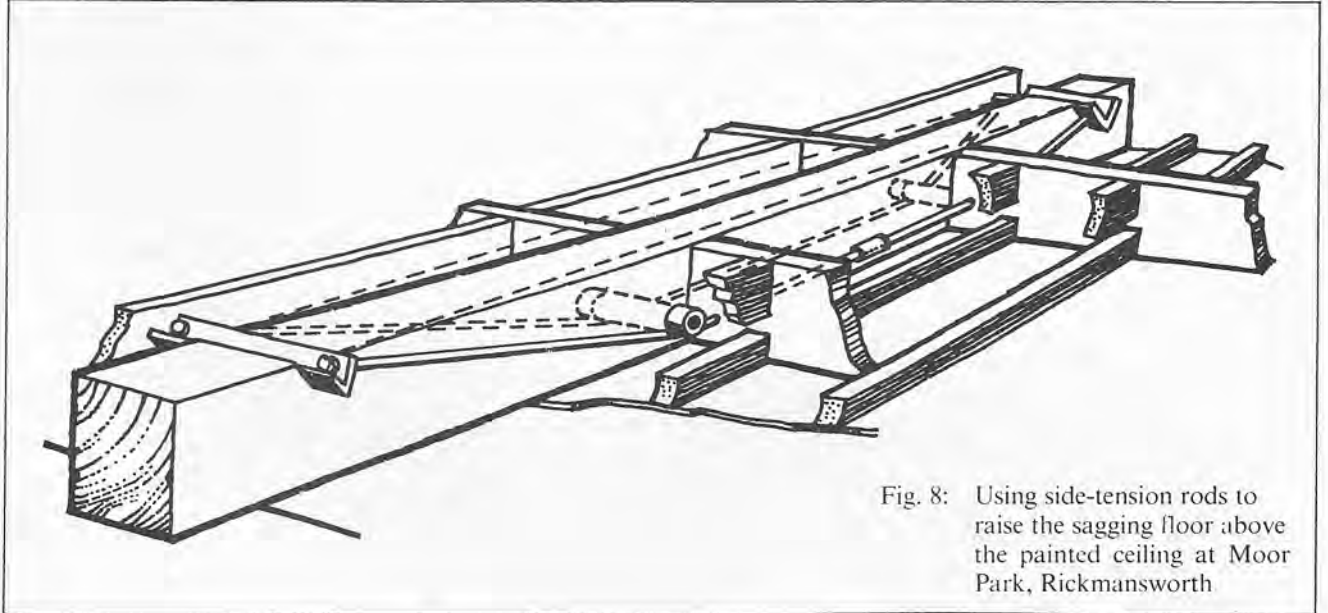
Fig. 8: Using side-tension rods to raise the sagging floor above the painted ceiling at Moor Park, Rickmansworth

In order not to disturb the ceiling, the floorboards above were removed, the beam was drilled through just above the ceiling, and two substantial steel-bearing tubes inserted. Angle irons

were notched into the upper side at either end and cranked steel tie rods were inserted through the end of the angle irons and under the projecting ends of the bearing tubes with nuts and washers at the ends with left-and-right-threaded union in the centre (Fig. 8). On tightening, the sag was reduced without appreciable effect on the painted ceiling.

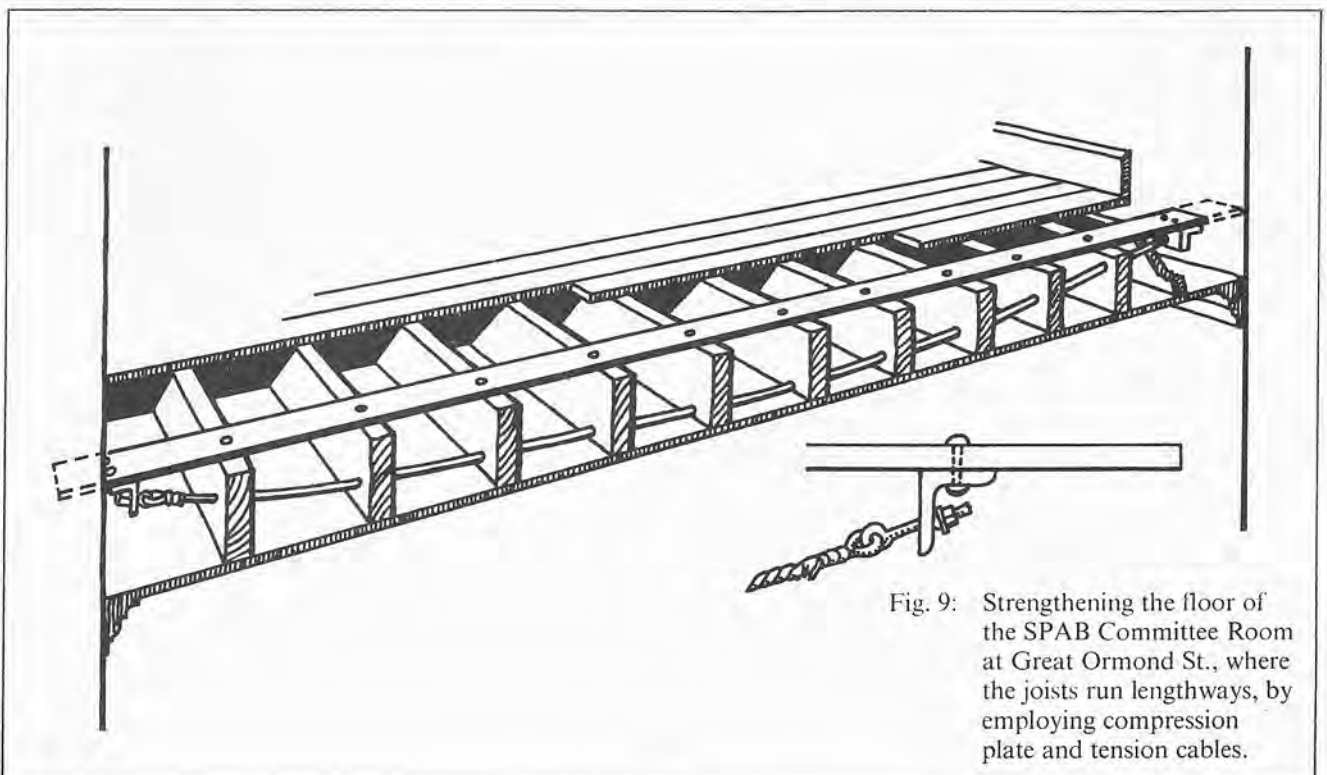
A sagging floor is found occasionally to be constructed with its joists running lengthwise, and it is desirable to

Fig. 9: Strengthening the floor of the SPAB Committee Room at Great Ormond St., where the joists run lengthways, by employing compression plate and tension cables.

strengthen it in its thickness by breaking the joist span in the centre in a transverse way. This problem arose in the adaptation of 55 and 57 Great Ormond Street, in London, for use as the offices of the Society for the Protection of Ancient Buildings. It was overcome by removing two or three floorboards, measuring and drawing a section through the joists on which was

plotted a sagging suspension line. In accordance with this line a series of holes was bored through each joist and a steel cable threaded, the ends of which were anchored to a flat steel plate passing on top of the joists and into the walls at either end (Fig. 9). By stressing this cable each joist is carried in the centre of its span as if on a cross beam.

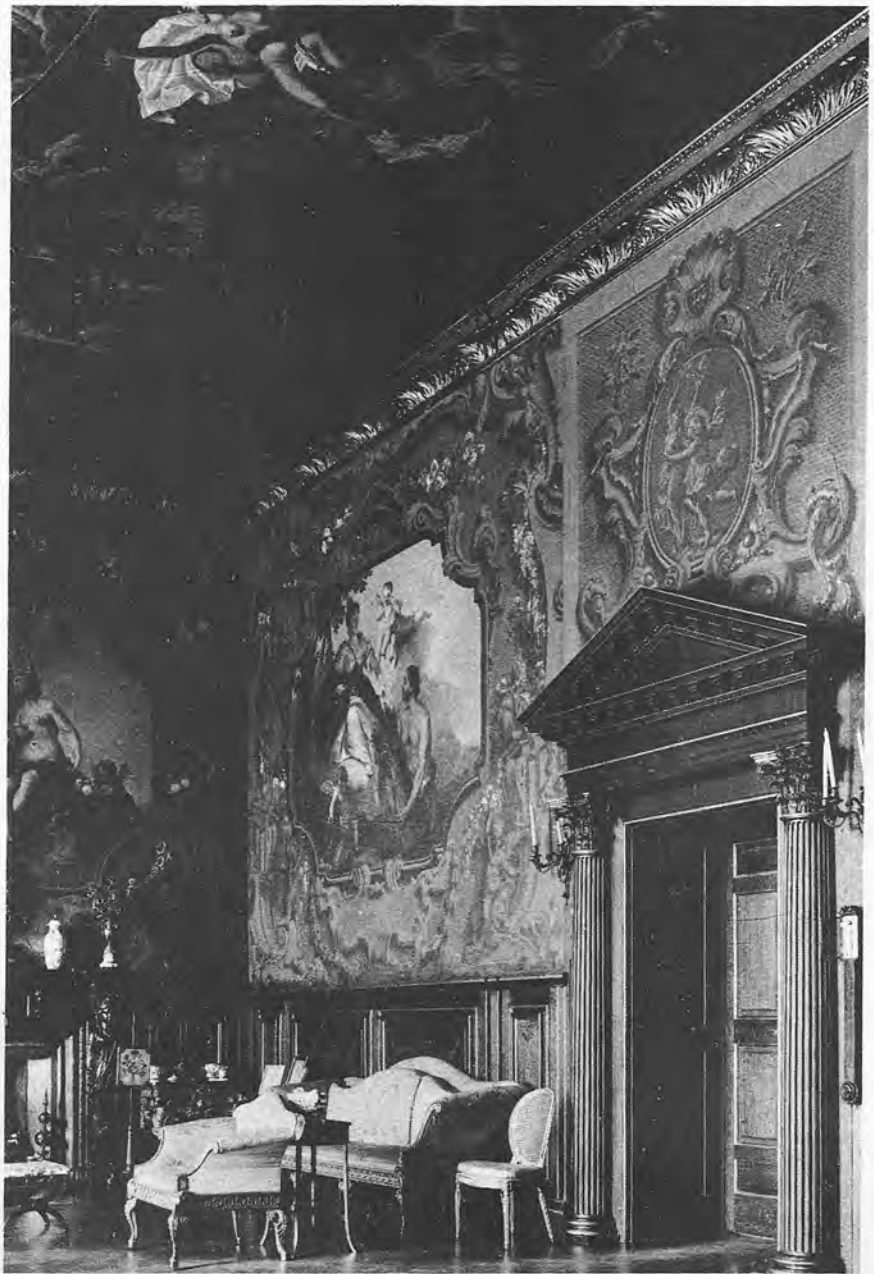
Fig. 7: The Great Salon at Moor Park, Rickmansworth

On occasions it is impractical to get at and strengthen the underside of a beam, and some other device is called for. Such a problem was met at Moor Park, Rickmansworth (Fig. 7), where

the floor over the great salon was sagging and springy. As the building was being opened to the public, concern was felt about the floor on account of the world-famous painted ceiling beneath.

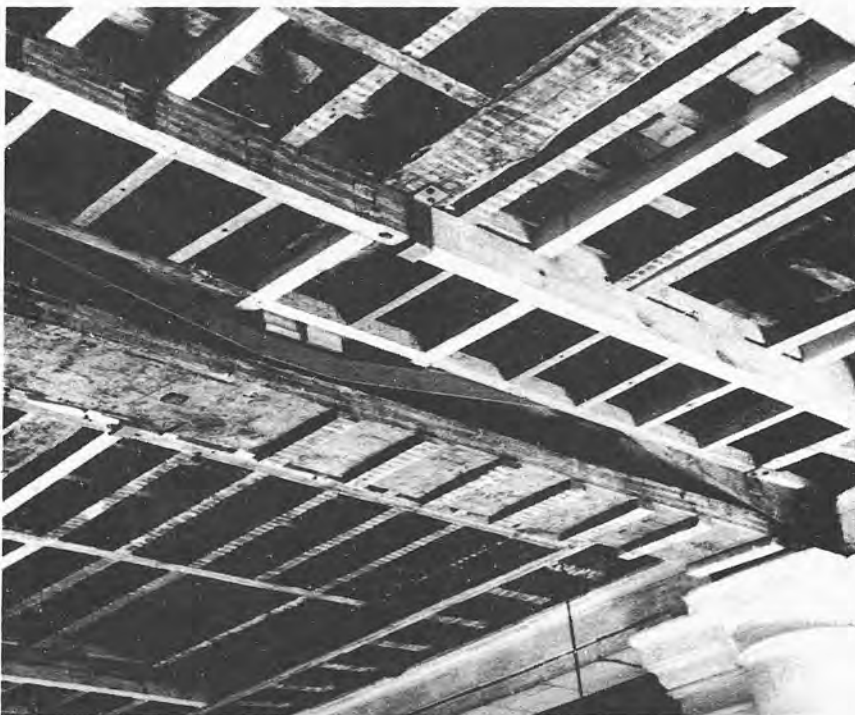
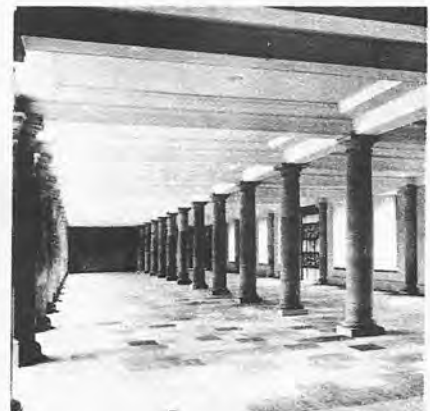
At the Wren Library, Trinity College, Cambridge (Fig. 5), the floor beams were suffering excessive sag and spring. Over-stressed from the first by the heavy load of books above, attempts to strengthen the beams began as early as 1685, when inclined compressional struts were housed in their sides. But these in turn eventually caused further weakness by splitting the beams along their grain at the internal strut pressure points. Wrought-iron hangers then added above also failed, because they could not be sufficiently anchored in the outside walls.

Fig. 5: (above) The cloisters below the Wren Library at Trinity College, Cambridge.

Fig. 6: (Left) The floor beams of the Wren Library were sagging. Inverted trussed girders were inserted and wedged up.

The problem was solved in 1970 by adding inverted trussed girders below the beams, housed entirely in the hollow plaster beam casings of the underlying cloister ceiling. Akin to the chassis beams of railway carriages, the girders consist of pairs of 3 in x $\frac{3}{8}$ in mild steel flats, coach screwed to both sides of each beam end. From these points they rake downwards to a level some 3 in below the beam centres, where they are fabricated as angles, set flange inwards. The flanges carry oak blocking pieces crosswise below the beam centres and are wedged up to them with folding oak wedges, driven from each side. The beams were thus effectively and invisibly stiffened causing no damage or disturbance to the marble floors of the Library above (Figs. 5, 6).

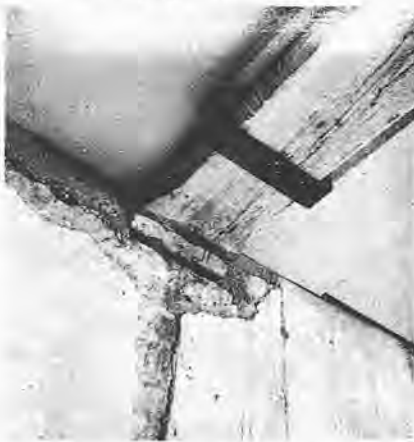
Fig. 13: A cradle of steel plates was used to support beams at Knole, in Kent

Frequently, the end of a beam, which is otherwise sound, has rotted, due to being pocketed into a damp wall. The beam end is, therefore, no longer providing the necessary support for the floor. It is possible to correct this fault by using a cradle of steel plates. The rotten end must be cut back to sound wood, and the pocket that originally held the beam end filled in. A 3 in x ¾ in stirrup runs beneath the beam end, and a similar stirrup is laid across the top of the beam 3 ft to 4 ft from it, the stirrups are held by 3 in x ¾ in bars, their projecting ends resting on a steel plate or concrete padstone built into the masonry of the wall (Fig. 12). All the components in this method are held in position by gravity and do not need to be bolted or welded. The ends of the supporting bars can be bent round in the masonry for additional stiffness. This method, which has often been used at Knole in Kent, can only be employed where the beam, or its upper part, is concealed in the thickness of the floor (Fig. 13).
