Conservation and Innovation – The Challenge of ‘Eco’ Renovation in Heritage Buildings

Caroline Pankhurst and Andrew Harris

In November 2011 the National Trust opened a new visitor centre at Morden Hall Park, south-west London, which is expected to be the most energy-efficient historic building in the country. The Victorian stable yard has been renovated using high standards of restoration work and innovative technology to provide an interactive demonstration centre for learning about sustainable green living, building conservation and new energy-saving products. The goal was to retain the architectural integrity of the stable yard and to minimize intervention in its historic fabric, while introducing a significant number of new and compatible materials and technologies. It was specified that, where possible, materials must be of low embodied energy, from sustainable resources or recycled materials, locally sourced or from National Trust estates, and have a low environmental impact. The outcome is a building that is both saving and generating energy, while also informing and inspiring others to carry out ‘eco’ renovations in heritage buildings.

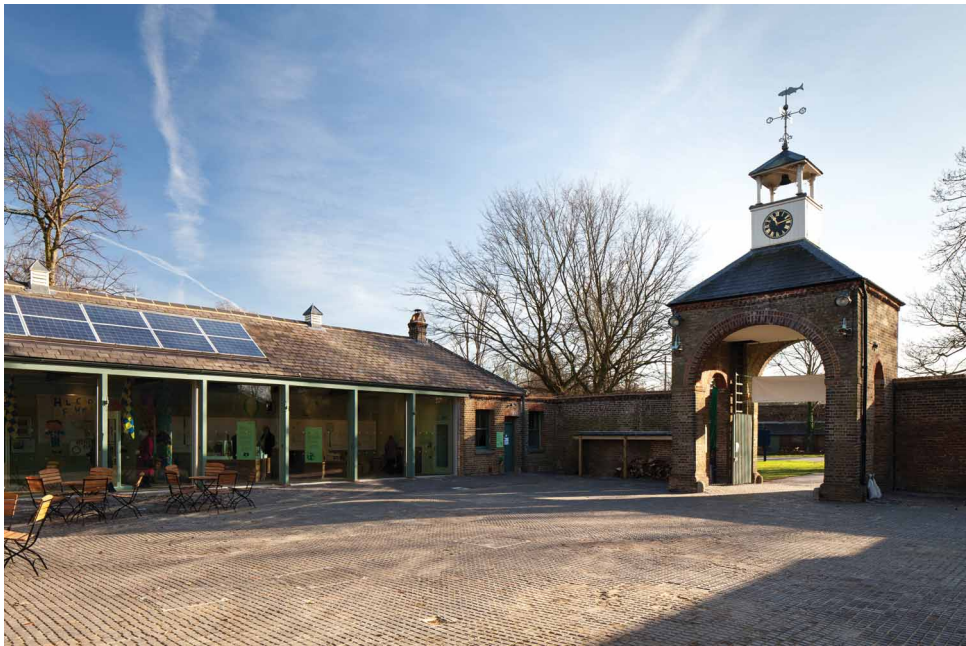
Figure 2. Clock tower and photovoltaic panels. (Credit: Louis Sinclair).

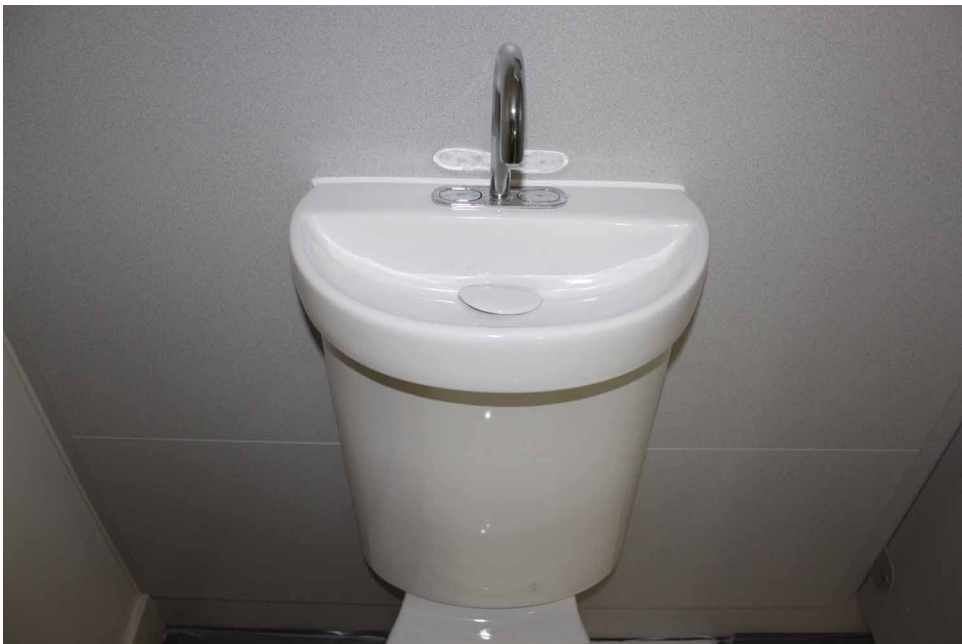
Figure 4. Innovative toilet with sink in cistern. (Credit: National Trust Picture Library/Jon Whitehead).

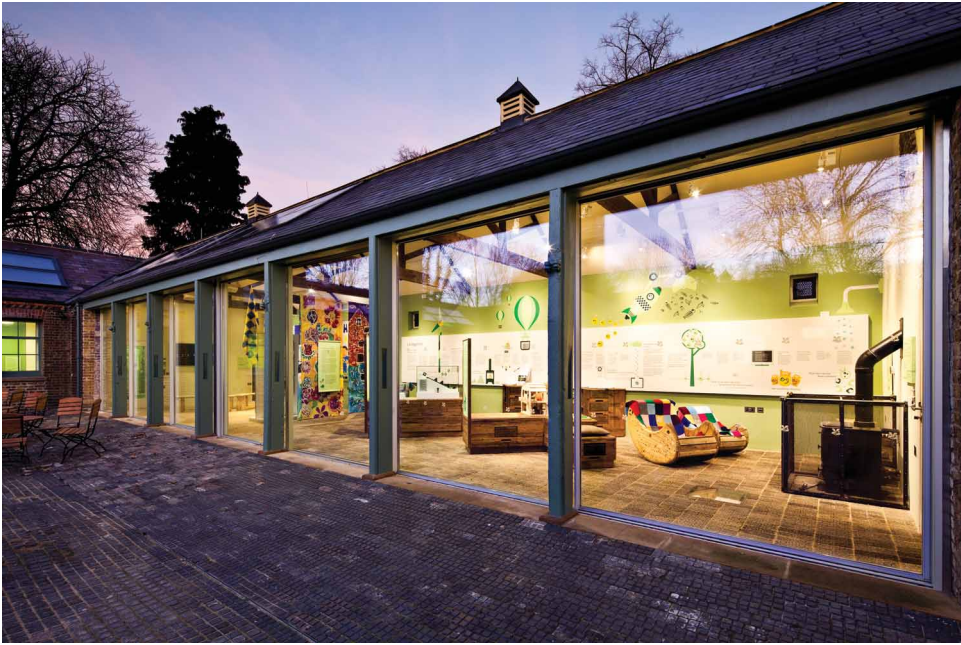
Figure 5. Triple glazed sliding doors to Livinggreen exhibition and wood burning stove. (Credit: Louis Sinclair).

The importance of preserving the openness of the original cart sheds was also recognized as an important element in the stable yard's aesthetic. This openness was retained by the introduction of large triple-glazed, argon-filled sliding glazed panels (Figure 5 and 6). The sourcing and installation of the large doors did cause some challenges; they had to be sourced from Portugal as they are not currently available in the UK. This took longer than anticipated, as the initial lifting tool chosen to install them was found to be unsuitable and so an alternative had to be found, causing a slight delay.

A 13.7 kW wood burning stove is fitted within the exhibition area (Figure 5). This not only provides comfort heating (4.5 kW) but is fitted with a back boiler, providing hot water (9.2 kW). Chosen for its sustainable source of fuel, the stove uses wood from the Park's regular tree maintenance works.

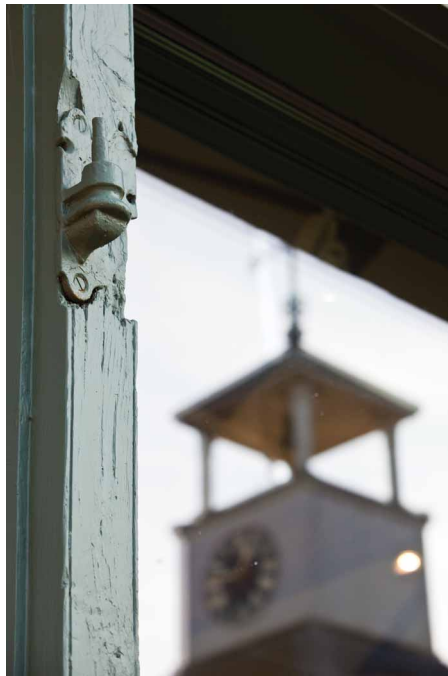
Figure 6. Cart shed door hinge and reflection of clock tower in triple-glazed doors. (Credit: Louis Sinclair).

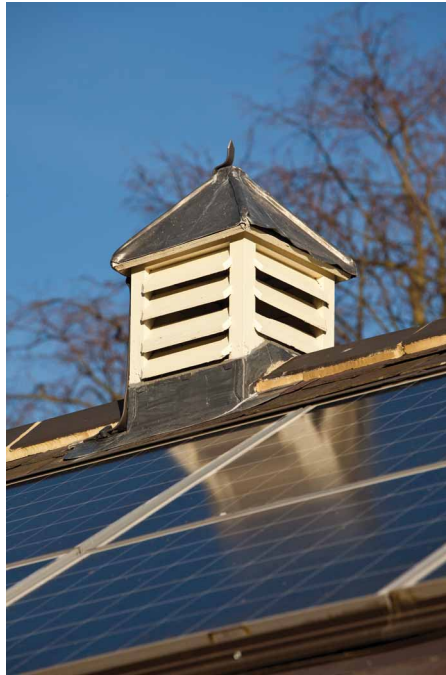
Figure 7. Original ventilation turret being refurbished and photovoltaic panel. (Credit: National Trust Picture Library/Jon Whitehead).

The original timber ridge mounted ventilation turrets, which were a feature of the original stable yard, were conserved and reused according to their original intended purpose (Figure 7). The addition of electric actuated dampers within the turrets means that these now control a passive ventilation scheme. However, the system has proved to be largely ineffective in the office areas. Heat build-up from occupation and office equipment, coupled with the high levels of insulation and relatively low areas of free ventilation, has resulted in uncomfortably warm working conditions in the office areas on many summer days. Conversely, over the winter period these high levels of retained heat have meant that for much of the time, additional comfort heating has not been necessary. With the benefit of hindsight, it would appear that the original ventilation turrets are too small and there is insufficient cross-ventilation to provide sufficient free ventilation in the office areas to dissipate the build-up of heat effectively.

Twelve PV solar panels occupying 18 m^2 were mounted on the west-facing roof slope. These were anticipated to produce 1,510 kWh per year (Figure 7).

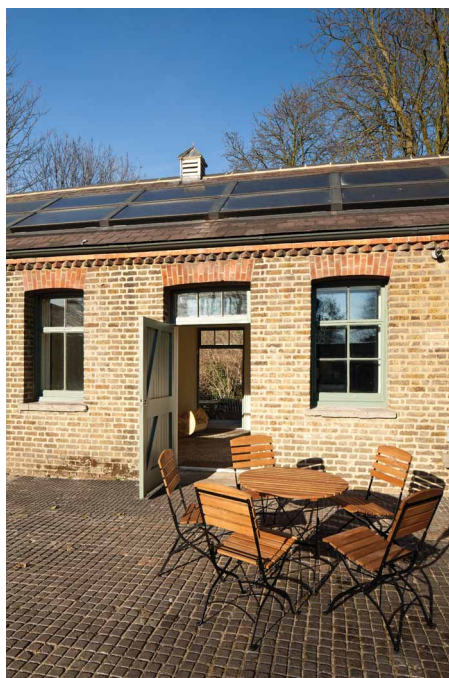
Figure 9. PV-T panels, café tables and original windows. (Credit: Louis Sinclair).

A total of 22 PV-T panels occupying 31.4 m² were mounted on the south-facing roof slope (Figure 9). PV-T panels are combined photovoltaic and solar thermal panels with PV cells on the surface and thermal collectors below. Not only do these combined panels produce two different sources of energy from a single panel (reducing space requirements on a roof) but they also work together beneficially. The efficiency of PV panels reduces in temperatures greater than 25°C, but in PV-T panels, the thermal collectors below reduce the heat in the PV cells increasing performance while producing hot water. This array was calculated to produce 12,570 kWh of useful heat and 3,400 kWh of electricity per year.

The energy level produced by the PV-T panels is also of concern. Predicted to have produced 12,570 kWh per year of heat, meter readings after the first year reveal that only a quarter of the heat expected has actually been produced. Similarly, the electricity generated by the panels is significantly less than expected. This is currently being investigated.

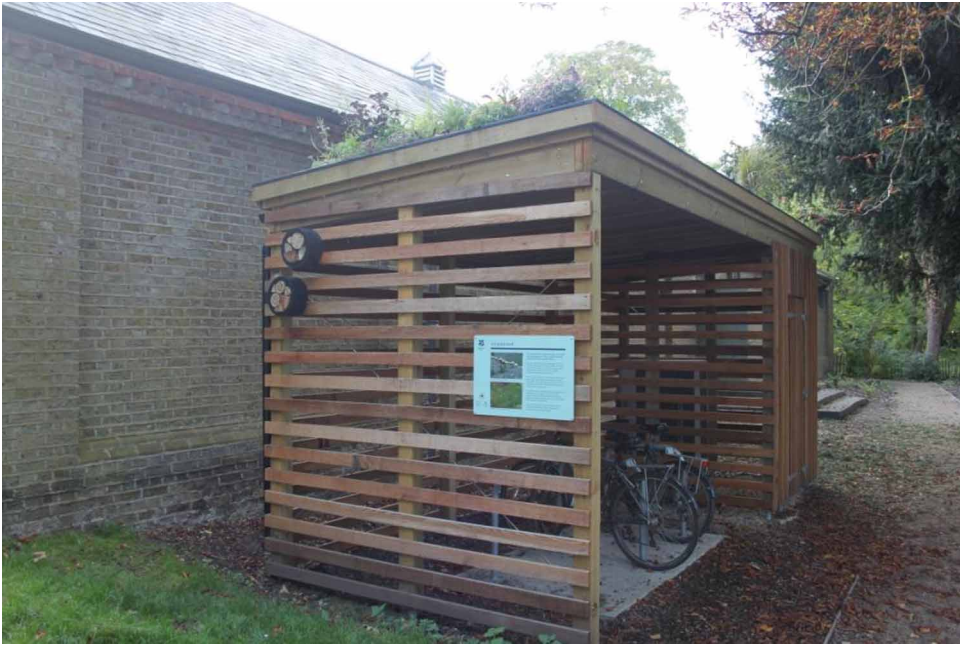
Figure 10. Air source heat pump in cycle shed with living green roof. (Credit: National Trust Picture Library/Caroline Pankhurst).

A 14 kW air source heat pump (Figure 10) supplies a thermal store which feeds an underfloor heating system (see below). The use of a ground source heat pump was discounted since one already serves the café located elsewhere in the park.

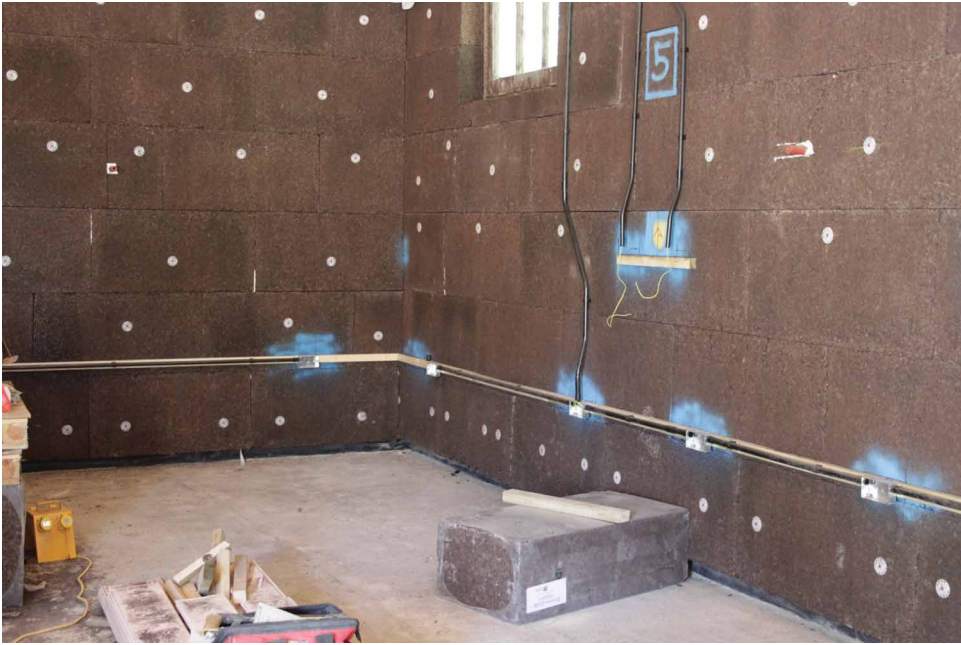
Figure 11. Cork insulation. (Credit: National Trust Picture Library/Jon Whitehead).

The choice of insulation to use in which area was driven largely by cost and the need to demonstrate a broad range of materials in the visitor areas. The cork (Figure 11) and recycled wool carpet were evenly distributed across walls to public areas of the building. However, the Aerogel insulation (Figure 12) was very expensive and was therefore confined to very limited wall areas such as circulation spaces. The original plan was to install two different types of roof insulation in the public areas, but owing to post tender budgetary constraints, hemp-based insulation was used almost throughout as this was the most cost-effective.

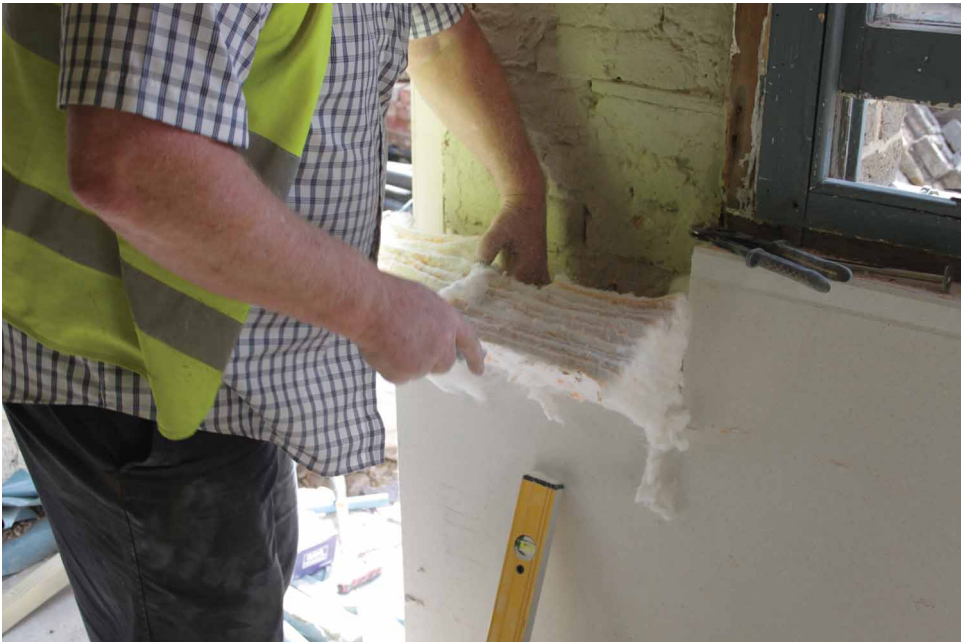
Figure 12. Aerogel insulation. (Credit: National Trust Picture Library/Jon Whitehead).

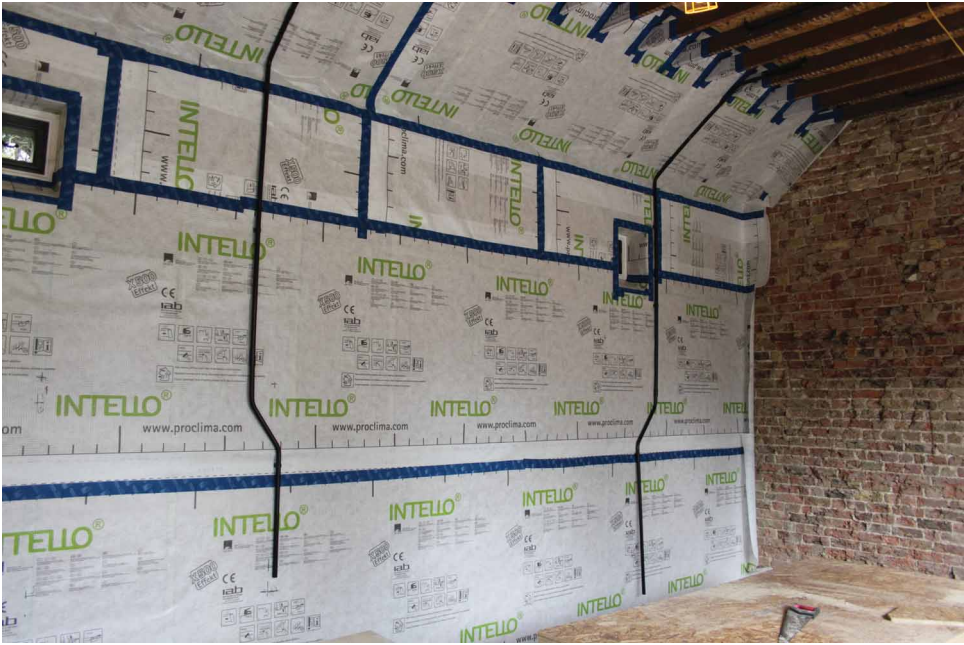
Figure 13. Intelligent membrane. (Credit: National Trust Picture Library/Jon Whitehead).

To reduce air leakage, all junctions and construction joints were detailed carefully by the architect. In addition, an intelligent membrane was used to provide a vapour check to both walls and ceilings (Figure 13). This innovative product, which has humidity-variable permeability, provides very low diffusion permeability in wintertime when the pores are closed and very high diffusion permeability in summertime when the pores open. Hence, in winter the membrane helps protect the building fabric from increased moisture levels and in summer it facilitates the rapid drying out of moisture from the structure.

All junctions and penetrations through the intelligent membrane were meticulously taped and sealed using the tapes and gaskets specified by the manufacturer. The contractor placed two dedicated, directly employed operatives on this task who were not under the pressure of working to a fixed price, thus ensuring that the high levels of workmanship required were achieved.
