Accessibility to Cultural Heritage

Nordic Perspectives

TemaNord 2009:572

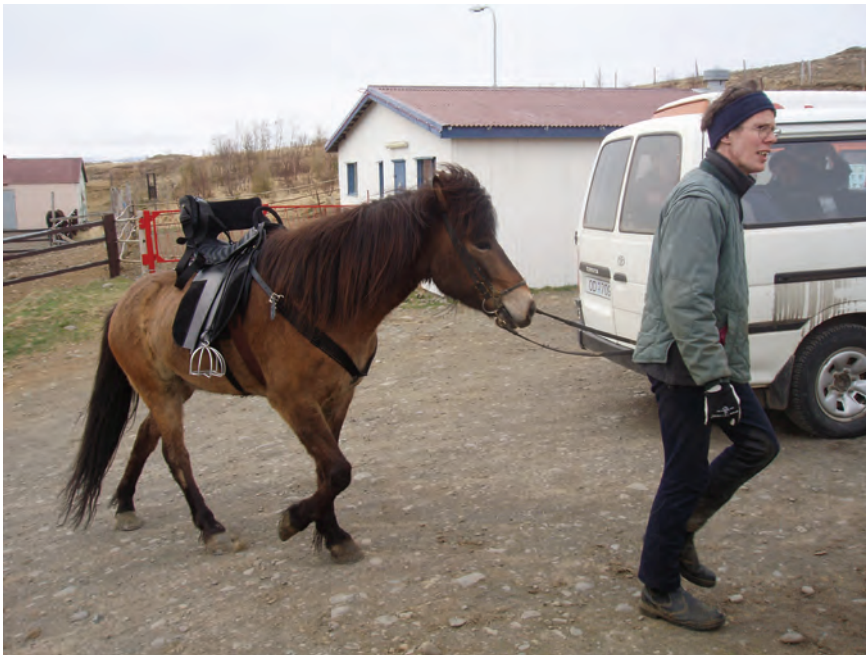
FIG 4-4 The saddle “Seifur” in use. Sambýlið á Blönduósi ©

The most serious problems connected to accessibility are those of getting close to the individual ruins and remains. Signs along the highway show the way to the ruins, but getting to them involves walks of between 500 and 1000 metres over uneven ground. This means that in most cases the ruins are inaccessible to people with walking difficulties. To make gravel roads for wheelchair users would often necessitate an unacceptable intrusion into the natural landscape. One possible solution is to use horses to carry people to the ruins. Recently a new type of saddle, called “Seifur”, has been developed that makes it possible for many disabled people to ride a horse. In Vatnsdalur horses are available for hire and rides with guides are offered. One of the aims of the Vatnsdalur project is to develop suitable riding routes and train tour guides with horses to assist the disabled on riding tours.

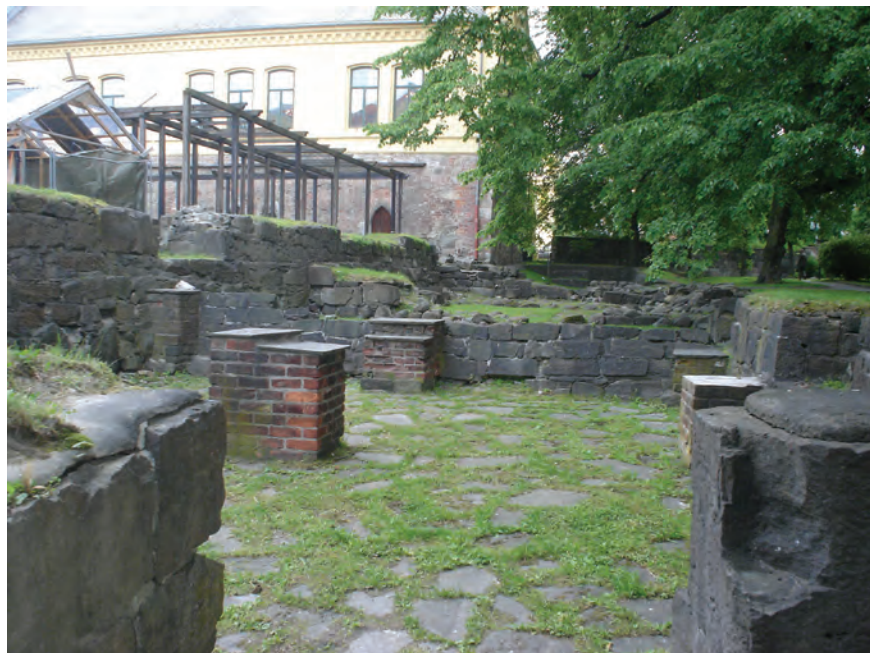
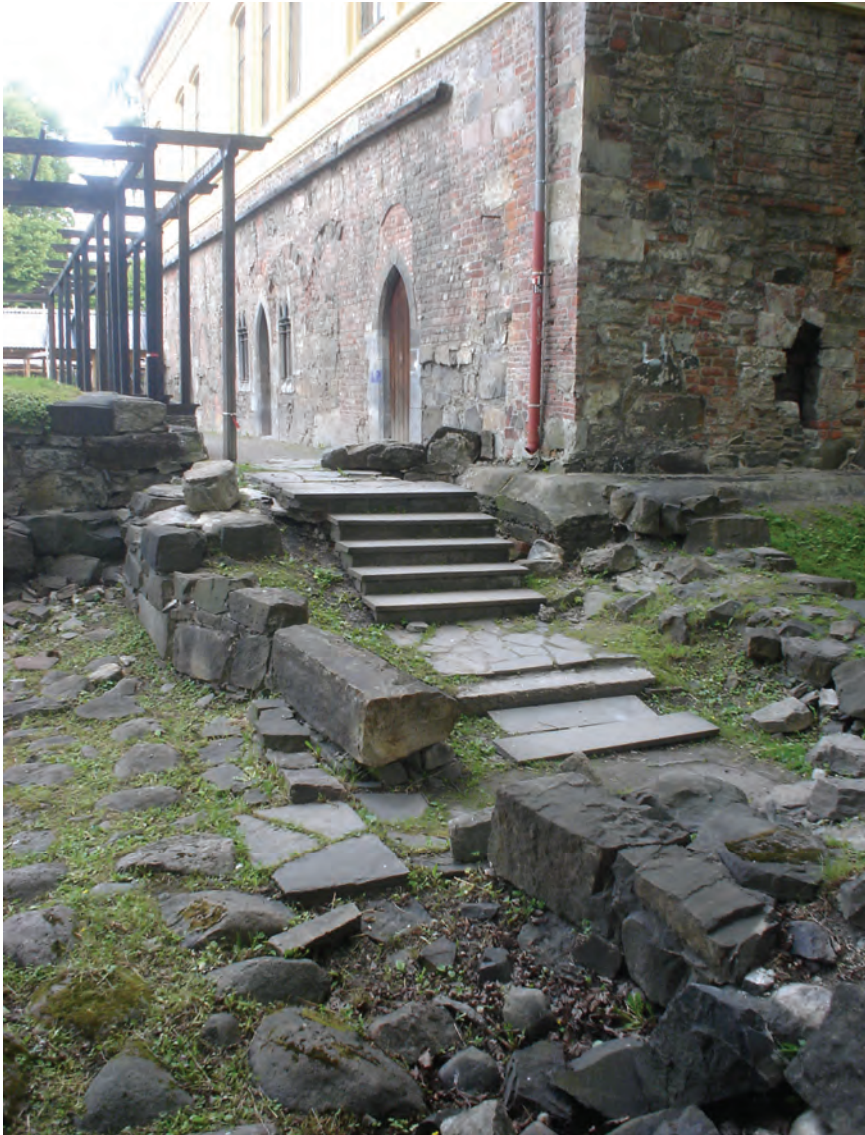
FIG 5–2. The ruins before accessibility interventions. Riksantikvaren ©

FIG 5–3. *The ruins before accessibility interventions. Riksantikvaren ©*

The physical condition of the ruins and their degree of conservation are challenges for the presentation of the site and the issue of accessibility. The importance of the different historical layers must be assessed, and user demands must be set against the need to protect the medieval traces. Accessibility measures constitute not only visual intervention but also a possible direct threat to the archaeological remains below ground level. New landownership, repositioning areas of activity to allow for silent zones close to the ruins, regular maintenance of the vegetation and solutions for signage, lighting and movement among the ruins are all factors to be considered.

In general the ruins are less than a metre high, which makes the layout relatively clear. One idea is to differentiate the once-internal and external parts of the ruined buildings. This can be achieved by using grass “outside” and a gravel cover “inside”. Historically, different floor materials were used for the rooms of the monastery and those of the church. These elements can be made visible in the parts of the ruins that are under cover and where it is not so important to simplify the story. The foundations for the buildings, which were meant to be hidden, should be re-covered as much as is practicable both to increase the readability and to protect them.

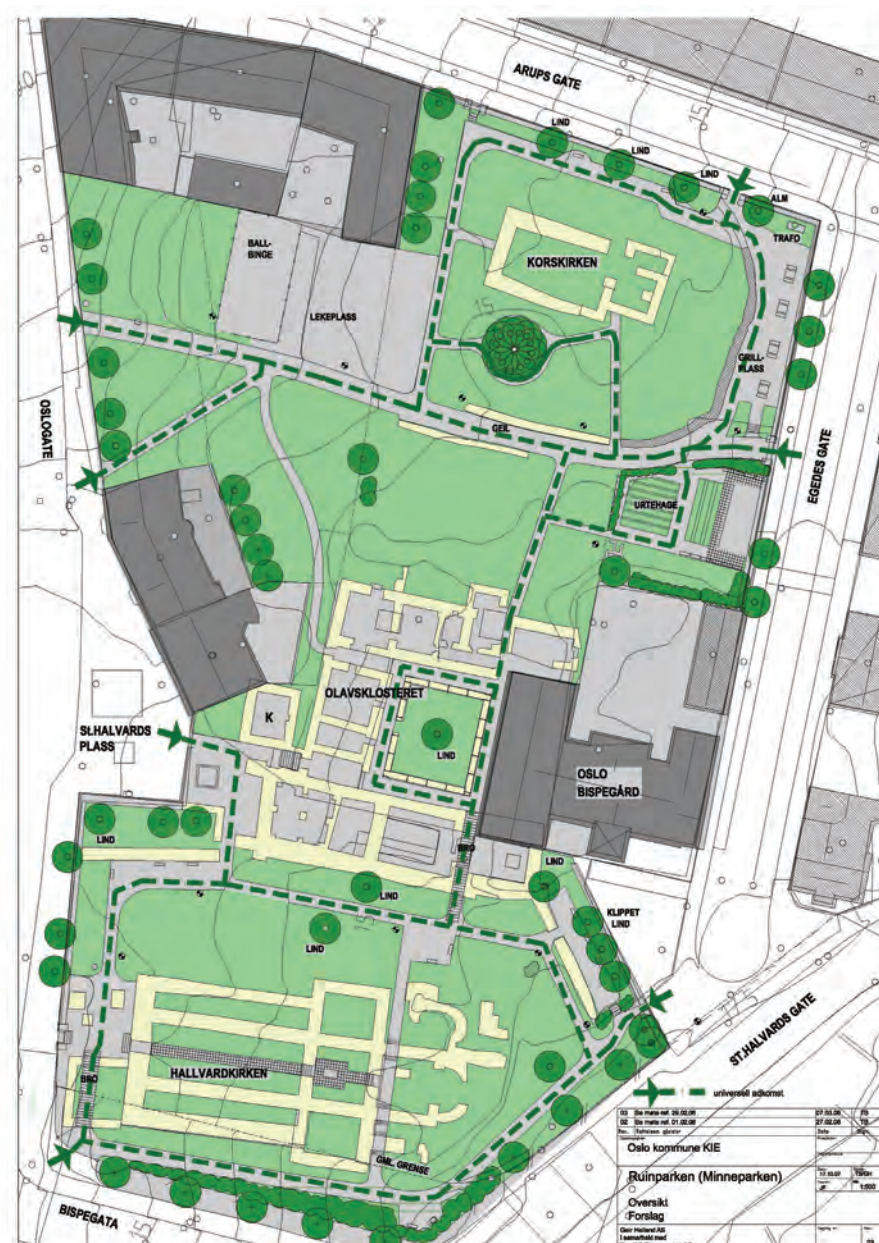
FIG 5-4. Suggestions for making the Memorial Park accessible. Geir Helleland A/S ©

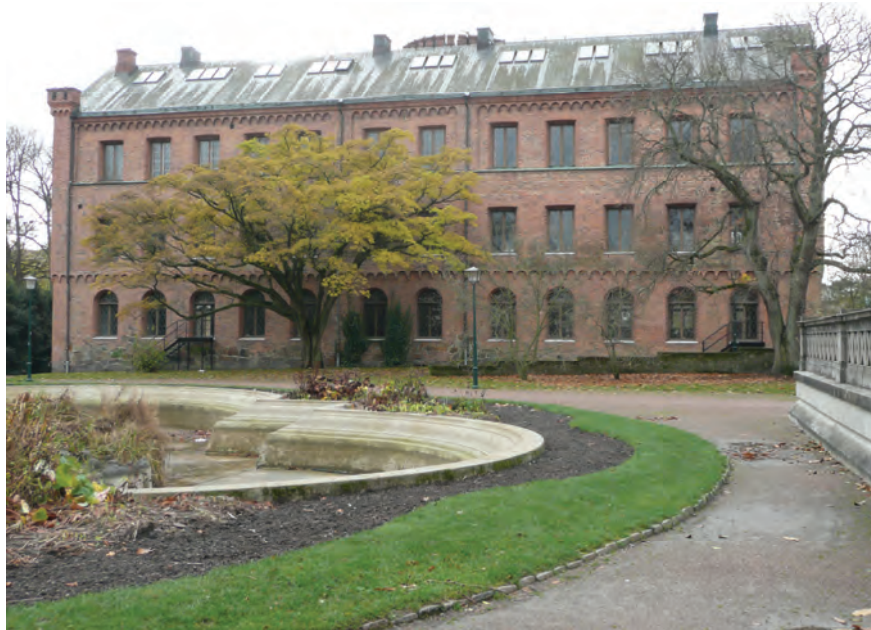
FIG 7–3. Lundagårdshuset seen from north. According to alternative 2 the new entrance should be through the window no 5 from the left side. The alternative 3 suggests an entrance through the window at the extreme right. Oiva Isola ©

This alternative satisfies both the accessibility requirements and the demand for a "dignified entrance". It will be possible to enter the building close to where the planned internal lift and stair will be.

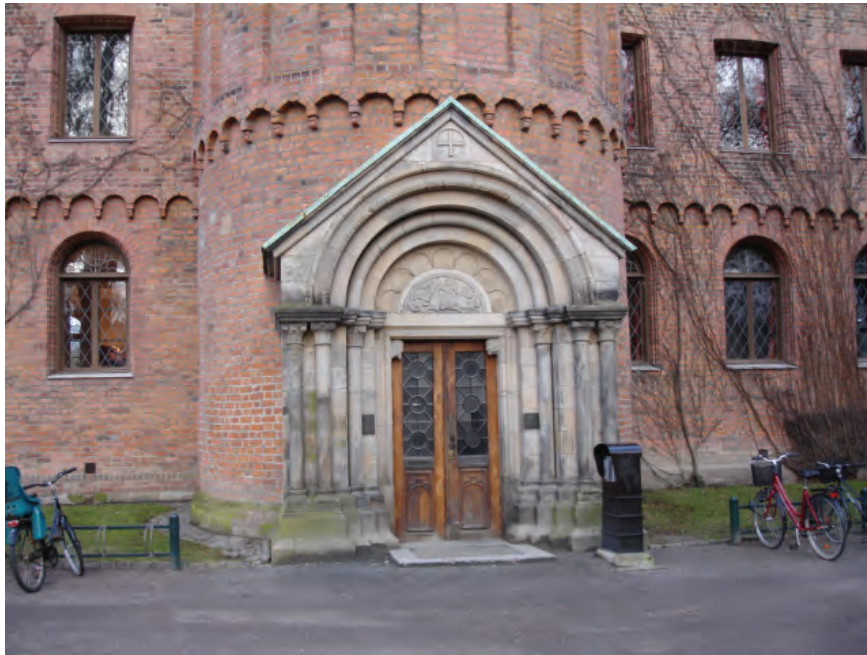
FIG 7-4. The main entrance is in the tower. According to alternative 4 a new entrance should be made under the window to the right of the tower. Ingrid Schwanborg ©

This alternative satisfies both the accessibility requirements and the demand for a “dignified entrance”. It will necessitate a passage through the Carolina Hall, where the library is today.

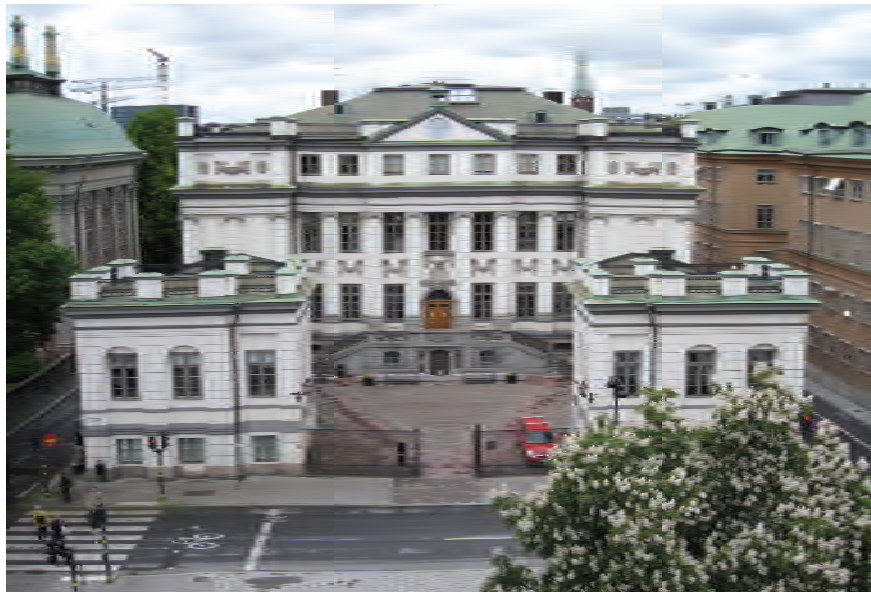
FIG 8–1. Bondeska palatset, southern façade after the interventions in 2004. The courtyard surface consists of cobblestones with paths of sandstone and markings with setts. Oiva Isola ©

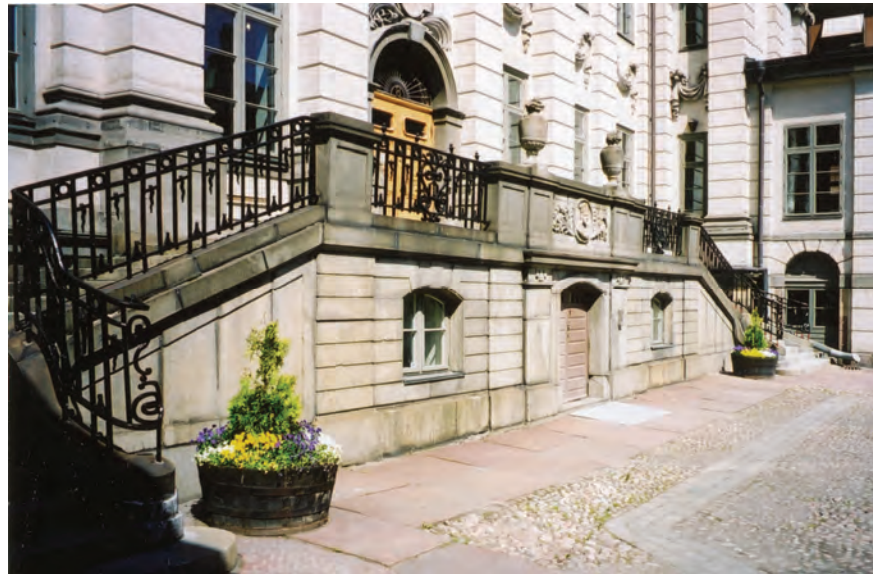
FIG 8-3. The personnel entrance before the intervention in 2004. Eva Göransson, AIX arkitekter ©

At the staff entrance a level discrepancy of two steps is built-over by two externally symmetrical sandstone-clad ramps (length 4.6 metre, gradient 1:12). The side of the ramp facing the courtyard is bounded by a low granite wall. Towards the façade the ramp is equipped with a handrail set into the ground. Two internal steps inside the entrance door are removed. An exterior double door is replaced by a new, higher and broader single automatic door. Two light armatures are mounted onto the façade, above the entrance. Two short interior stairways are equipped with step lifts to bridge the 1.5 metre level discrepancy between the staff entrance and the interior lift that serves all the floors.

The low stone wall successfully hides the ramp seen from the street which means that the visual influence to the building's exterior and entrance court is minimal. Also with respect to material and surface appearance the wall is adapted to the building's granite base, which means that it appears to be integrated with the building. Reusing the existing sandstone slabs in the ramp contributes to retaining homogeneity in choice of material and degree of wear. The holes in the sandstone slabs for fastening the poles can be accepted since the slabs are relatively modern, originating from the rebuilding of the courtyard in the 1940s. Although the handrails, poles and armatures are made in modern material – dull steel – and are of modern design, they match the colour of the grey stone façade behind very well. The form and thin dimensions of the handrail contribute further to the harmony. On the other hand, a handrail of more traditional design in black wrought iron would have been more clearly noticeable. The width of the flat post with elbow opener/control panel is overdimensioned. Two armatures are mounted symmetrically onto the façade. The installation of a handrail on the ramp nearest to the façade minimises the visual impact compared to a handrail on both sides of the ramp.

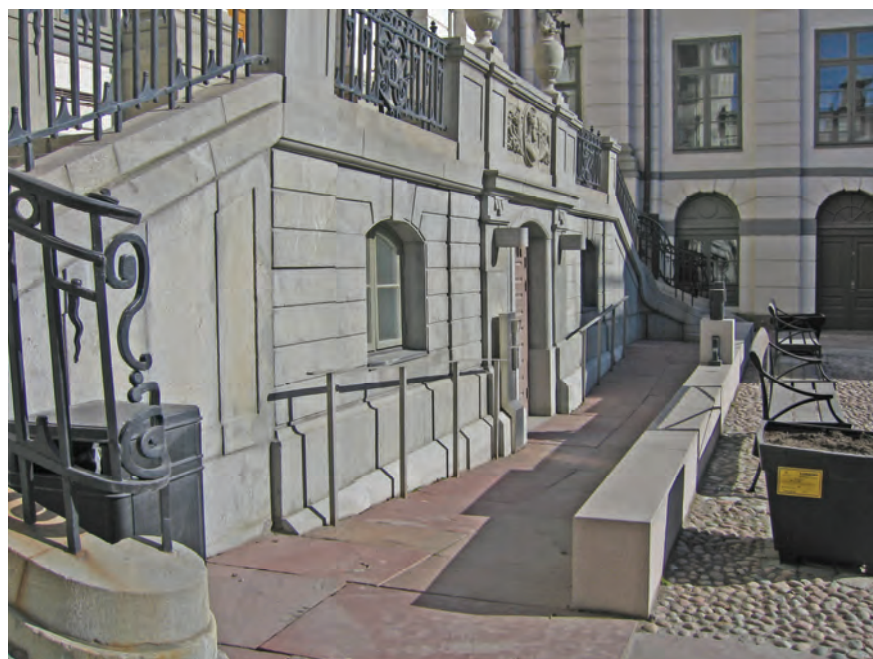
FIG 8-4. The personnel entrance after the intervention in 2004. Oiva Isola ©

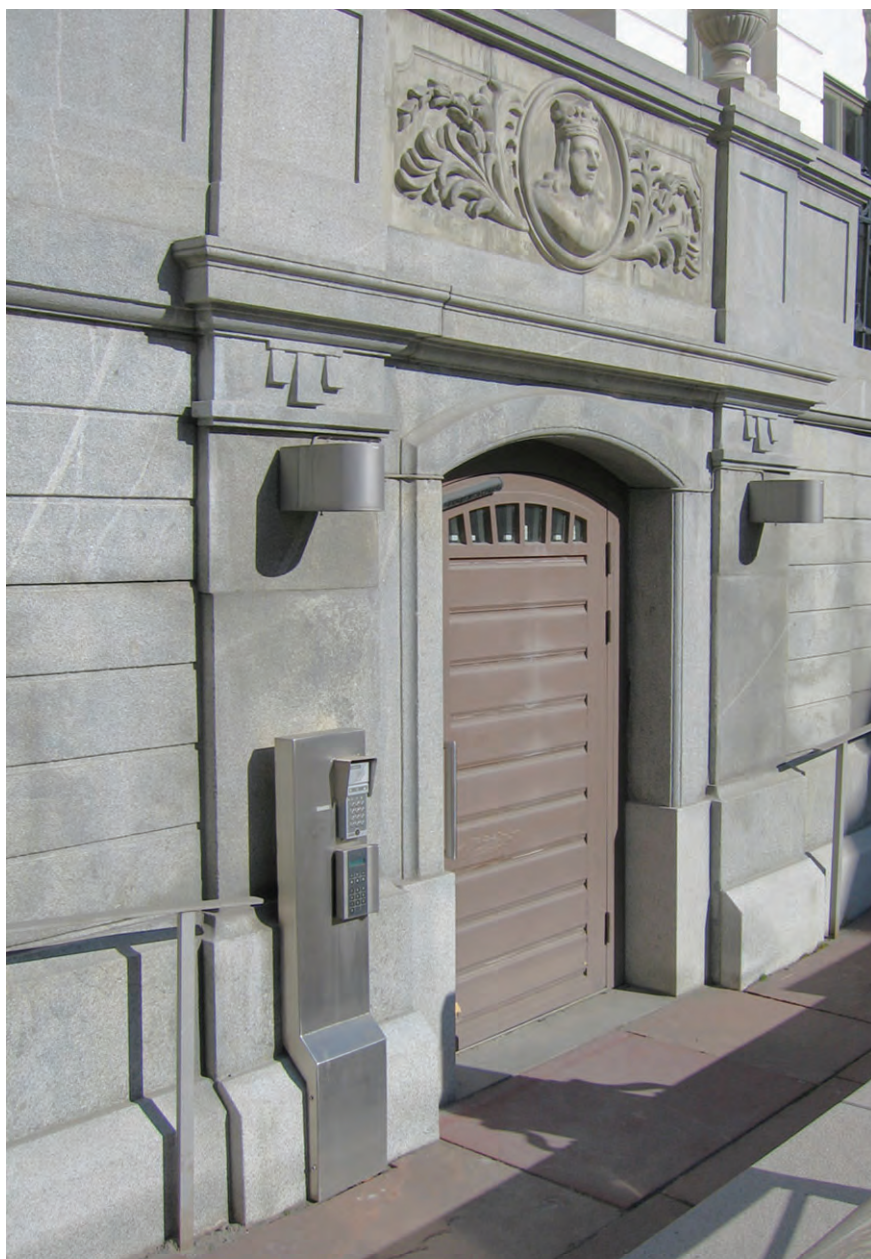
FIG 8-5. The new adjusted entrance is equipped with a new outward going door with automatic opening door opener, handrail, armatures and a post for entry control. O. Isola ©

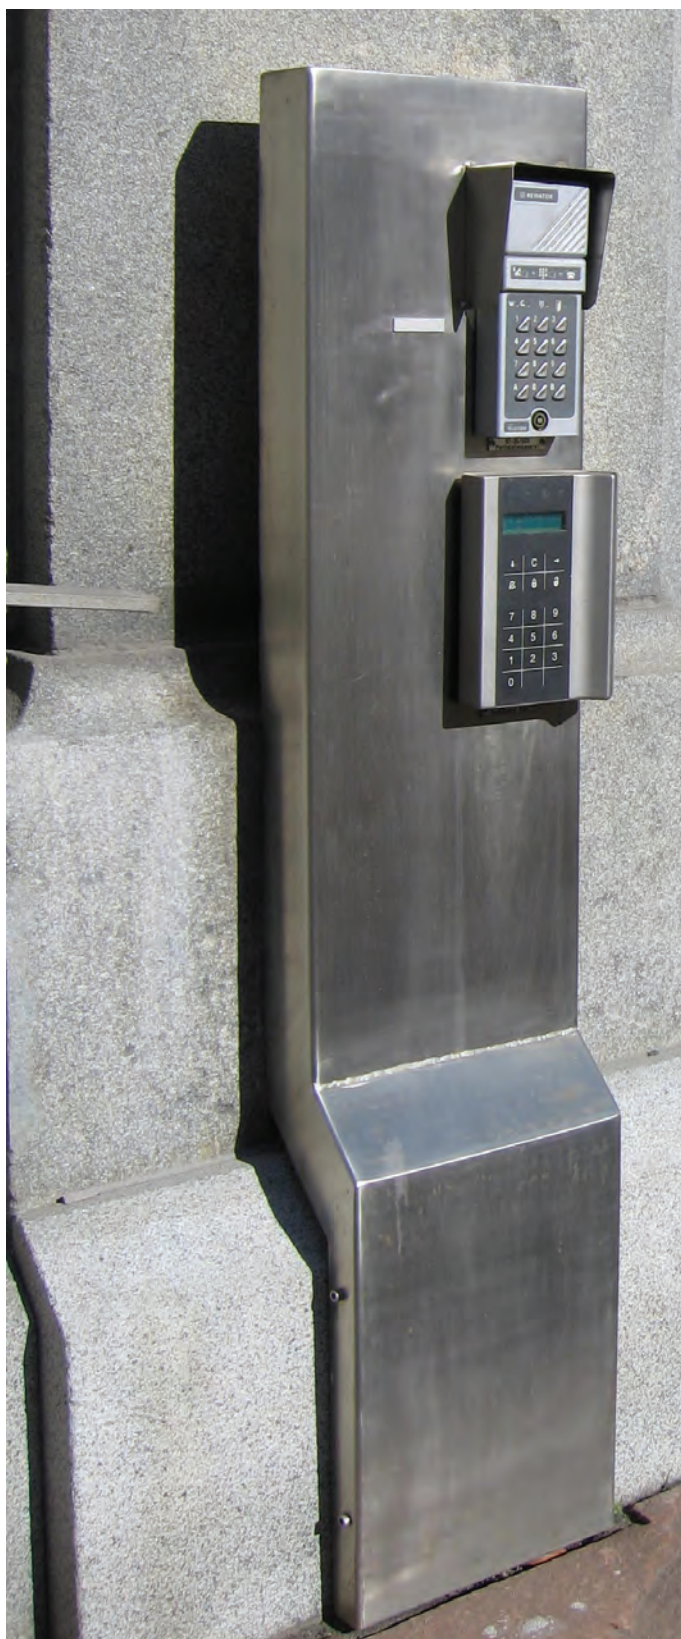
FIG 8–6. The post with elbow switch, buttons for entry code and entryphone have been installed at a distance from the wall and attached only to the ground. O. Isola ©

This exterior solution homogenises well with the building's monumental architecture and symmetrical expression, subordinating and partly adapting to the already existing elements with regard to material and colour. The additions respect the building's original architecture which is assigned high cultural historical values. The internal stair lifts differ from the earlier interior with regard to design and materials, and because of this they are experienced as foreign and tangible elements which, however, are reversible. The spots for attachments in the floors and walls cause a minor loss of original material, but this should not be important for future interpretation of the building's history.

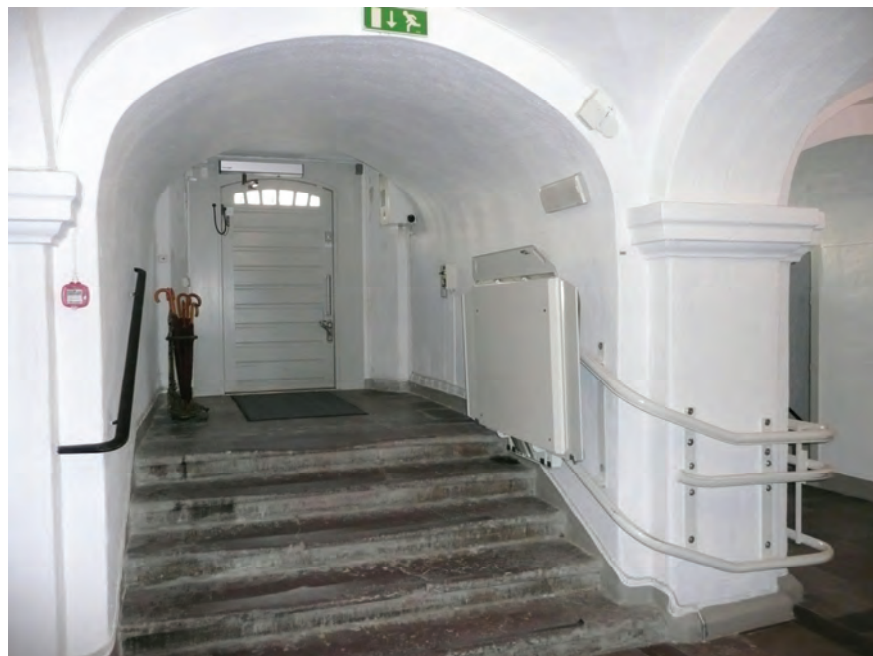
FIG 8–7. The new door to the personnel entrance is fitted with an automatic door opener. The stair lift is in an uplifted position. Oiva Isola ©

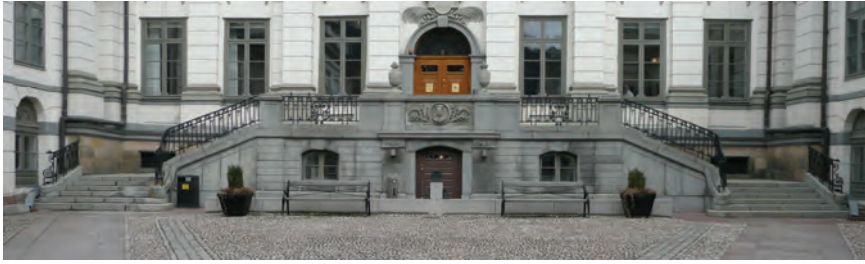
FIG 8–8. The main façade after the installation of the ramp. Oiva Isola ©

The aim of creating a common, dignified entrance for all is not fully achieved by this alternative. Moving downwards from the ground level is not experienced as a natural entrance to a building's main floor one flight up. However, one advantage is that the staff uses this entrance and that it is situated near to the main entrance. It is also possible for a person to enter the building independently. The ramp's breadth and gradient fulfil the norms for a ramp although it had been preferable to have a ramp with a lower gradient (1:20). However, the majority of people can use the ramp successfully since it is short. Although the handrail is placed on one side of the ramp only, those who need to use it can use either hand as the ramp is double-sided. The worn and rough sandstone offers a sufficiently non-slippery surface. However, the well adapted and partly hidden ramp may be difficult to find.

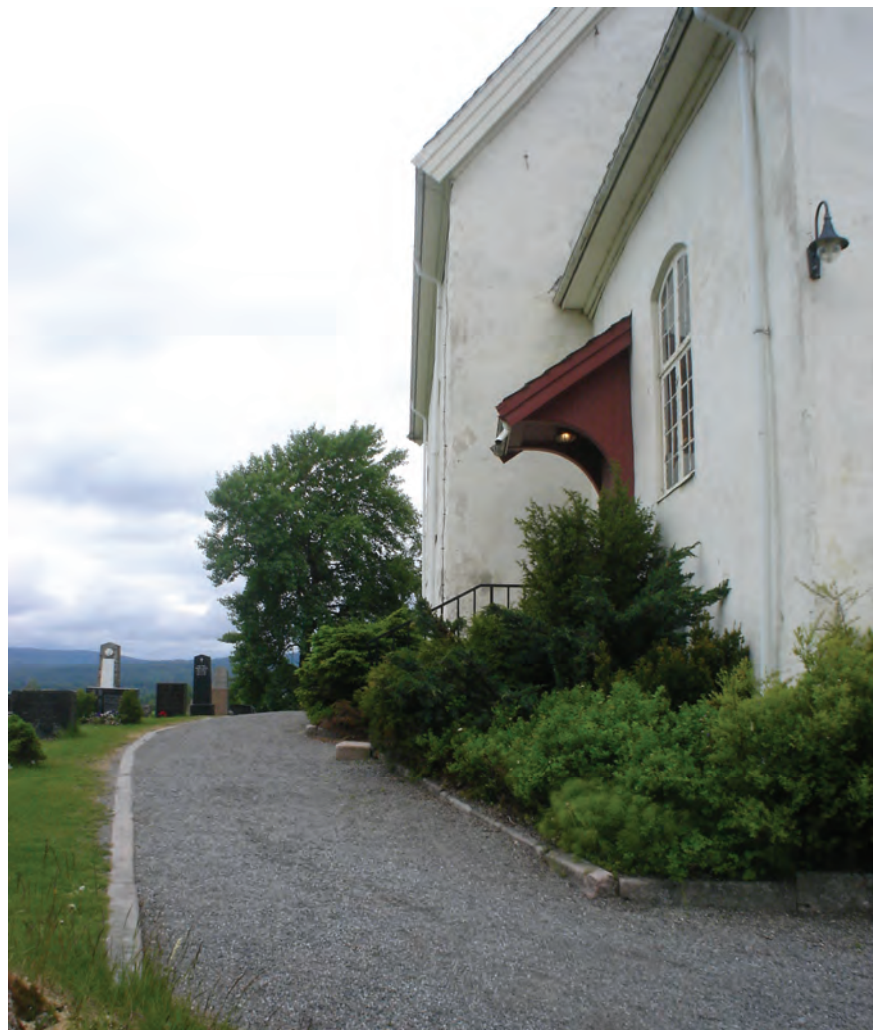
FIG 9-2. The current main path to the entrance. Inger Karlberg ©

The most obvious solution is to build a ramp with a gradient that makes it possible for a person in a wheelchair to get up to the entrance unassisted. In a rural community where people often have appropriate experience and a practical approach to work, making a ramp might seem to be the easiest and least expensive solution.

Since the parking area is east of the church, the ramp will slope up from east to the west on the southern side of the church.

The historic fabric: Above the ground this will not mean any intrusion into the historic fabric. However, the part of the building below ground level is also a part of the fabric. In this case the ramp might have an impact on the medieval foundations. It is not certain if this will be the case here, but it is probable.

Archaeology: Any construction on the ground will have to take into consideration the frost and the ground movements caused by freezing. This means that the ramp will need proper foundations. Since this is a graveyard from the middle ages, and parts of the foundation of the church are very likely to be medieval, this work will need scrutiny and permission from the archaeological experts. Consent would entail carrying out archaeological excavations or surveillance of the work. The depth of possible building foundations is not known. An archaeological excavation is likely. A graveyard is the most obvious place to find important human remains, and all human remains from the middle ages are listed.

Taking the site and climate into consideration, there will always be a danger of snow and ice falling off the roof in the winter season. In the winter the slope will also have to be cleaned and kept ice free. To prevent this, stoppers may have to be installed on the roof against the snow.

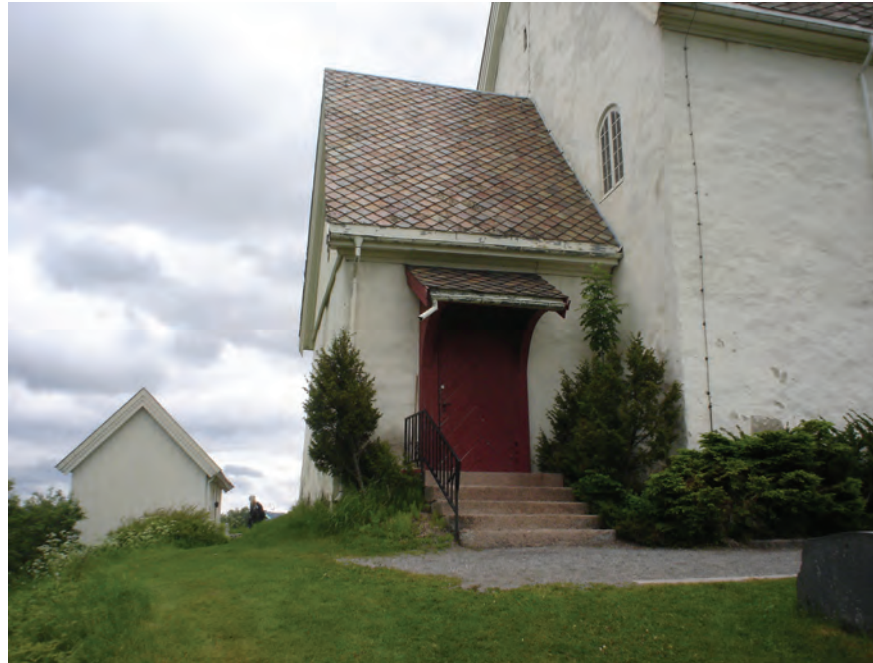
FIG 9-3. The main entrance, Inger Karlberg. Riksantikvaren ©

9.4.2 Alternative 2: A lift or floor lift at the entrance

The historic fabric: The porch was added at an unknown date, but certainly later than the time of the building of the church. It has, however, been altered several times, and is further away from the medieval foundations. The stairs are of 20th century date and can be altered or adjusted to accommodate the lift.

The crucial functional point seems to be the climatic conditions. Lifts of the appropriate kind are regularly used outdoors in Nordic countries, but there is sometimes a reluctance to invest money in expensive technical devices that are believed to malfunction in severe winter weather.

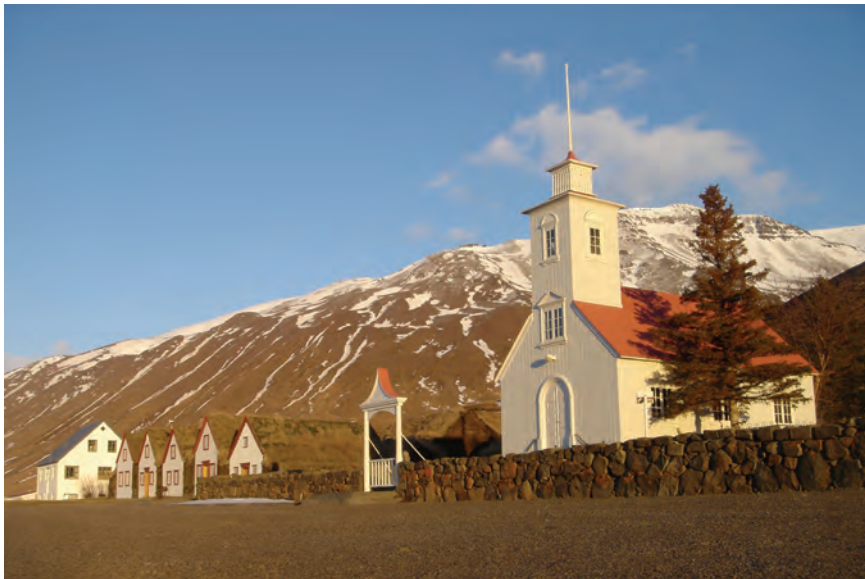
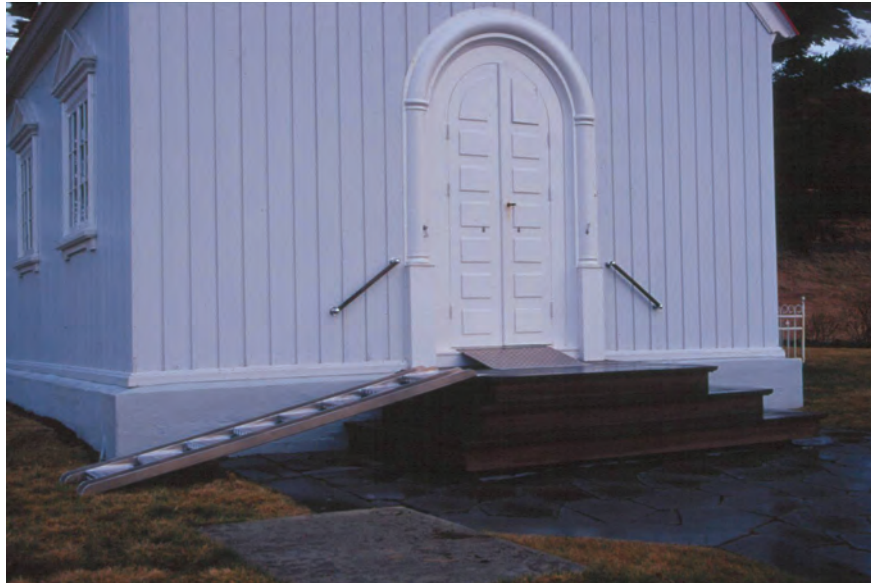
FIG 10–1. Laufaskirken. Magnus Skulason. Húsafriðunarnefnd ríkisins ©

FIG 10–2. Laufaskirken. Magnus Skulason, Húsafríðunarnefnd ríkisins ©

The situation here was complicated because the church is on sloping terrain and its only entrance is at the front via three steps. This made it difficult to envisage a scheme for improved permanent accessibility that did not detract visually from the site. The present incumbent is a wheelchair user, making it even more important to find a solution.

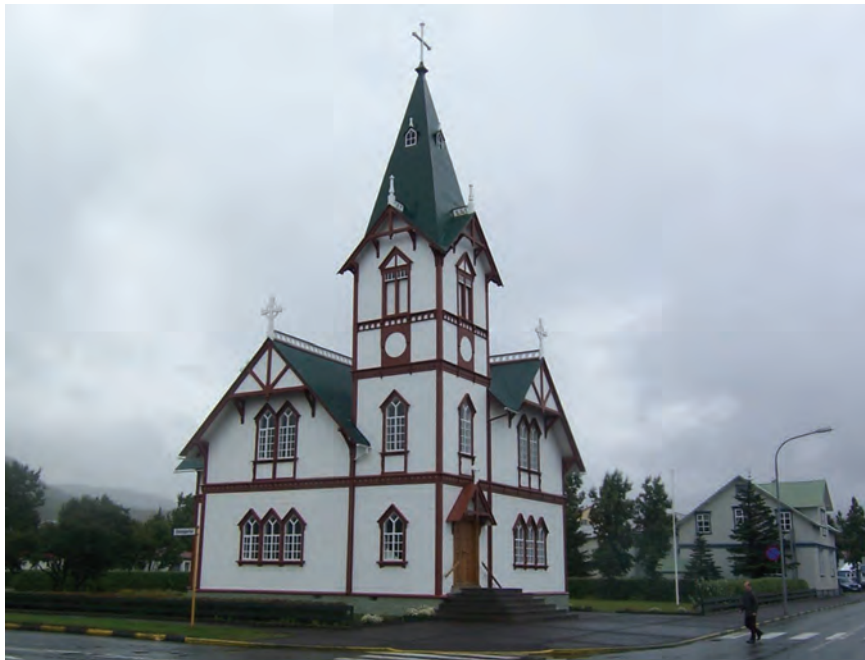
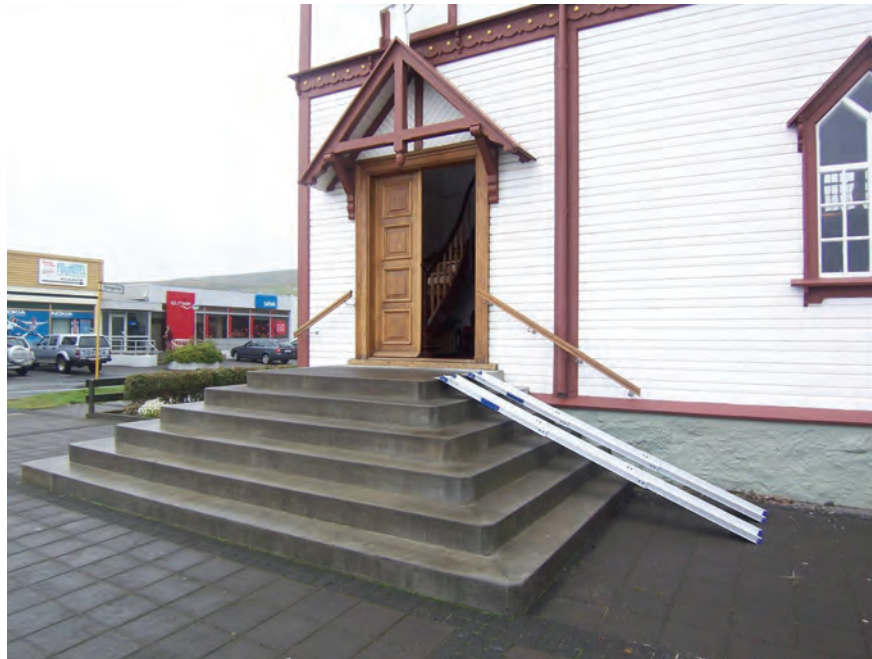
FIG 10-3. Husavik kirke. Magnus Skulason, Húsafriðunarnefnd ríkisins ©

FIG 10–4. Husavik kirke. Magnus Skulason, Húsafríðunarnefnd ríkisins ©

At the main entrance, facing the main street, there is a concrete flight of six steps. At the side entrance on the southern side of the church the ground rises slightly and consequently the flight of steps there is not as high. There is no lift or ramp at either of the entrances. Inside the church there are stairs up to the organ and the choir's gallery.

The provision of an aluminium ramp offers an acceptable temporary solution, allowing time for better and more satisfying permanent solutions to be considered.

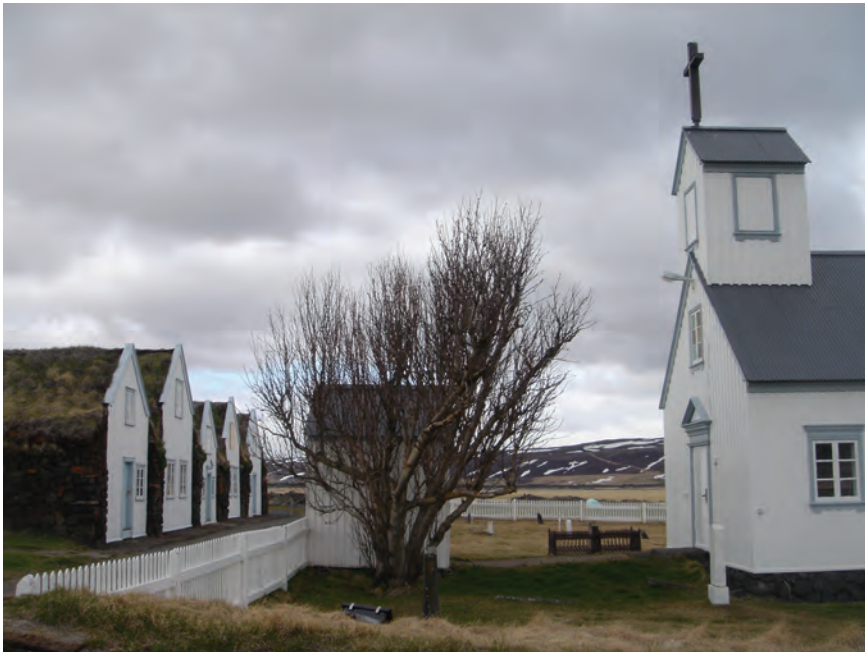
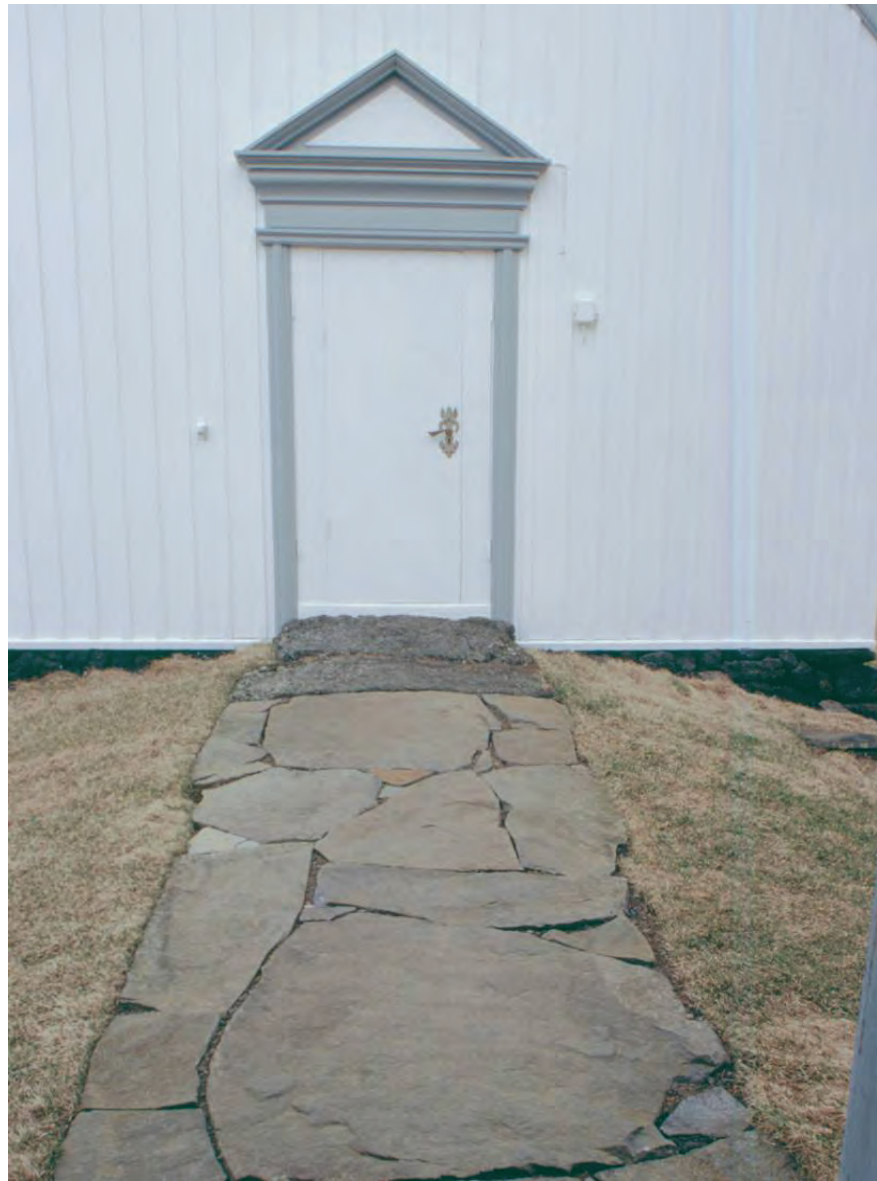
FIG 10–5. Grenjadarstada kirke. Magnus Skulason, Húsafríðunarnefnd ríkisins ©

FIG 10–6. Grenjadarstada kirke. Magnus Skulason, Húsafríðunarnefnd ríkisins ©

Visitors have to pass through a freestanding clock gate in front of the church and then walk up a 6-metre-long path of natural stone before reaching the church door. The path is 40 centimetres lower than the floor level of the church. The solution to the accessibility challenge in this case has been to raise the ground level of the stone path in front of the church. This works well and the raised area is heated geothermally.

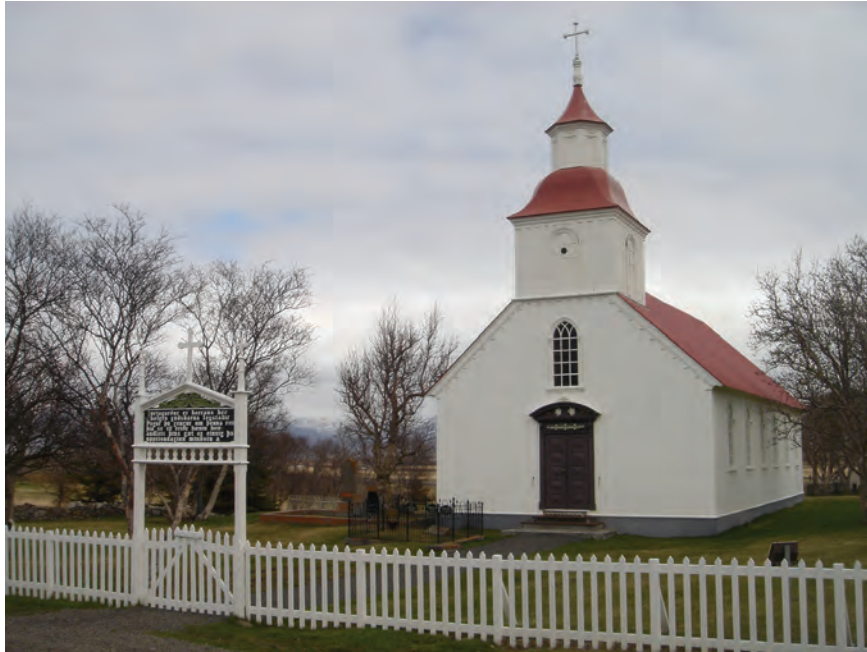
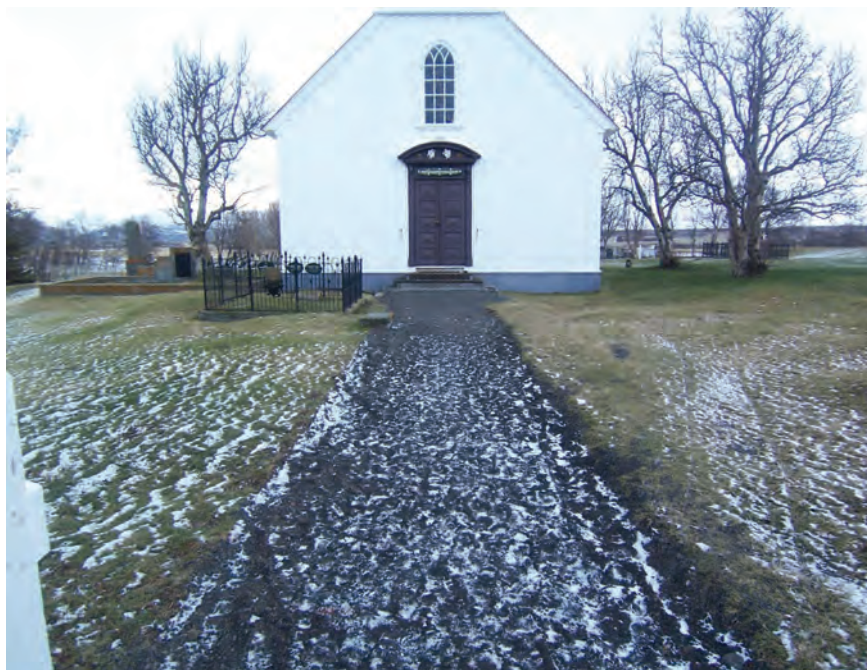
FIG 10-7. Modruvalla kirke. Magnus Skulason, Húsafríðunarnefnd ríkisins ©

FIG 10-8. Modruvalla kirke. Magnus Skulason, Húsafríðunarnefnd ríkisins ©

Modruvalla church is situated on the western side of Eyjafjord, not far from Akureyri. Access to the church has been difficult for a long time because the path has never had a hard surface, only grass. In this area

Installing a ramp up to the church door could damage the nearby old graves and have an adverse impact on the architecture of the church. One suggestion is to make a geothermally heated and raised path that takes the graves into consideration. A copy of the cast-iron step, with a larger area in front of the door and a handrail on both sides, would improve the church's accessibility for disabled people.

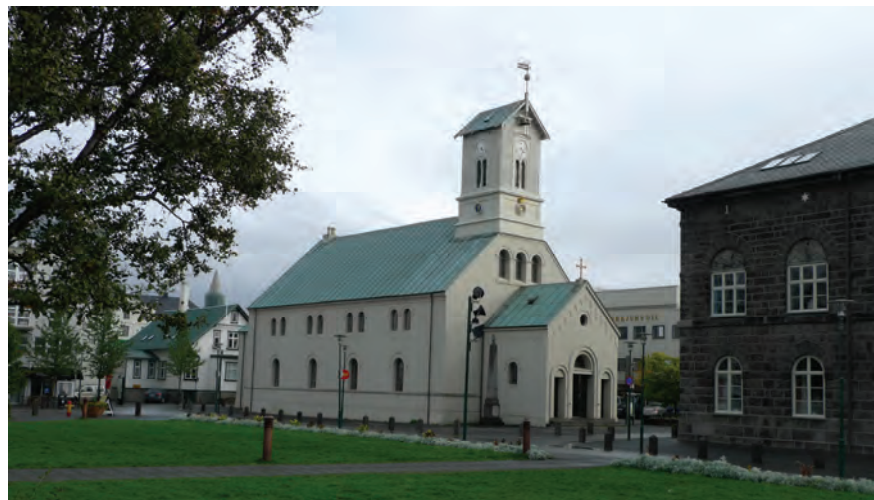
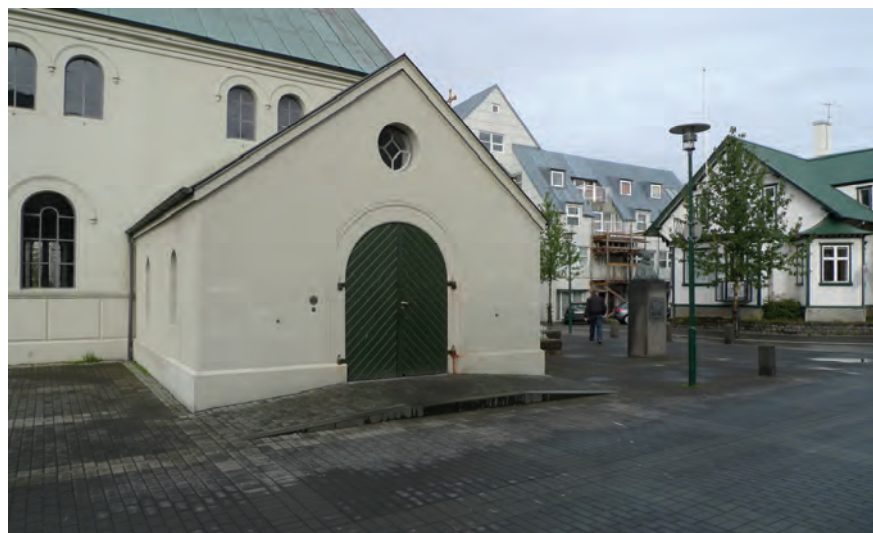
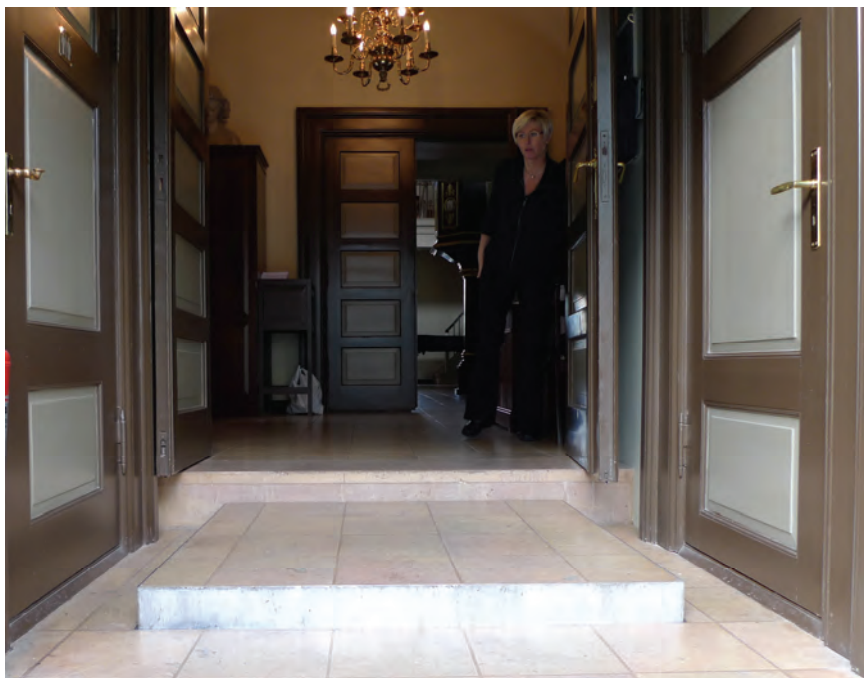
FIG 10–9. Reykjavik katedral. Magnus Skulason, Húsafriðunarnefnd ríkisins ©

FIG 10–10. Reykjavik katedral. Magnus Skulason, Húsafriðunarnefnd ríkisins ©

FIG 10–11. Reykjavík katedral. Magnus Skulason, Húsafríðunarnefnd ríkisins ©

The original architect of this stone church was Anders Kirkerup, the Royal Master Carpenter. The church was extended and rebuilt in 1846 with Danish bricks. The architect in charge of the extension was the Royal Surveyor, Laurits Albert Winstrup. The church has two entrances: the main entrance and one through the sacristy.

By 1985 there was a growing demand for making the church accessible for disabled people and for wheelchair users through the main entrance. In front of the main entrance there is a flight of four steps, in cut natural stone. A thorough evaluation concluded that a ramp at the main entrance would mean significant visual alteration to the cathedral's façade, with serious negative consequences for the appreciation of its architecture.

The alternative of an entrance for wheelchair users through the sacristy was proposed, as the difference in height there was less significant and not so apparent. There was, however, a height difference between the different floor levels in the sacristy itself.

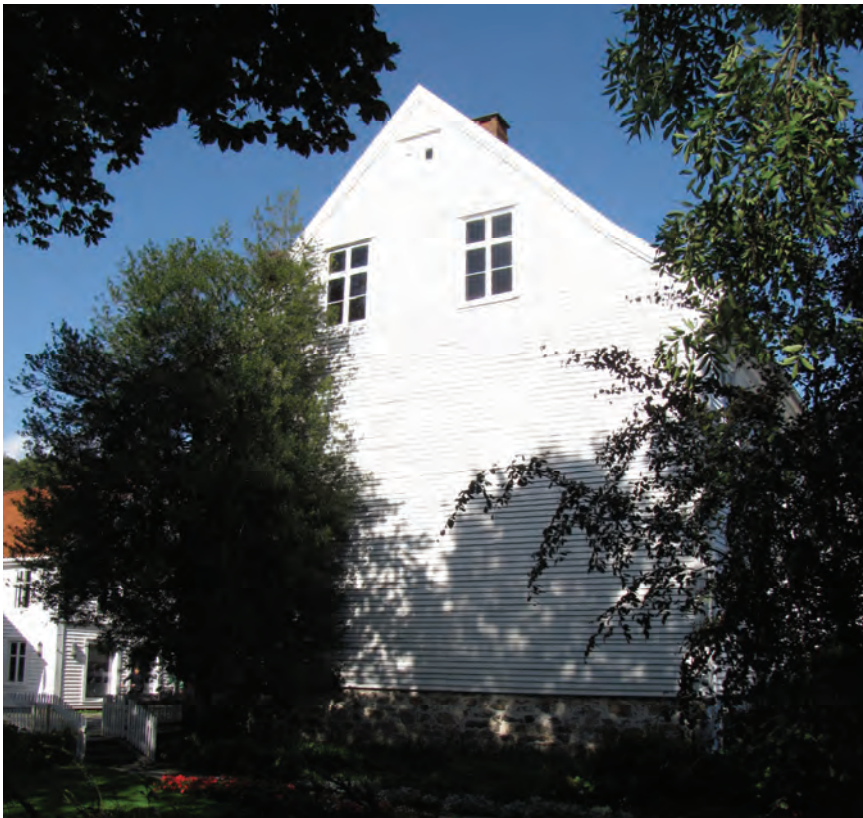
FIG 11-4. The gable seen from the garden. Thor Gunnar Hansen, Vest-Agder-museet Mandal ©

The building has one freestanding gable end, since there is no other building directly attached on this side. This space is currently occupied by part of the garden. This proposal is for a simple lift tower to be built on this side, linked to but not in the gable. A lift tower would be a modern addition to the original building, and it would be visible, although not to any great extent, from the street, but it would not impinge on the impression of the main façade. It would be preferable if the tower was made of wood, to match the materials and design used on the façade. Modern materials and design are theoretically feasible, but would be more prominent than the wooden boarding.

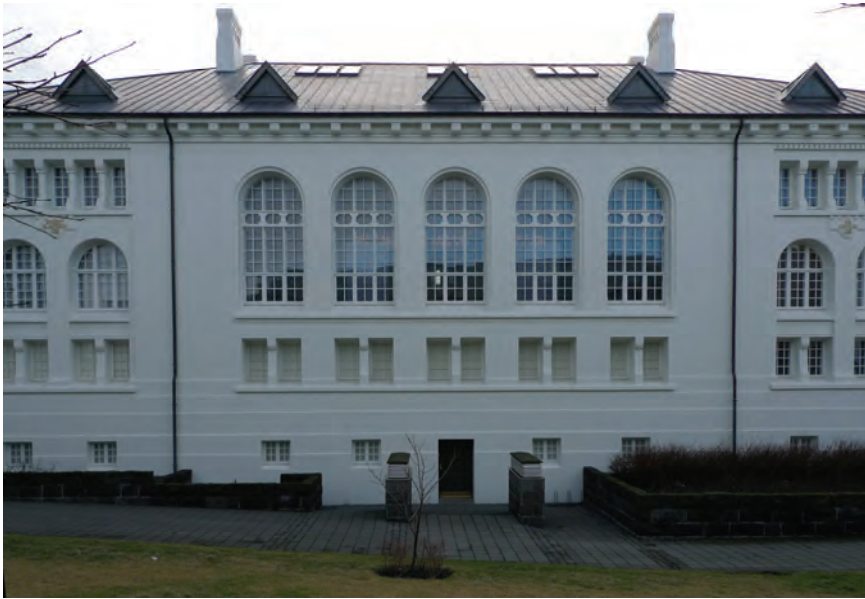
FIG 12–4. The rear side, showing the alternative of an entrance in the basement. Magnus Skulason, Húsafríðunarnefnd ríkisins ©

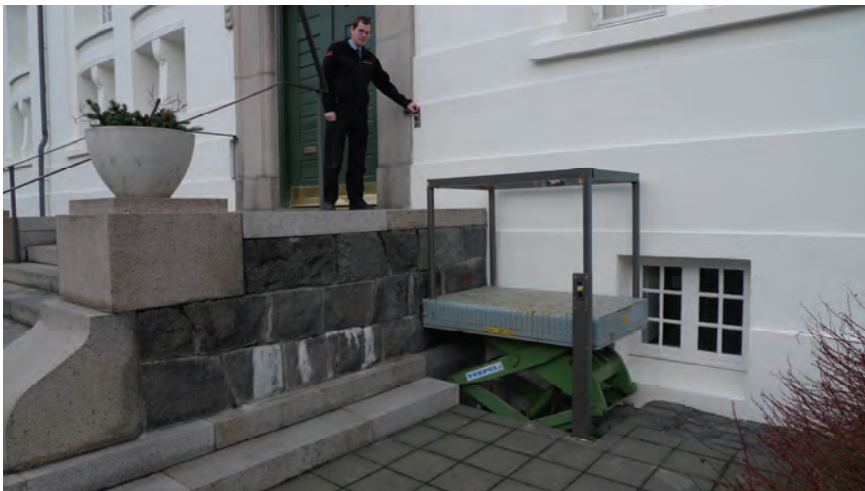
FIG 12–5. The new lift to the main entrance. Magnus Skulason, Húsafríðunarnefnd ríkisins ©
