Accessibility to Cultural Heritage

Nordic Perspectives

TemaNord 2009:572

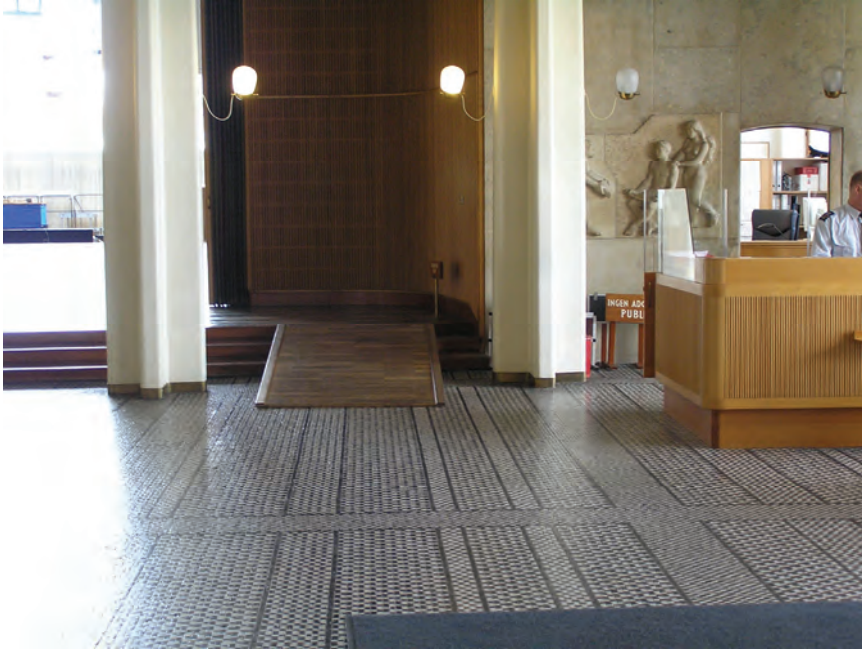
FIG 13-3. The ramp in the vestibule. Alice Rosenborg ©

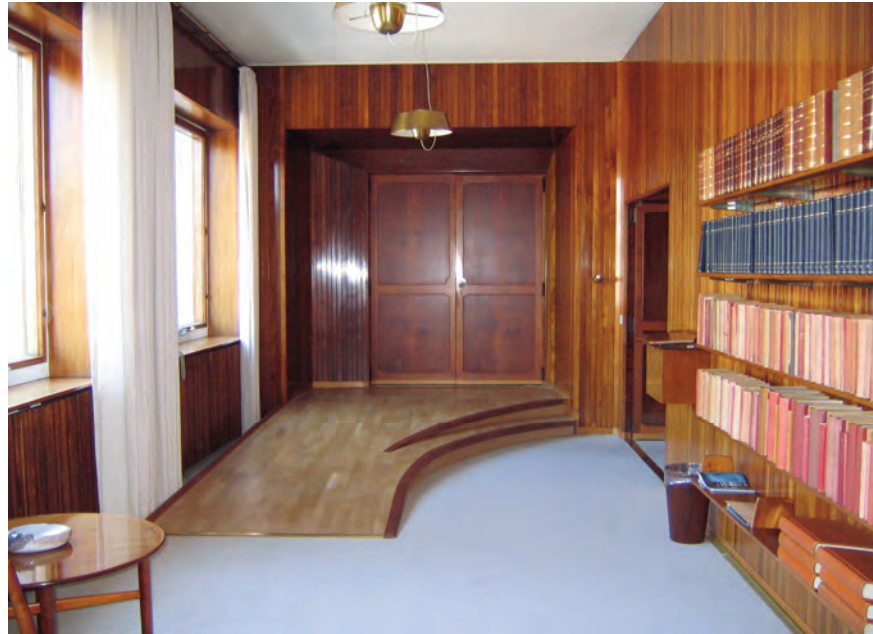
FIG 13-4. The ramp to the city council hall. Alice Rosenberg ©

From the main entrance the visitor enters into the vestibule. The entrance of the vestibule is three steps lower than the rest of the vestibule. In one corner the difference in level is resolved by a fixed bench. The surface of the entrance floor is covered in mosaic stone; the floor of the remainder of the vestibule and hall is parquet made of bog oak.

In order to overcome the difference in levels, a short ramp is situated next to the security man's desk. The ramp which has low raised edges is made of bog oak staves.

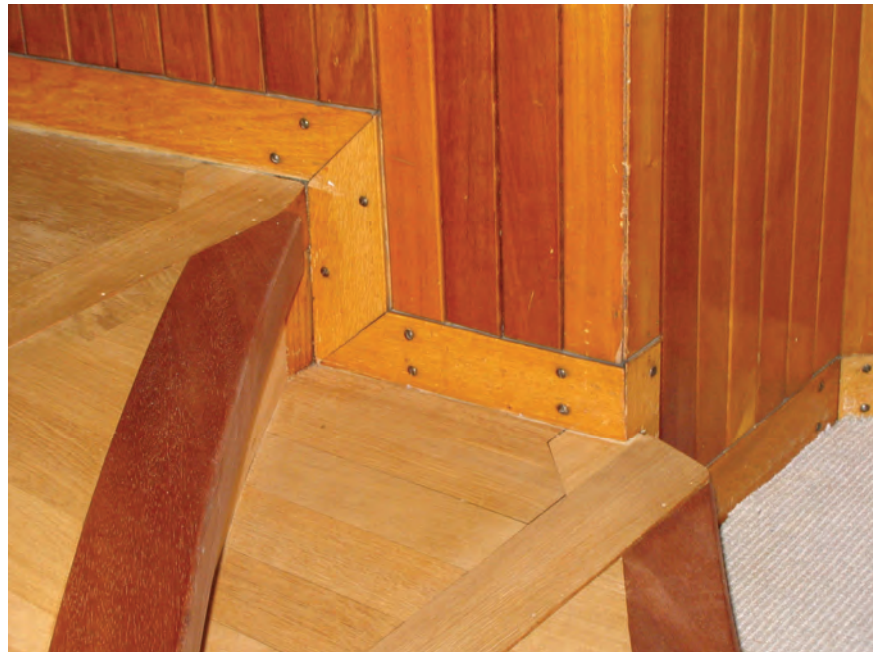
FIG 13-5 Detail showing how the new ramp meets the existing step. Alice Rosenberg ©

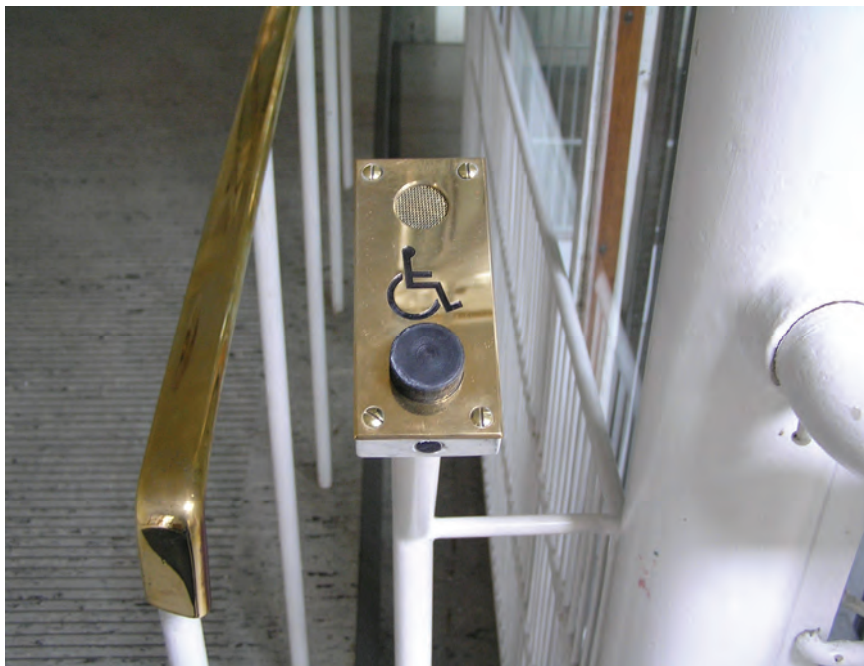
FIG 13-6. The call button at the lift. Alice Rosenborg ©

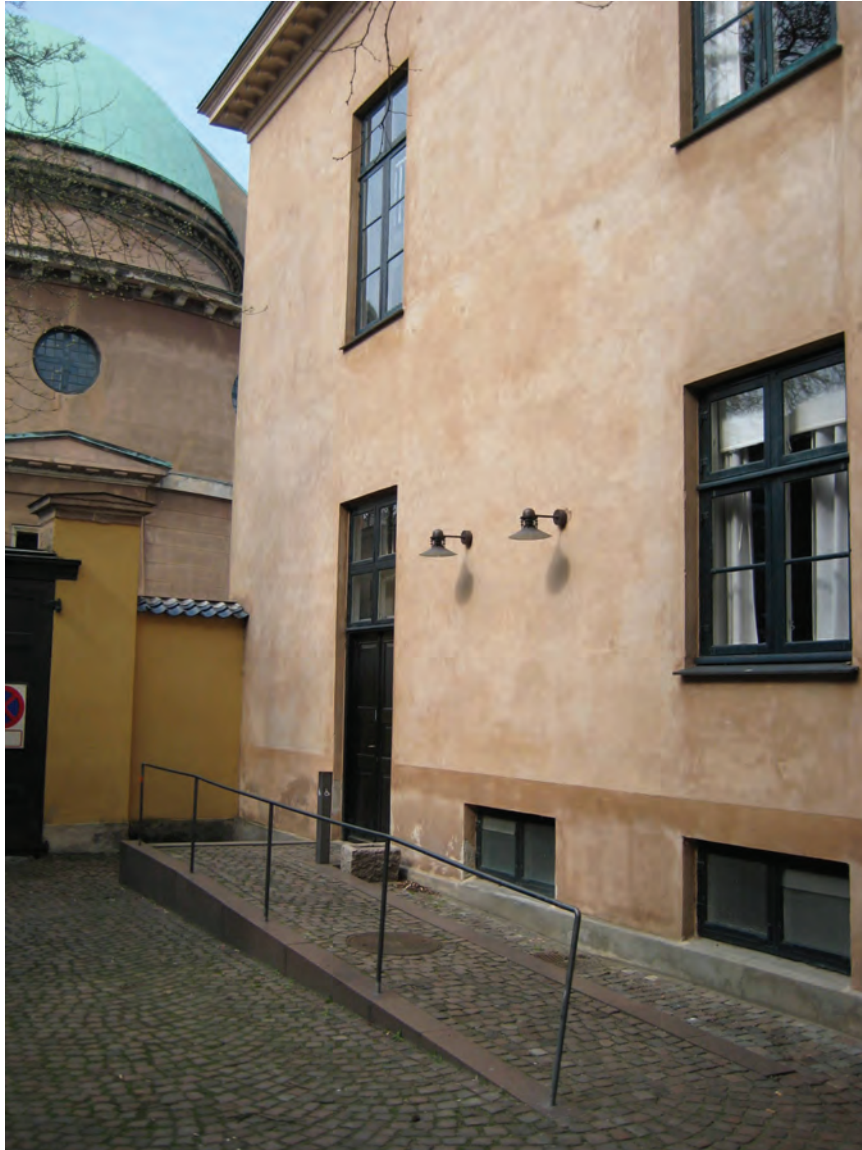
FIG 14–1 Metropolitanskolen: Access via a door in the gable of the building. Ebbe Keld Pedersen, Kulturarvsstyrelsen ©

People with mobility impairments and wheelchair users have access to the building via a door in the gable of the building. A short ramp leading up to the door has been fitted in under the window, with the same width as the window.

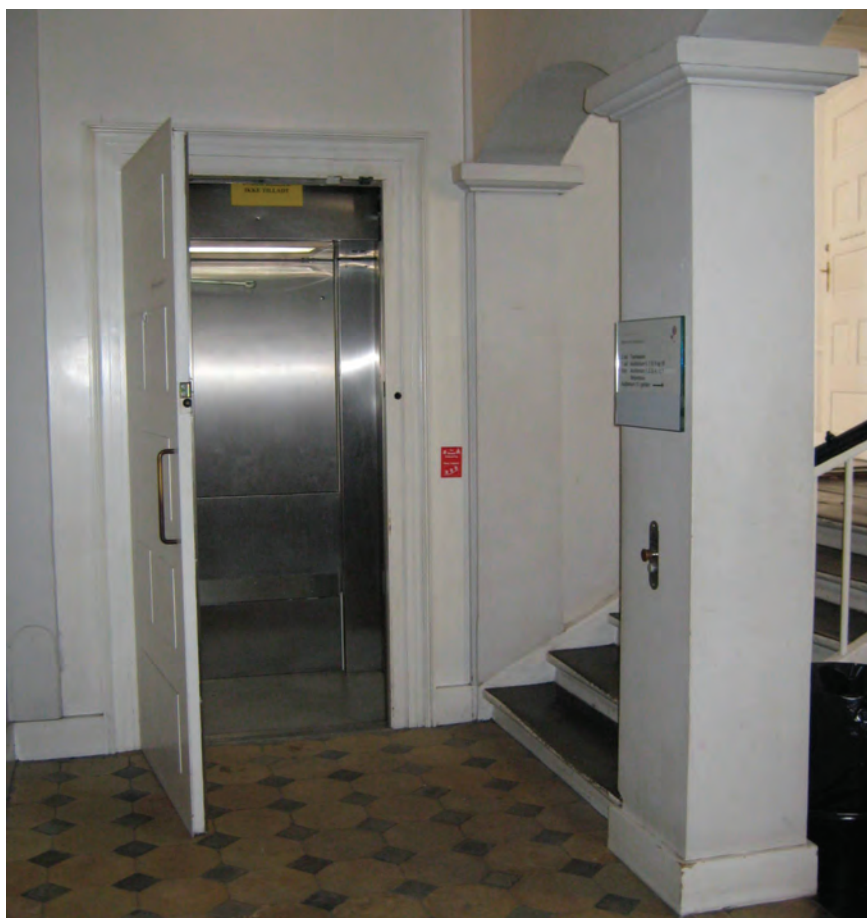
FIG 14-2. Internal lift. Ebbe Keld Pedersen, Kulturarvsstyrelsen ©

To give access to the ground floor and the basement level a lift has been installed in the double wall. The doors leading into the lift are automatic. The new door on the ground floor has been cut into the wall symmetrically with the old door; its design has references to the old door but at the same time clearly marks it as new.

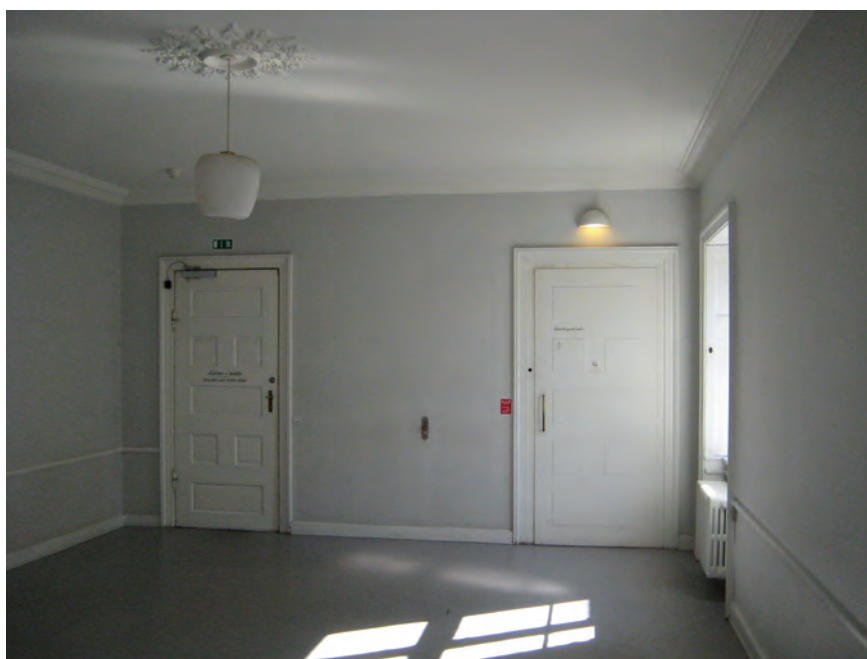
FIG 14-3. The new door to the right. Ebbe Keld Pedersen, Kulturarvsstyrelsen ©

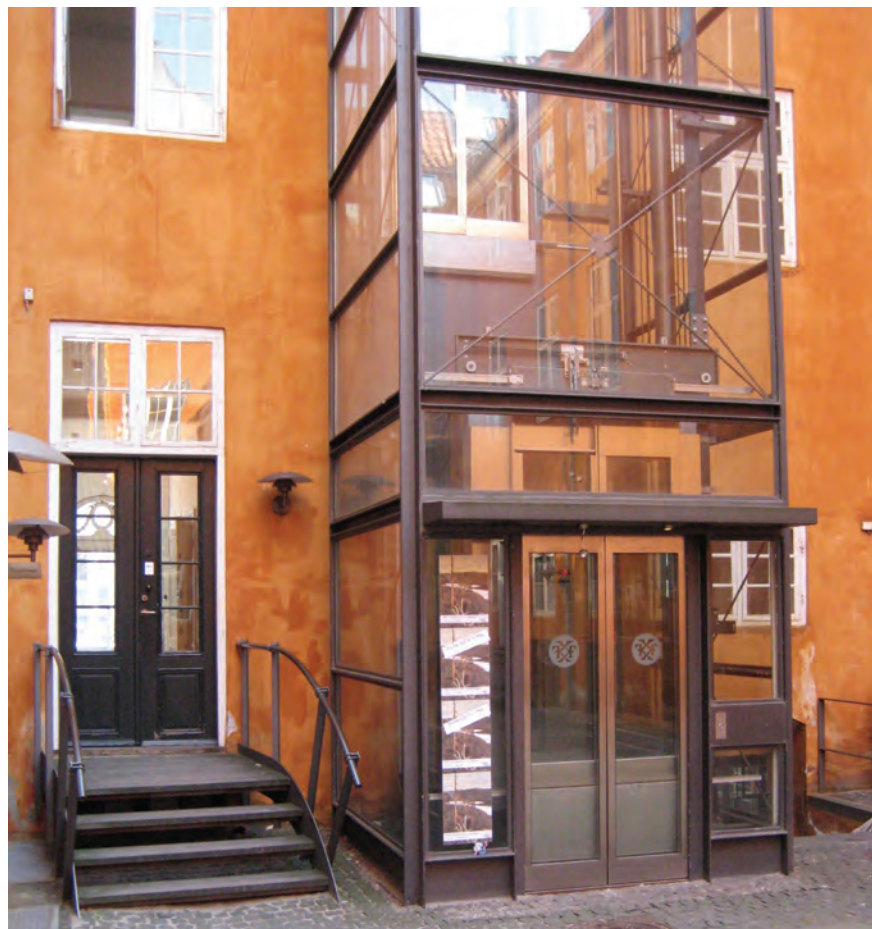
FIG 14–5. The lift in the courtyard. Ebbe Keld Pedersen, Kulturarvsstyrelsen ©

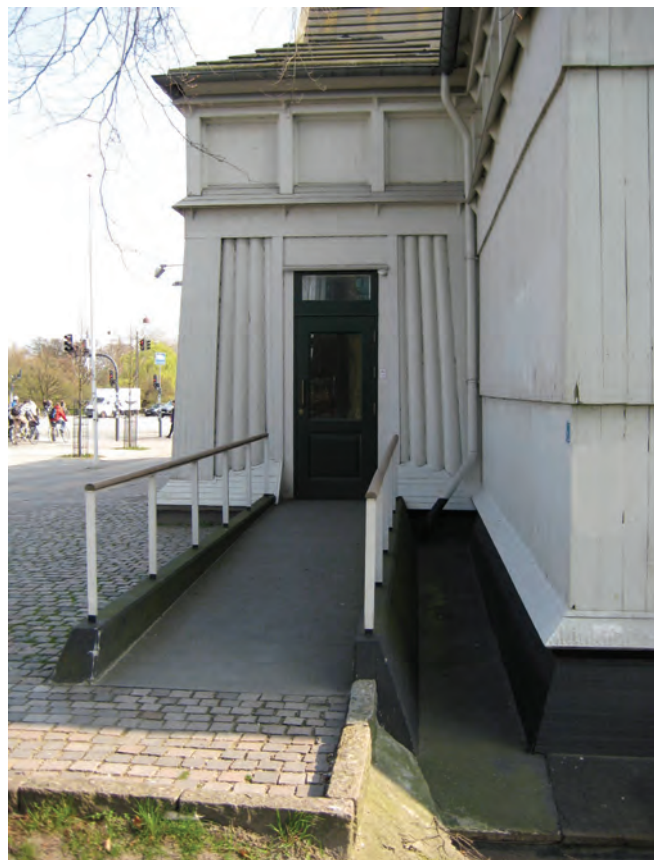
FIG 14-7 The new side entrance. Ebbe Keld Pedersen, Kulturarvsstyrelsen ©

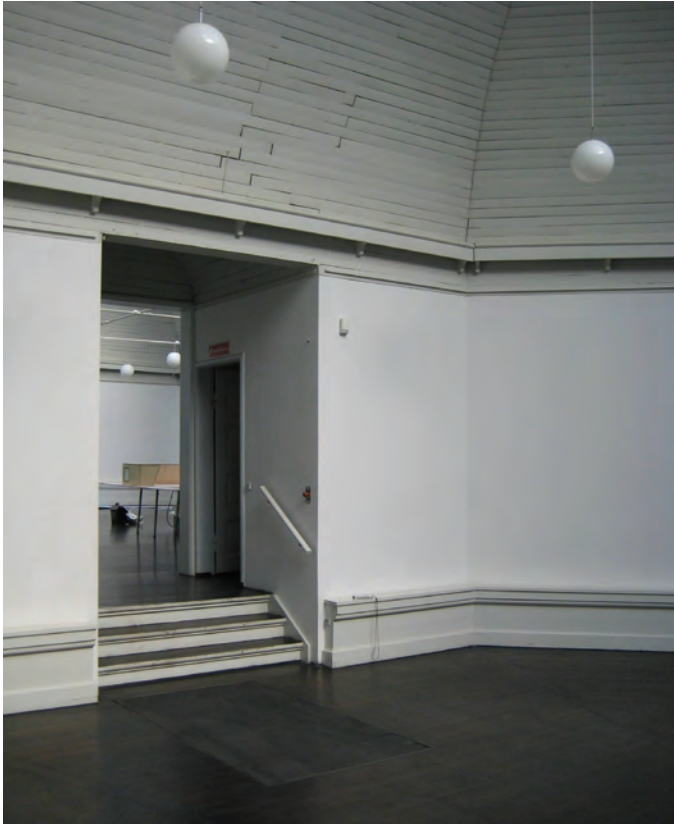
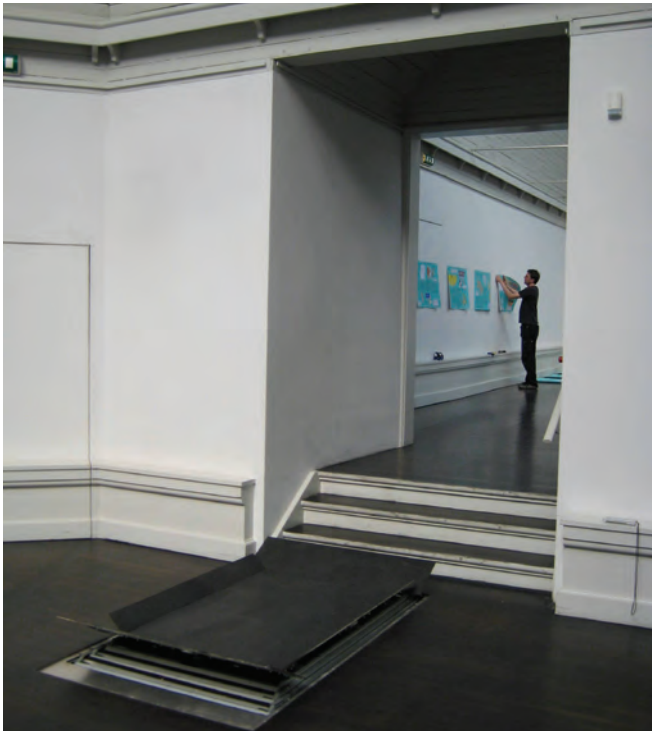
FIG 14–8. Den Frie Udstillingsbygning, internal lift. Ebbe Keld Pedersen, Kulturarvsstyrelsen ©

FIG 14–9. Den Frie Udstillingsbygning, internal lift. Ebbe Keld Pedersen, Kulturarvsstyrelsen

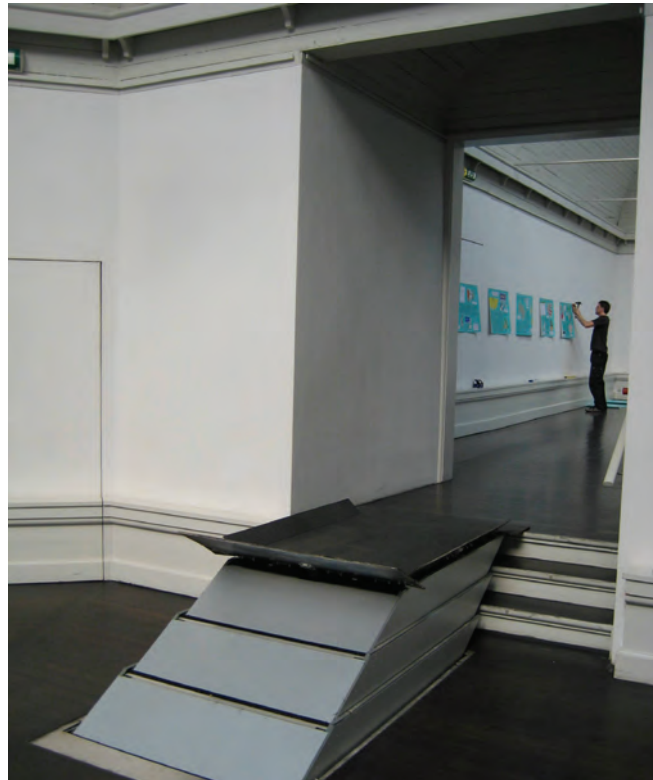
FIG 14–10. Internal lift in contemporary design. Ebbe Keld Pedersen, Kulturarvstyrelsen ©

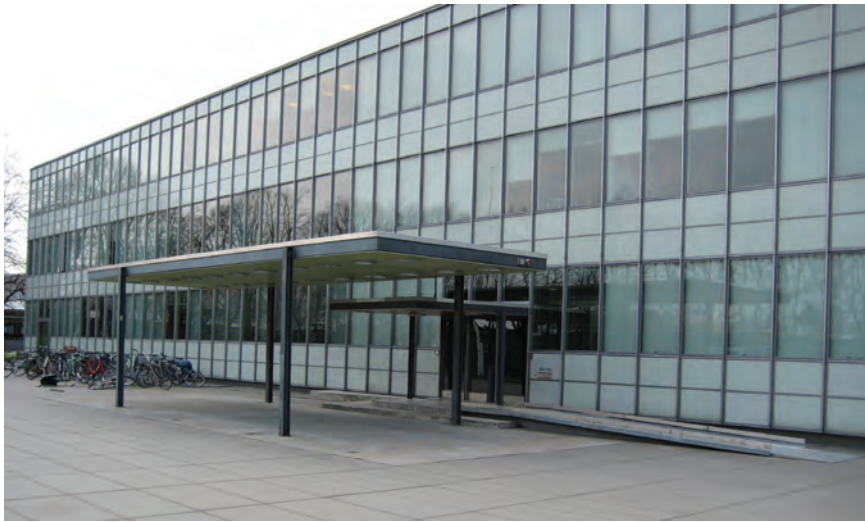
FIG 14–11. Rødovre Rådhus, external entrance. Ebbe keld Pedersen, Kulturarvsstyrelsen ©

The main entrance is marked by a low baldachin, canopy, supported by two steel columns. In front of this there is a bigger and higher baldachin, which is an independent construction. From the level of the town hall square two steps lead up under the baldachin to the entrance door. Once inside the building there are a further two steps up to the ground floor. The challenge was to find solutions for wheelchair users that would harmonise with the building's refined architectural details.

The external difference in level is bridged by a freestanding ramp that is parallel to the façade. The upper wide step makes it possible for the wheelchair user to turn directly to the entrance door.

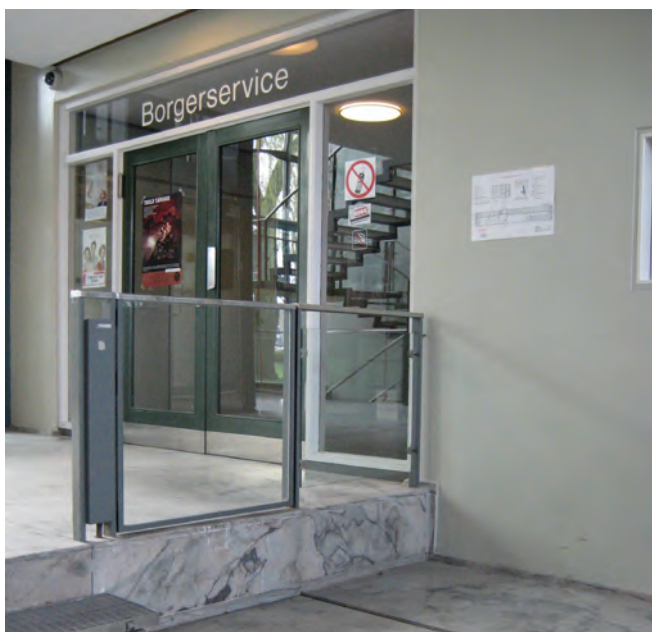
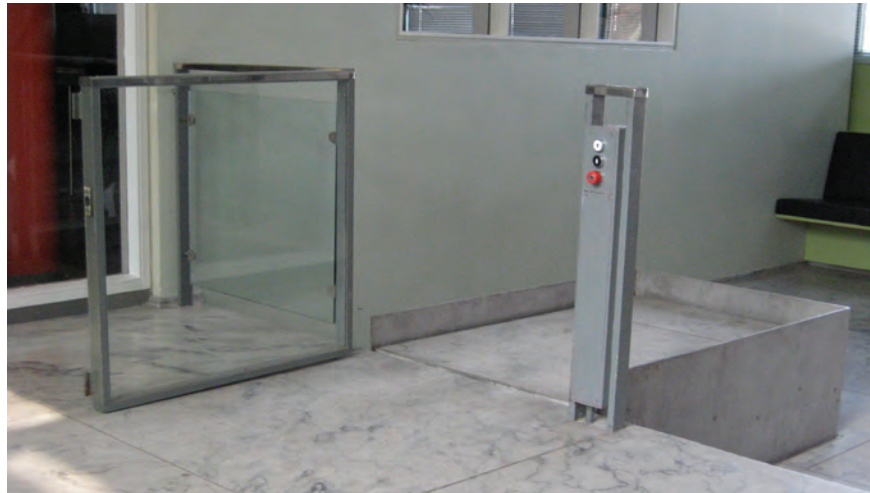
FIG 14–12. Internal lift in contemporary design. Ebbe Keld Pedersen, Kulturarvsstyrelsen ©

FIG 14–13. Internal lift in contemporary design. Ebbe Keld Pedersen, Kulturarvsstyrelsen ©
