## THE NEED FOR OLD BUILDINGS TO "BREATHE"

Philip Hughes

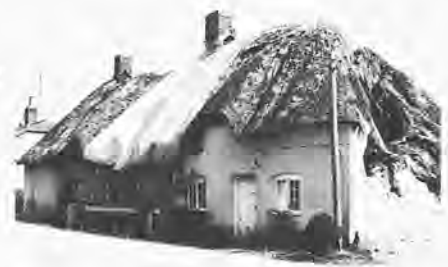
Water penetration at the top of the cob walls has resulted in their decay. The cement render applied externally prevented the walls from drying out and led to the suddenness of the collapse.

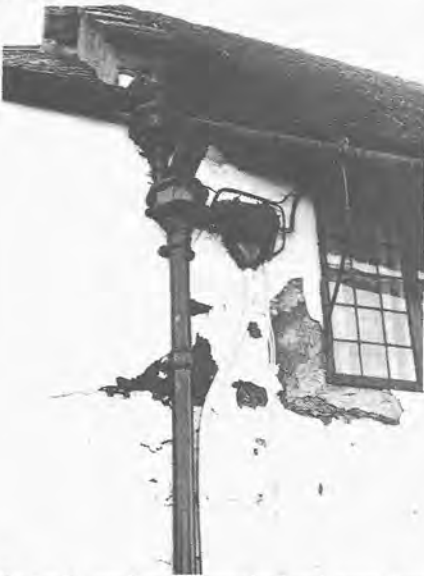
Frequently overflowing hopperhead and gutter have saturated the wall behind an impervious paint layer. Decay of the walling immediately behind the paint film has resulted in flaking.

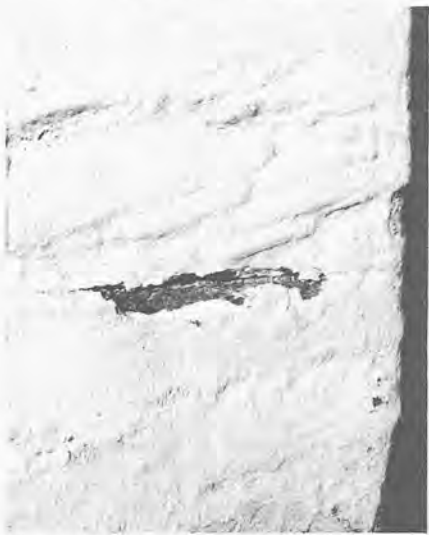
Moisture trapped behind an impervious paint film has caused it to blister. The effect of salts and frost has led to further decay.

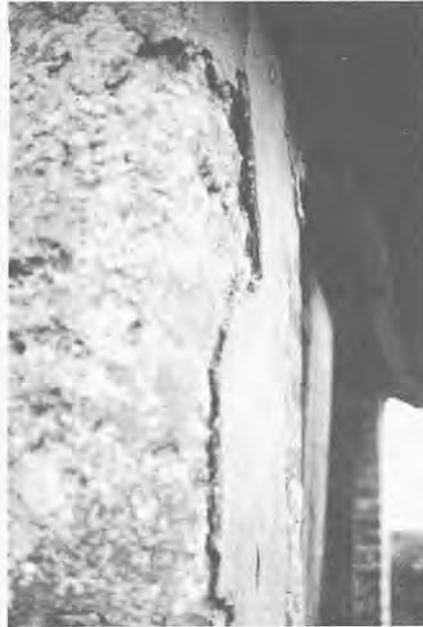
Strong cement render on a cob wall. The render is being forced off the wall and is taking the surface of the cob with it. The cob behind this is decaying.

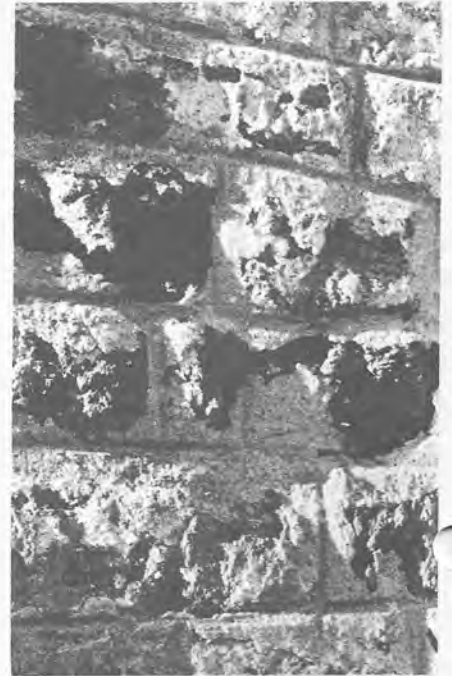
Dense cement pointing splurged over the face of the stonework inhibits the evaporation of water from the wall and leads to rapid decay of the stone.

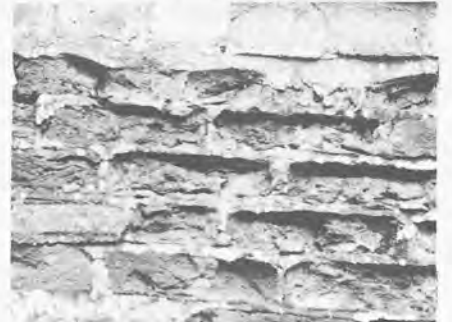
Strong cement-based mortar survives while the wall it was used to point-up decays. This could have been avoided by the use of a lime-based mortar, weaker than the brickwork.

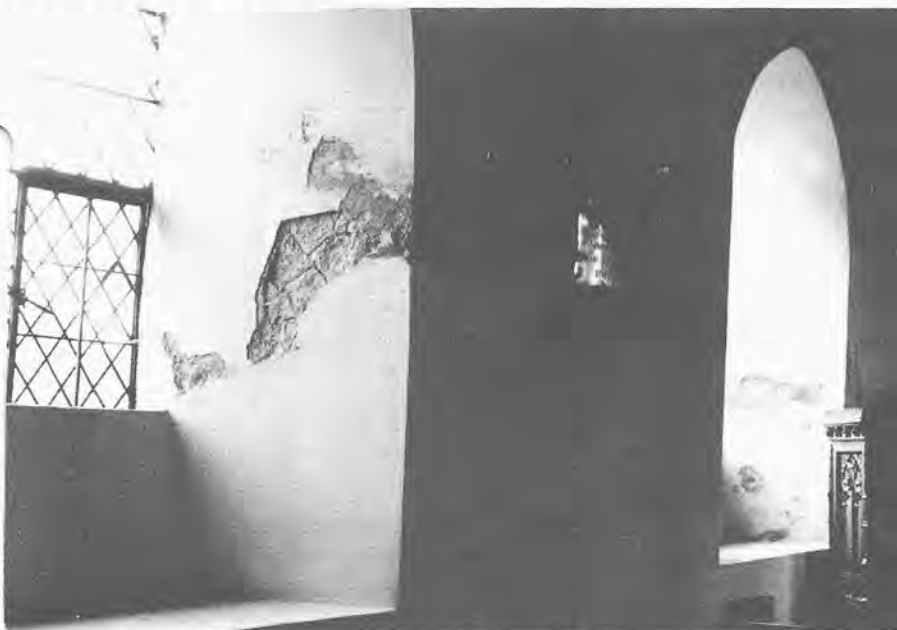
Strong cement-based render has been used to replace plaster affected by damp on the lower part of these massive walls. As a result the damp has risen higher in the wall and has now affected old plaster that had remained sound.

Where dense plasters are used to cover a wall suffering from rising dampness the effect may be only to drive the moisture higher up the wall. This may cause old plaster which had remained sound hitherto to become affected, or may force moisture up the wall and into contact with timber, making it susceptible to decay.

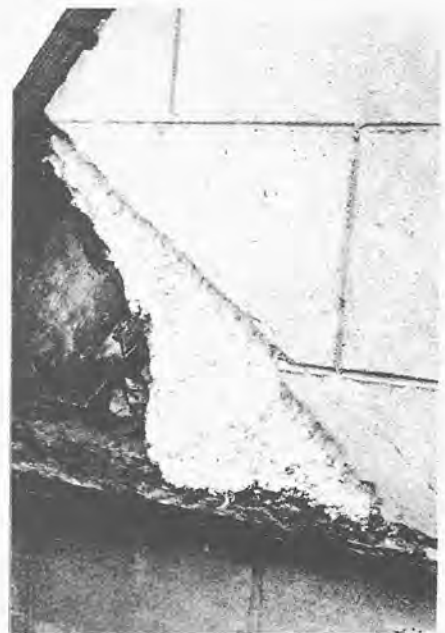
Cement render has been applied over a lime roughcast on this timber-framed building. The cement is being carefully removed in small pieces by forming hairline cracks with a lump hammer.

Cement renders can sometimes be removed after working over the surface thoroughly with a hammer to fracture the render into small units. Levering off large sheets of render will cause severe damage to soft underlying materials. Where a render is so hard that it does not respond it is probably best to leave it to age naturally. Rendering should be in a lime or a very weak cement/lime mix (see *Mortars, Plasters and Renders in Conservation* by John Ashurst).

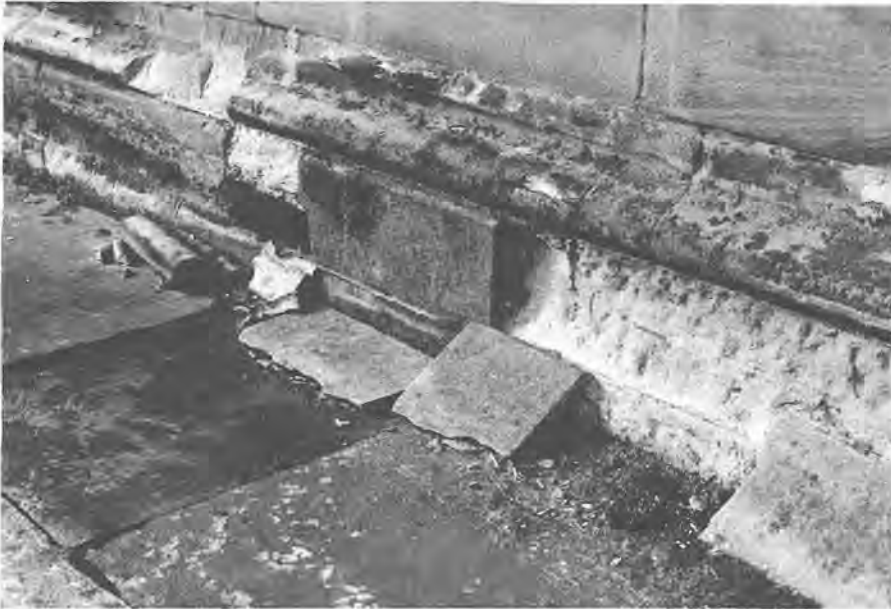
Salt crystallisation behind the strong cement patches on this plinth has led both to these being forced off and to further disintegration of the stonework.

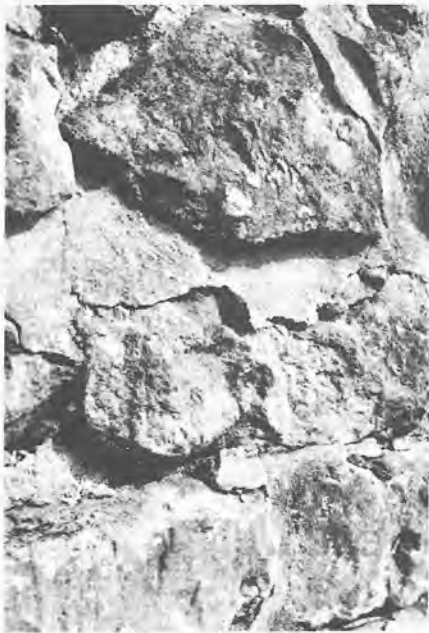
Strong cement pointing being forced off the wall by crystallisation of salts behind. Increased levels of dampness within the wall have caused decay of the earth-lime mortar, leading to compaction of the wall—also forcing off the dense pointing.
