Chimneys in old buildings

by
G. B. A. Williams FRIBA

Society for the
Protection of
Ancient Buildings

Technical pamphlet 3

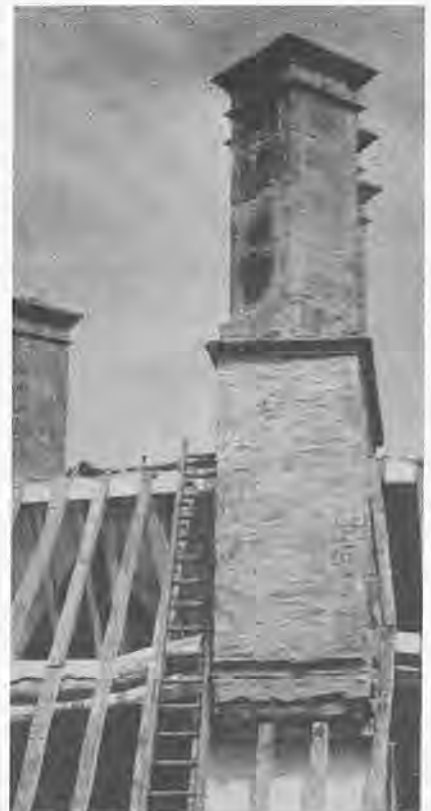
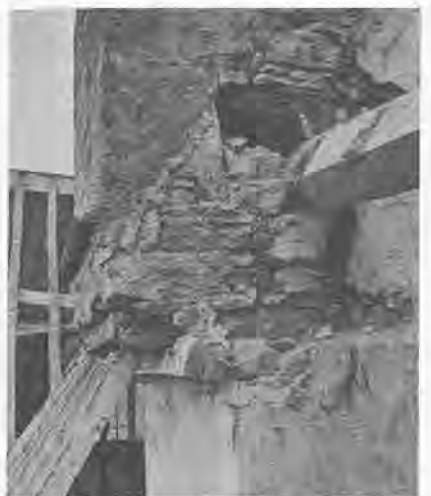
Above: General view of the central chimney stack at Kelmscott Manor. Below: Detail of the defective supporting timbers revealed on opening up (see Fig 6).

(v) *With old buildings special cases can always arise.* One such was a chimney stack, 15ft high and 45ft from the ground. It was leaning inwards 10in due to a built-in-wall-plate running lengthwise along the base of the stack which had crushed due to rot. The joints on the outside of the stack were thoroughly raked out at eaves level to form a 'hinge' the stack carefully jacked back to the vertical, the rotted wall plate removed, a concrete pad substituted, and the raked out joints repointed (Fig 6).

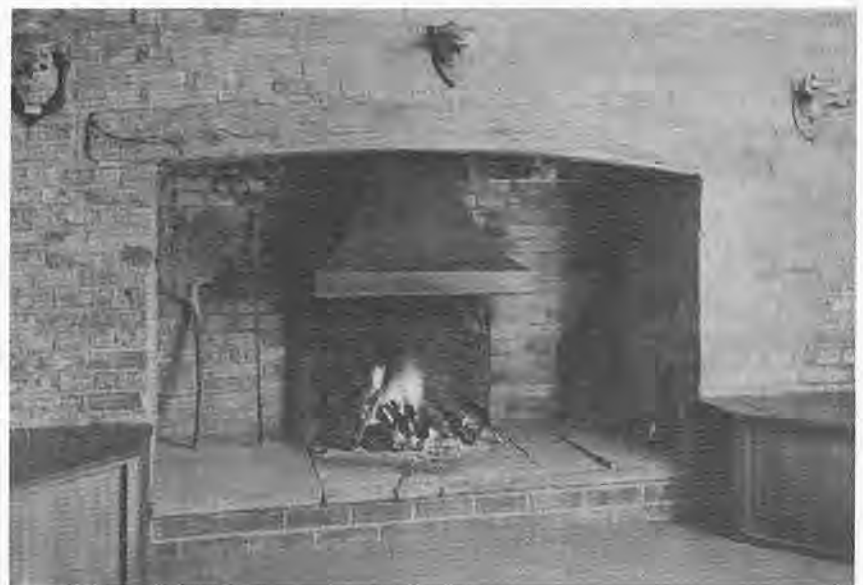
Right: Improvements to a medieval fireplace at Woodsell, near Faversham, Kent. This illustrates the use of a raised hearth with air inlet and a hood and flue liner above
