Strengthening timber floors

by John E M Macgregor OBE, FSA, FRIBA

Strengthening Timber Floors: A notice from the SPAB Technical Panel

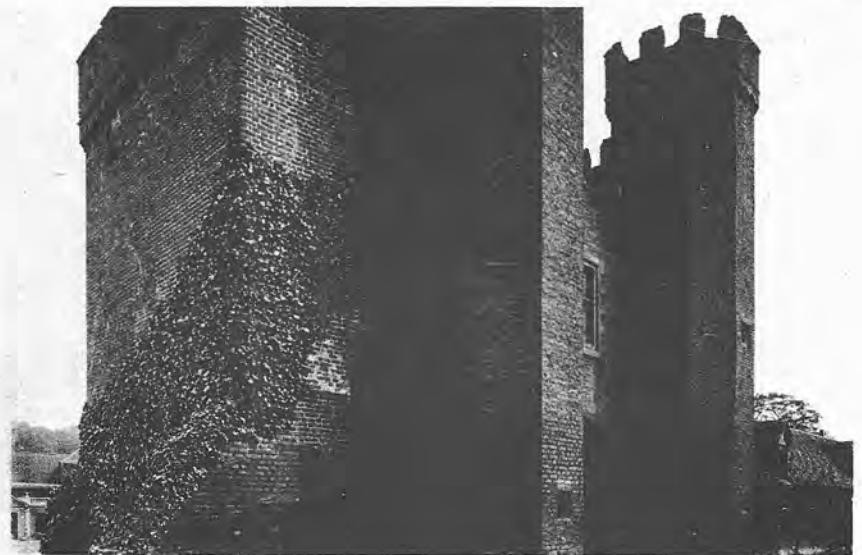
Fig. 3: Lullingstone Castle, Kent, where a 15th-century beam was supported by top and bottom plates.

A richly moulded 15th-century beam at Lullingstone Castle, in Kent (Fig. 3), which was split and fractured completely in many places and had rich, moulded oak joists on both sides, was recently dealt with successfully in this manner (Fig. 4). The only visible effect is a 3 in x 1/2 in plate on the under side, which, when tinted to the colour of the oak, is hardly noticed.

This method consists of placing metal plates beneath and on top of the sagging or fractured beam and then bolting vertically, so that steel takes the place of the top and bottom flanges of the rolled-steel joist, and the timber acts merely as the web.

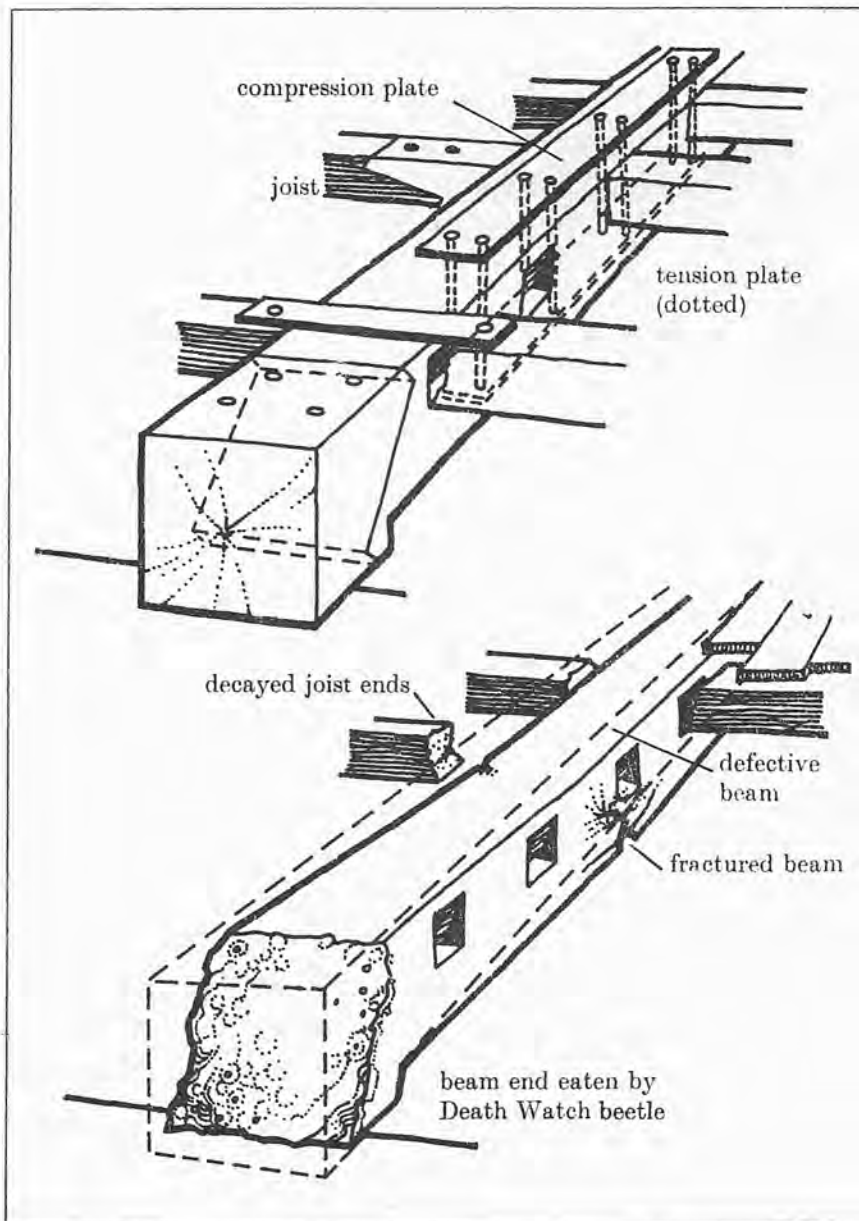
Timber beams always fracture first on the under-side (Fig. 1), showing that it is the tensile portion of the beam that is weakest. Bearing this in mind the following methods for dealing with a fractured or sagging beam can be considered.

Fig. 1: Inserting a tension plate to support a beam that has fractured
