The Surface Treatment of Timber-Framed Houses

37 Spital Square, London E1 6DY: 01 377 1644

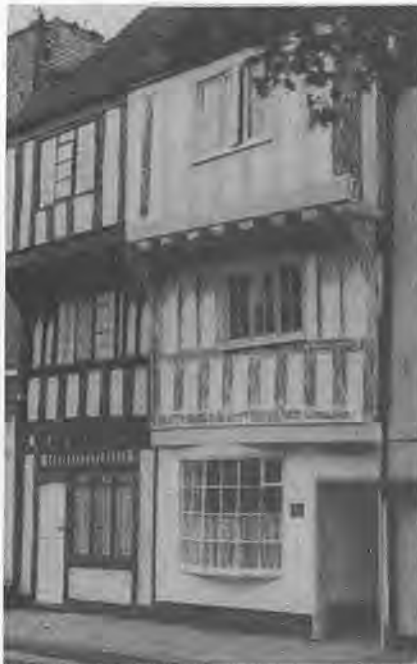
The Society advises against blackening timbers in favour of limewashing both timber and panel. Numbers 82 and 83 Church Street, Tewkesbury, demonstrate the subtlety of the latter.

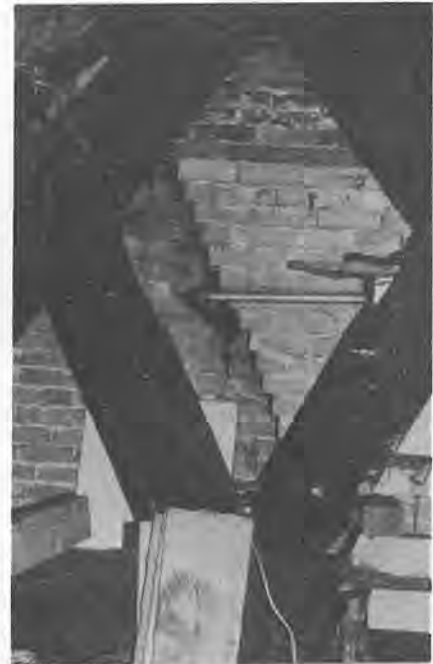
The heavy smoke blackening and soot encrustation is evidence of an early date for this building. A hearth in a hall open from ground to roof without a chimney would have produced this effect. The chimney in the background is a later insertion.

A further point to be remembered by those engaged in the repair of old timber-framed houses, is that in the halls of medieval houses, the central fire blackened the roof timbers and although subsequent floors and chimney stacks may have been inserted, the blackened timbers are a valuable record of the historic evolution of the building and an interesting feature; therefore the surface should not be cleaned or scraped but gently brushed to remove loose dust.

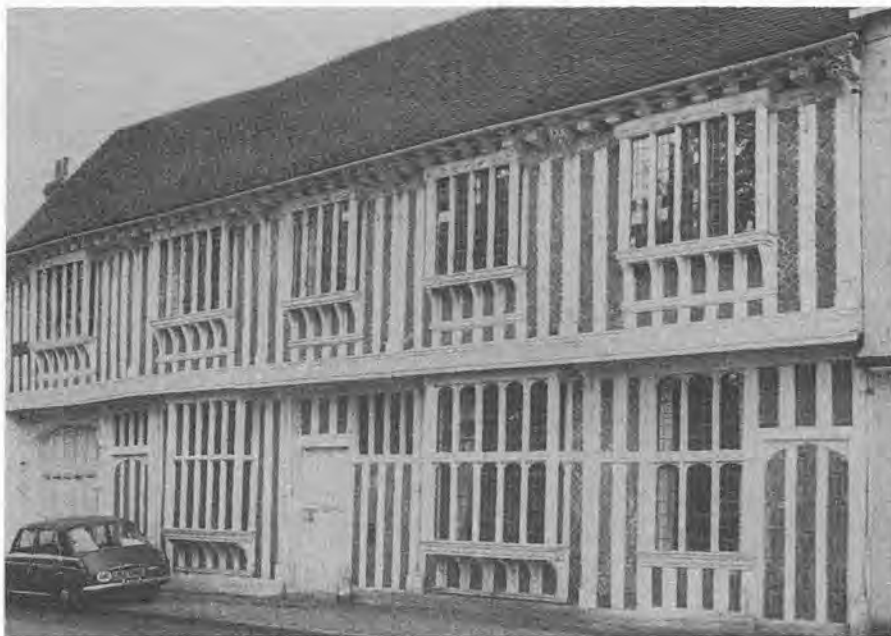
At Paycocke's in Coggeshall, Essex, the timbers were limewashed leaving the brick nogging exposed. This photograph was taken when the work was first carried out. The effect is startling. After three years, however, the oak weathered to a superb-looking silvery colour.

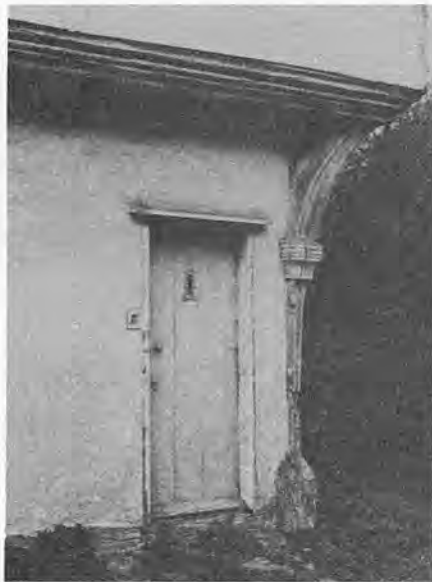
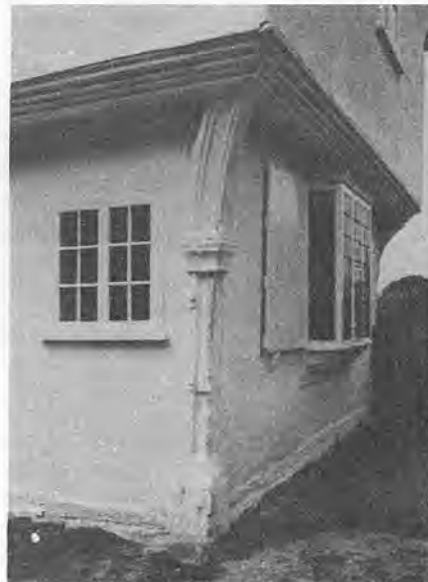
Above: Church Row, Clavering: detail of corner post and bressumer before and after limewashing. The corner post and bracket requires a further coat although the gradual flaking leaving the silver oak exposed is not unattractive.

4. Sometimes when defective rendering has to be removed, presentable old timber-framing is revealed which one does not wish to cover up again. Despite satisfactory repair the surface of the oak can present a blotchy effect. This can be rectified by carrying one or more coats of limewash over both panel and tim-

ber; the deposited lime is removed with a bristle brush on the following day. Alternatively coats of sulphate of iron can give a mid-grey effect.

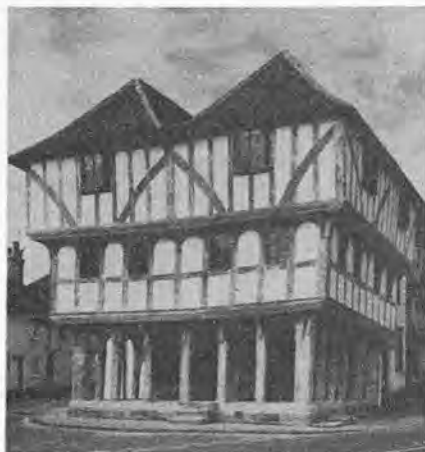
Left: At Thaxted Guildhall the limewash was lightly brushed off the exposed timbers leaving all the crevices and holes filled. The brushing was done to maintain the half-timbered appearance of a well loved tourist landmark.
