Society for the
Protection of
Ancient Buildings

Panel infillings to timber-framed buildings

Technical pamphlet 11 by Kenneth Reid RIBA

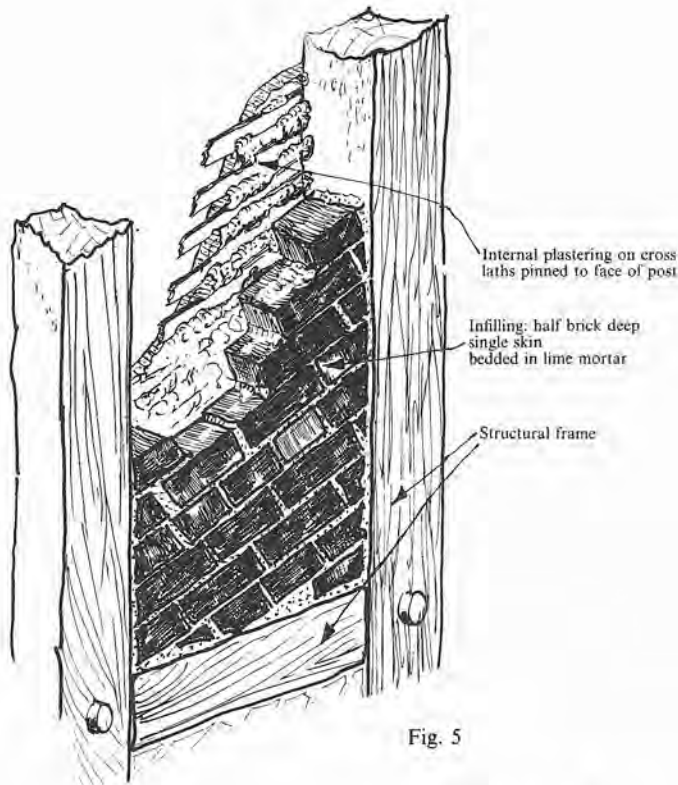
Fig. 5

Fig. 5: *Brick nogging panel*. The practice did not become common until the latter part of the 16th century by which time brick making had become widely established.* In some areas the courses were at first laid at an approximate angle of 45 degrees, but later they were laid horizontally. The great majority of brick panels are later replacements of wattle and daub.

The unavoidable slight dimensional changes and movements, inseparable from oak framing, combined with the weight and lack of flexibility of the brick panel itself, increase the likelihood of penetrable cracks. Hence many brick panels were subsequently rendered over.

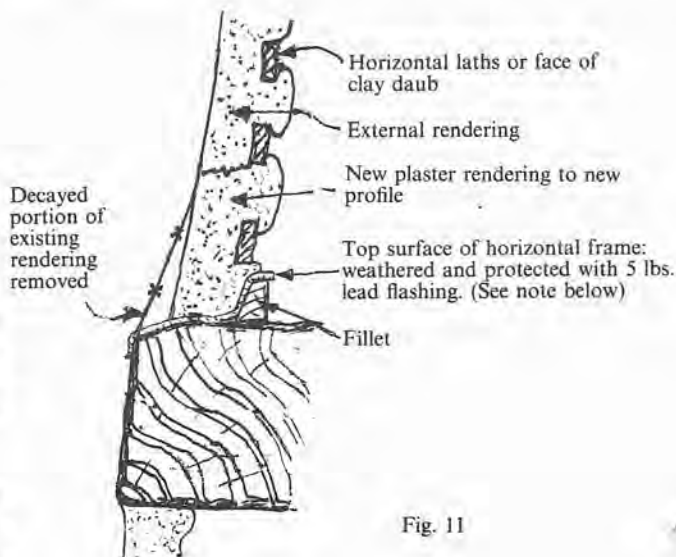
Fig. 11

Fig. 11: shows where movement in the structural frame has brought about a failure in the rendering. The lower portion has suffered a more continuous wetting than the rest of the panel and, as it seldom dries out, this leads to disintegration of the plaster. The repair shown illustrates a partial remedy. With this treatment the new surface would be kept as near vertical as conditions allow.

N.B. Although a lead flashing should overcome weathering of the sill there is a danger of water penetration through the render in exposed locations; moisture could run down the back of the lath and plaster and be trapped by the batten and lead flashing. It may be preferable, under certain conditions, to accept the alternative of renewal of the render at the base of the panel from time to time.

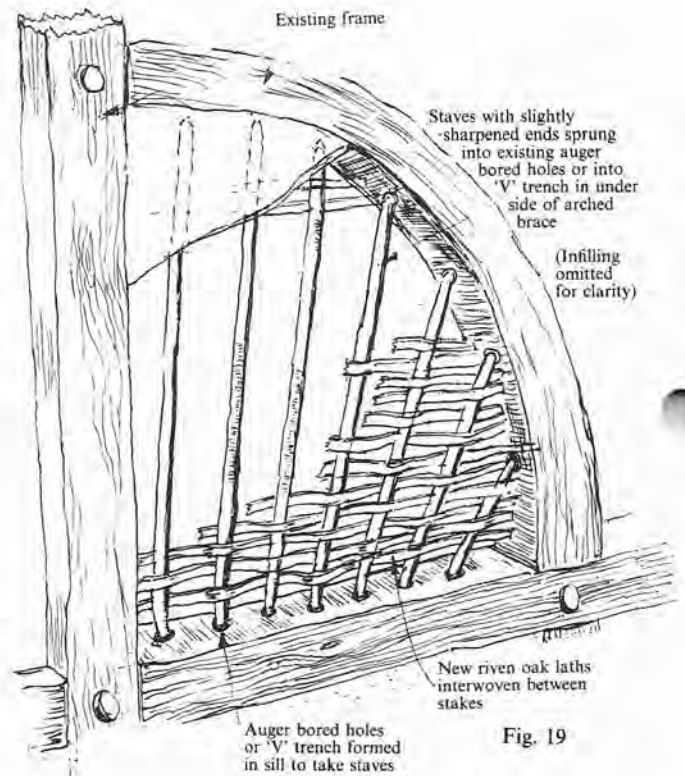
Fig. 19

Fig. 19: The foregoing examples have assumed panels of familiar rectangular shapes, but there will be others such as those abutting curved struts. Here the staves are placed radially from a lower corner and the withies of laths interwoven to produce an approximately even mesh. Where the staves remain firmly in position, and provided that beetle infestation is no longer active, freshly riven and treated laths can again be interwoven between the staves, and fresh clay 'cats' (slightly damp balls of clay mixed with a small proportion of cow-dung, chopped straw, flax stems or animal hair) 'puddled' in as in the case of normal panel shapes. Where existing staves and wattle are beyond repair, renewal can follow methods previously described.
