Society for the
Protection of
Ancient Buildings

Technical pamphlet 12

The Repair of Timber Frames and Roofs

By James Boutwood FSA RIBA

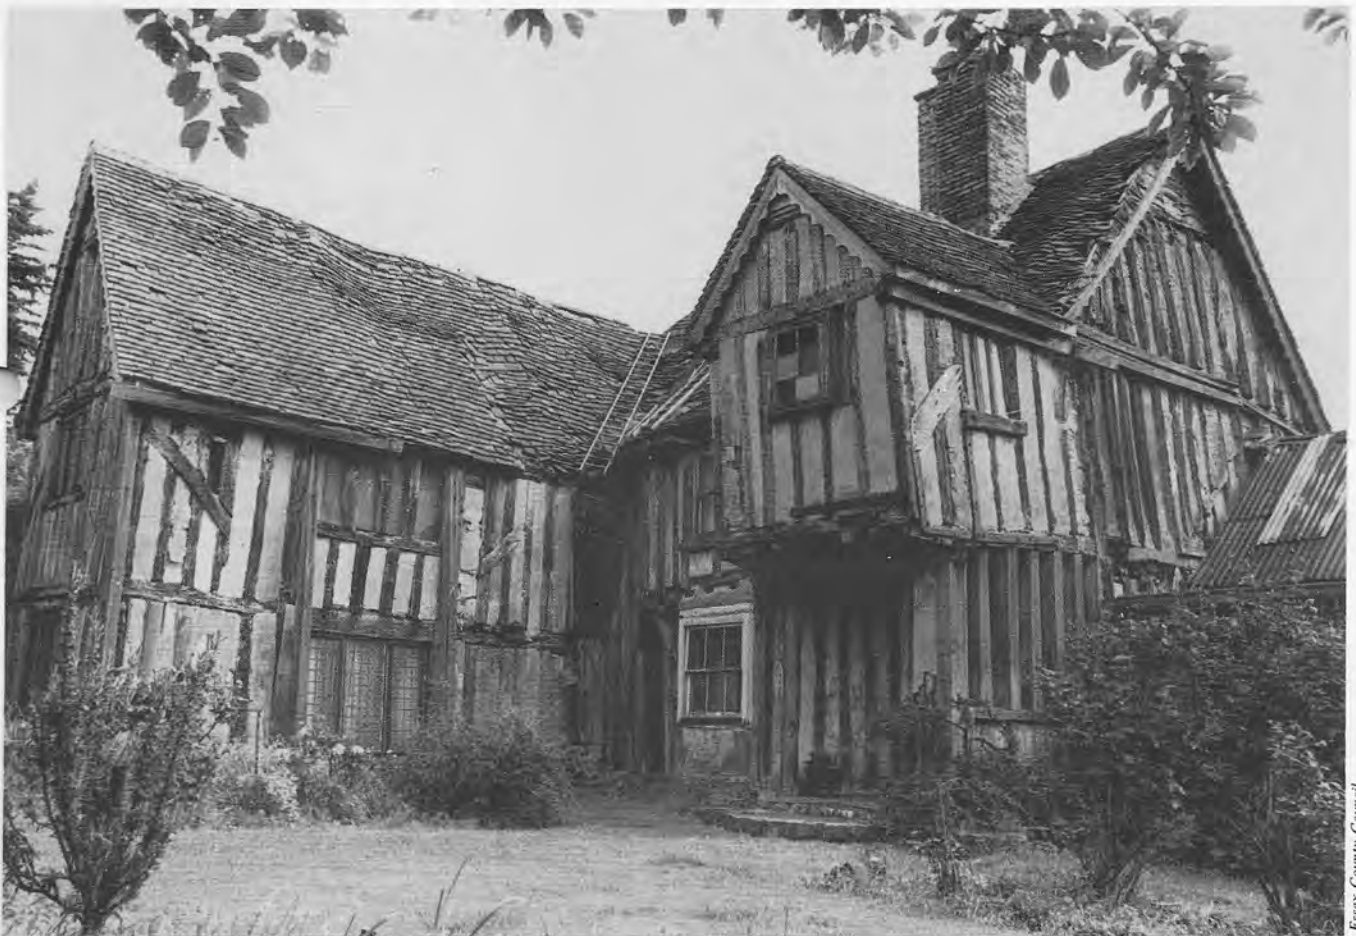
Willis Farm, near Chelmsford: it was decided that the best way to save this magnificent frame and greatly reduce the amount of repair was to put back the rendering which was first applied in the 17th century and removed by an enthusiastic amateur in the 1920s.

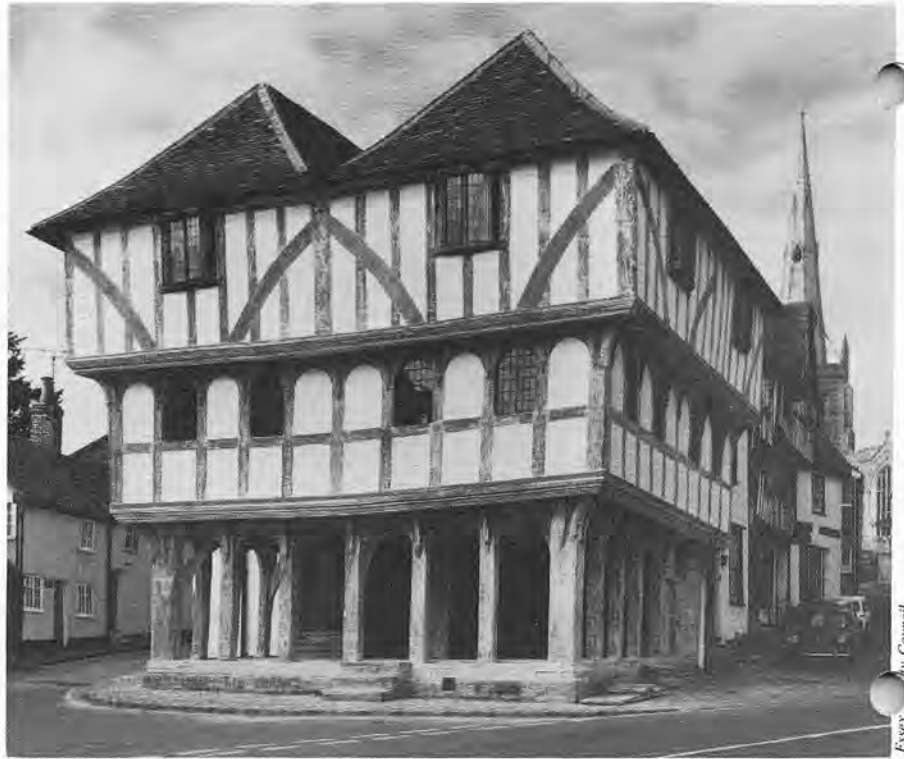
An example of conservative repair using traditional materials—all external wood and plaster surfaces were limewashed.

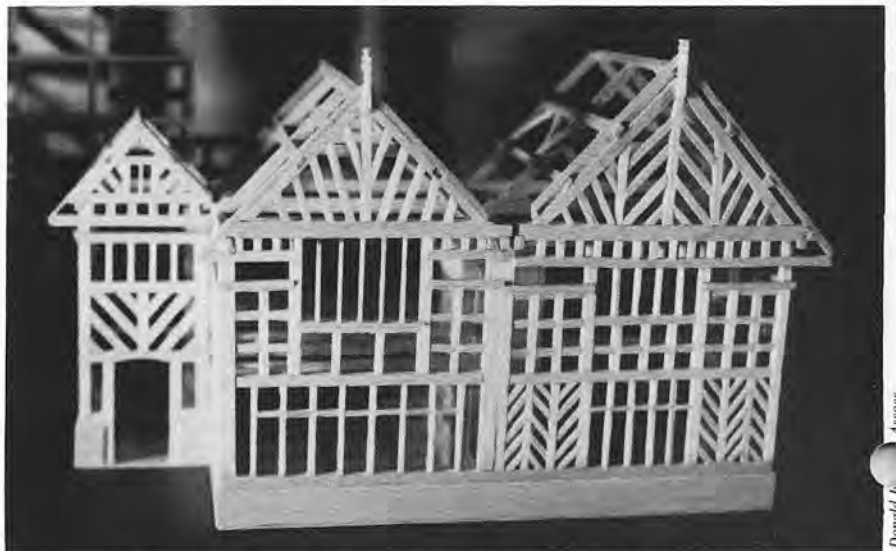
This model of timber-framing is a reconstruction of a building allowing the original construction and subsequent changes to be understood in context. The production of a model should be enough to satisfy any urge to 'restore' a timber frame to its original state; leave the building with its historical changes.

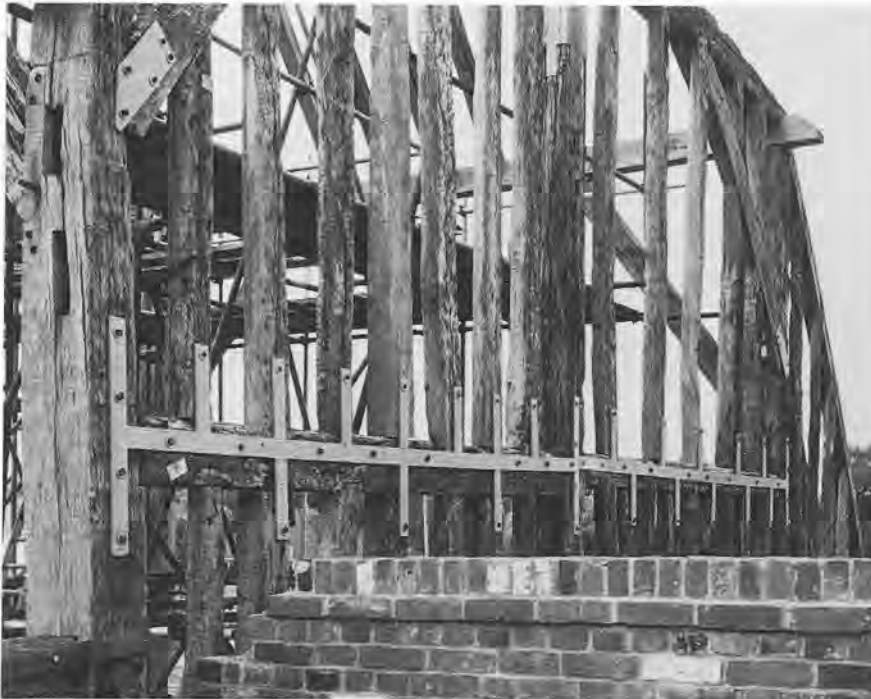
East end of Coggeshall Barn. This frame had collapsed. In its repair the use of steel strapping allowed much timber to be saved. The strap shown above is purpose-made and is covered by the external weatherboarding.

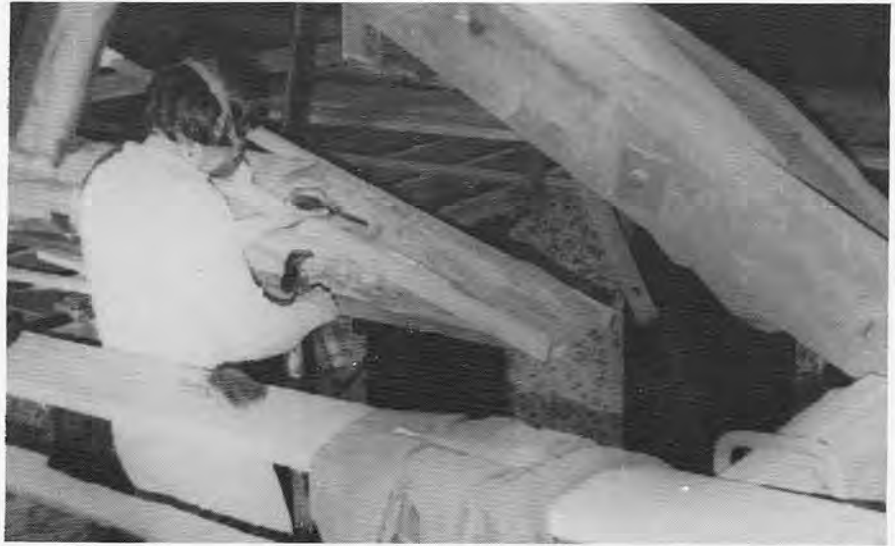
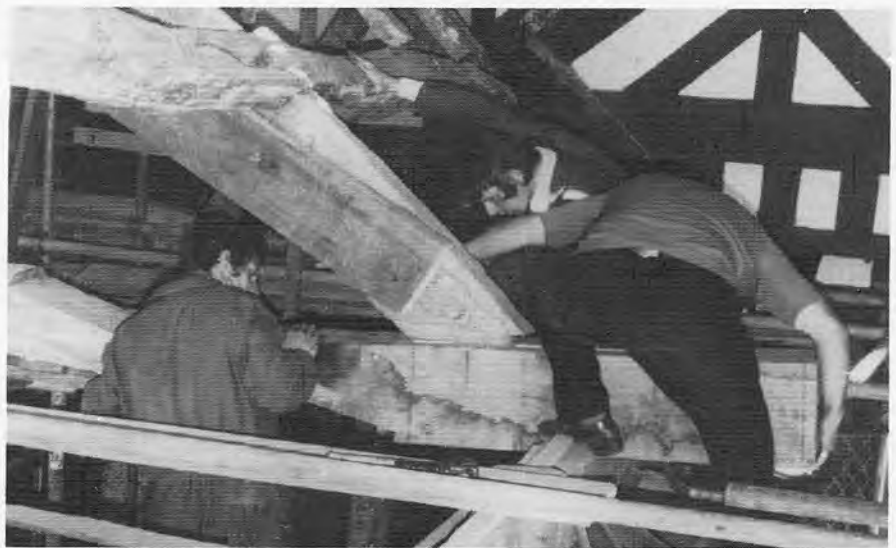
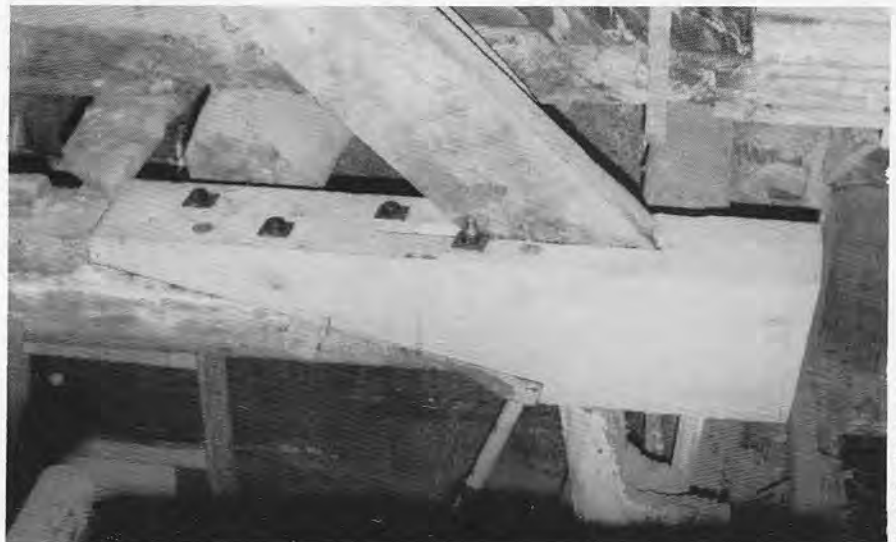
An inverted scarf joint introducing a new end and retaining the existing moulding to the underside of the tie beam.

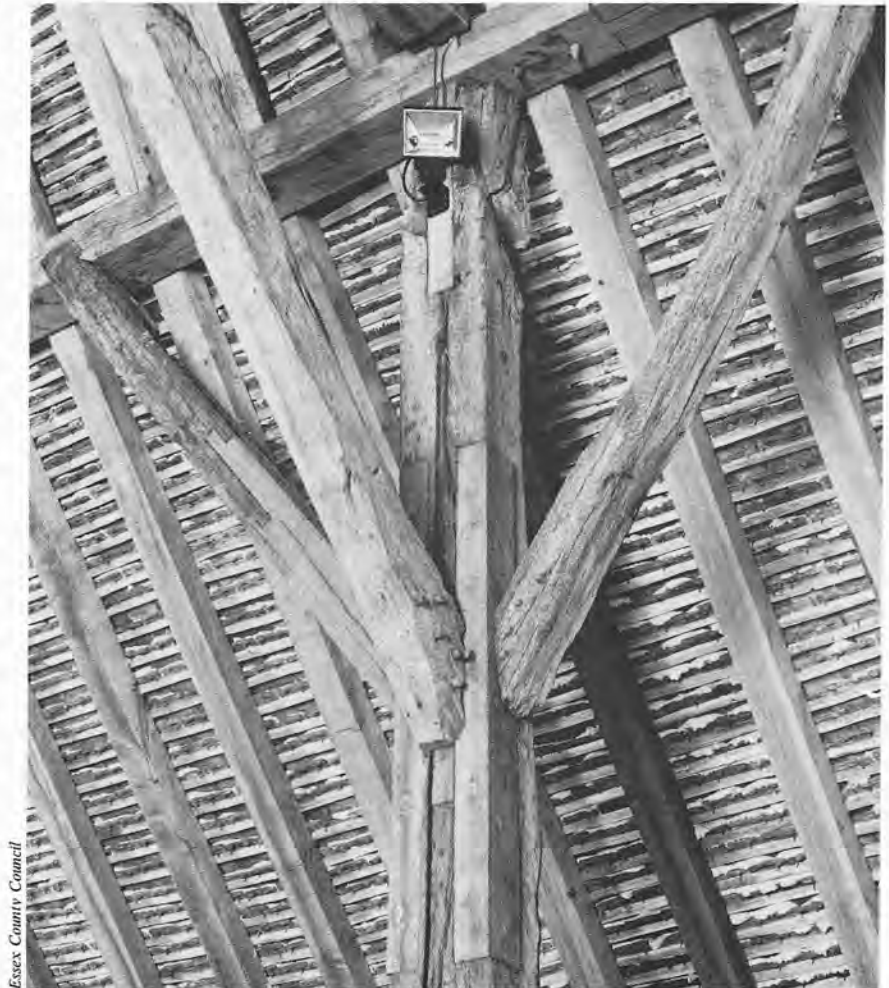
Myriad timber repairs to an early barn frame leaving much of the original timber remaining, and thus the evidence of structural changes in the past.

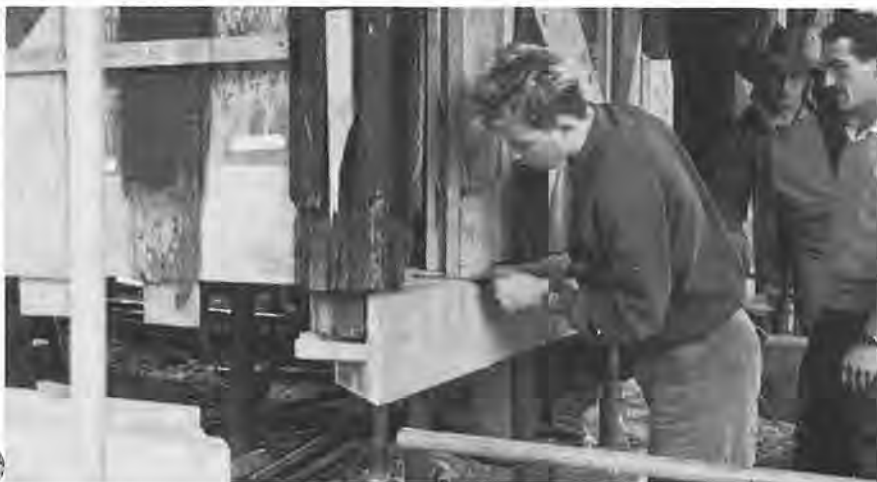
Left: Repairing a timber frame which has suffered decay in the sole plate is complex. Rarely is it necessary to replace the whole plate as shown here, but in this case the plate is a beam supporting the granary above.
